OIL PAINTING ON STONE: A CASE STUDY ON ORIGINAL TECHNIQUE AND DETERIORATION OF AN EARLY 20TH CENTURY PAINTING BY GIUSEPPE CALÌ IN MALTA

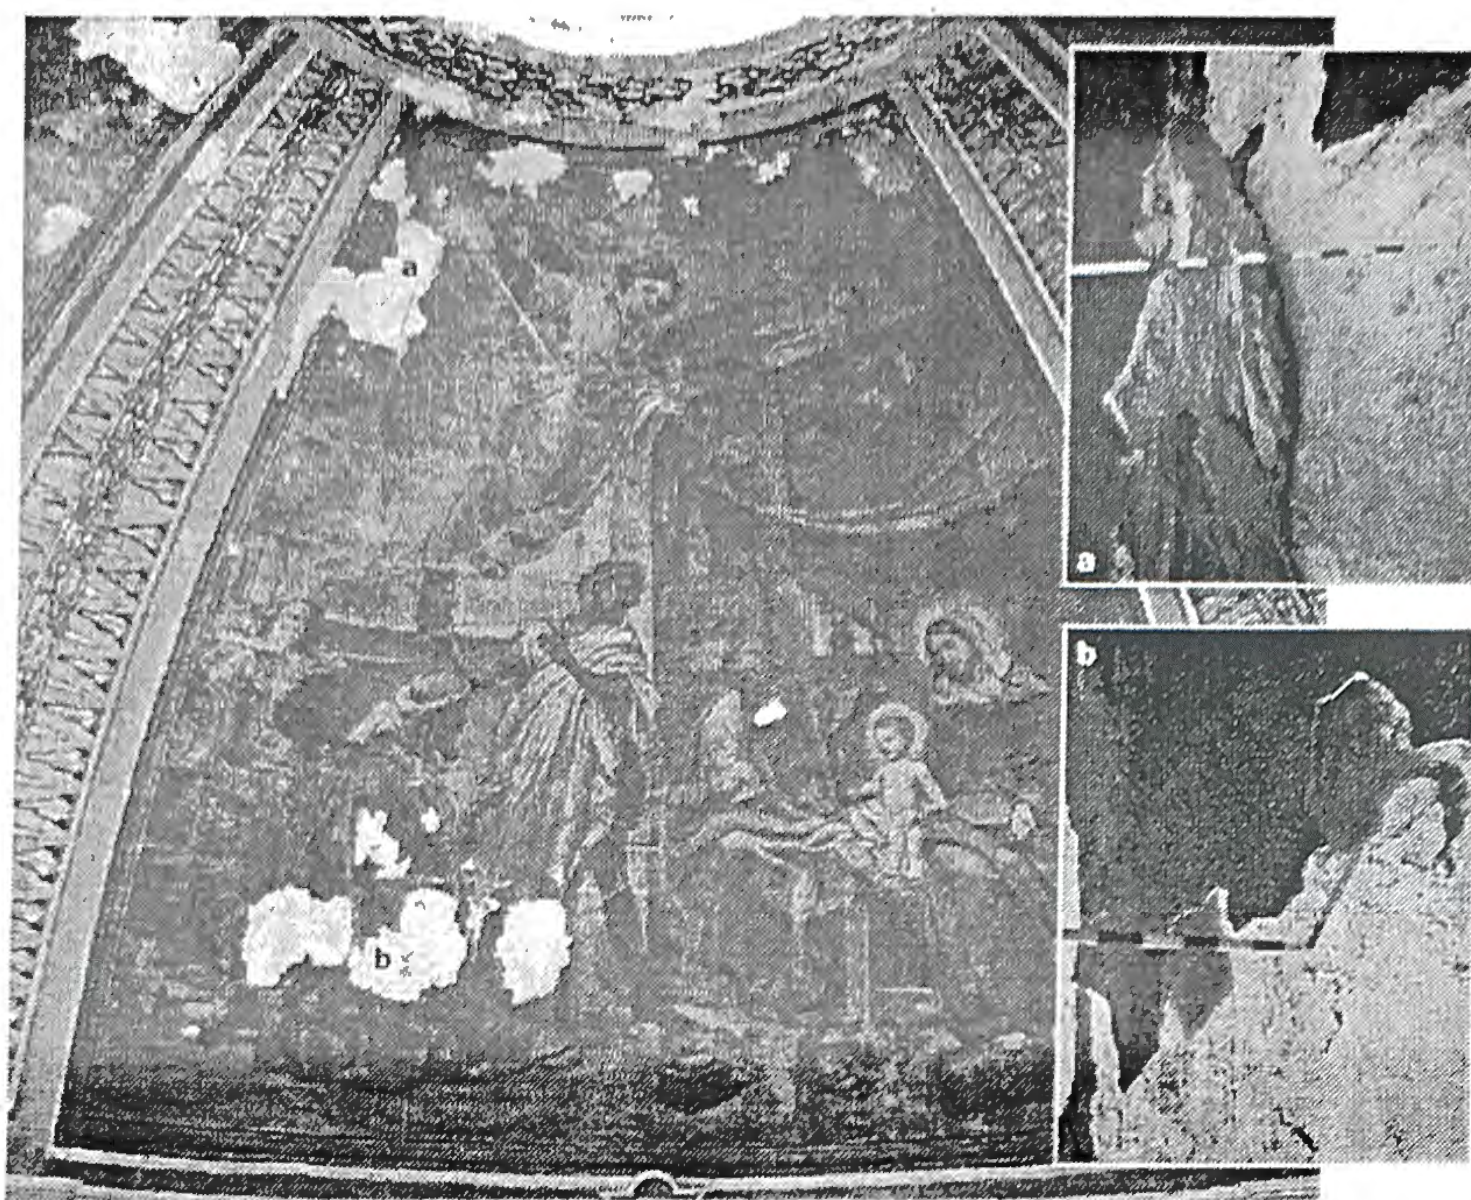
After their completion in 1903, the only documented restoration of the dome paintings occurred in 1963. By that time approximately half the painting by G. Cali was already lost and the restorer intervened extensively by infilling, repainting the areas where the painting was lost and overpainting to match his additions. After that date, no other restoration was carried out and the dome underwent a period of neglect. The hydraulic waterproof plaster (*deffun*) covering the external surface of the dome started to deteriorate and water infiltration commenced. The plaster was replaced in 1999 by a waterproofing membrane. The areas where the water infiltration had occurred show severe losses associated with advanced stone powdering and extensive detachment of both stone flakes and paint layers (fig. 2). The portions where the painting by Cali had already been lost and repainted in 1963 show diffuse, thin and well-adhered efflorescences and large areas of paint flaking.

Figure 2: Northwest bay (Adoration) showing two examples of deterioration.

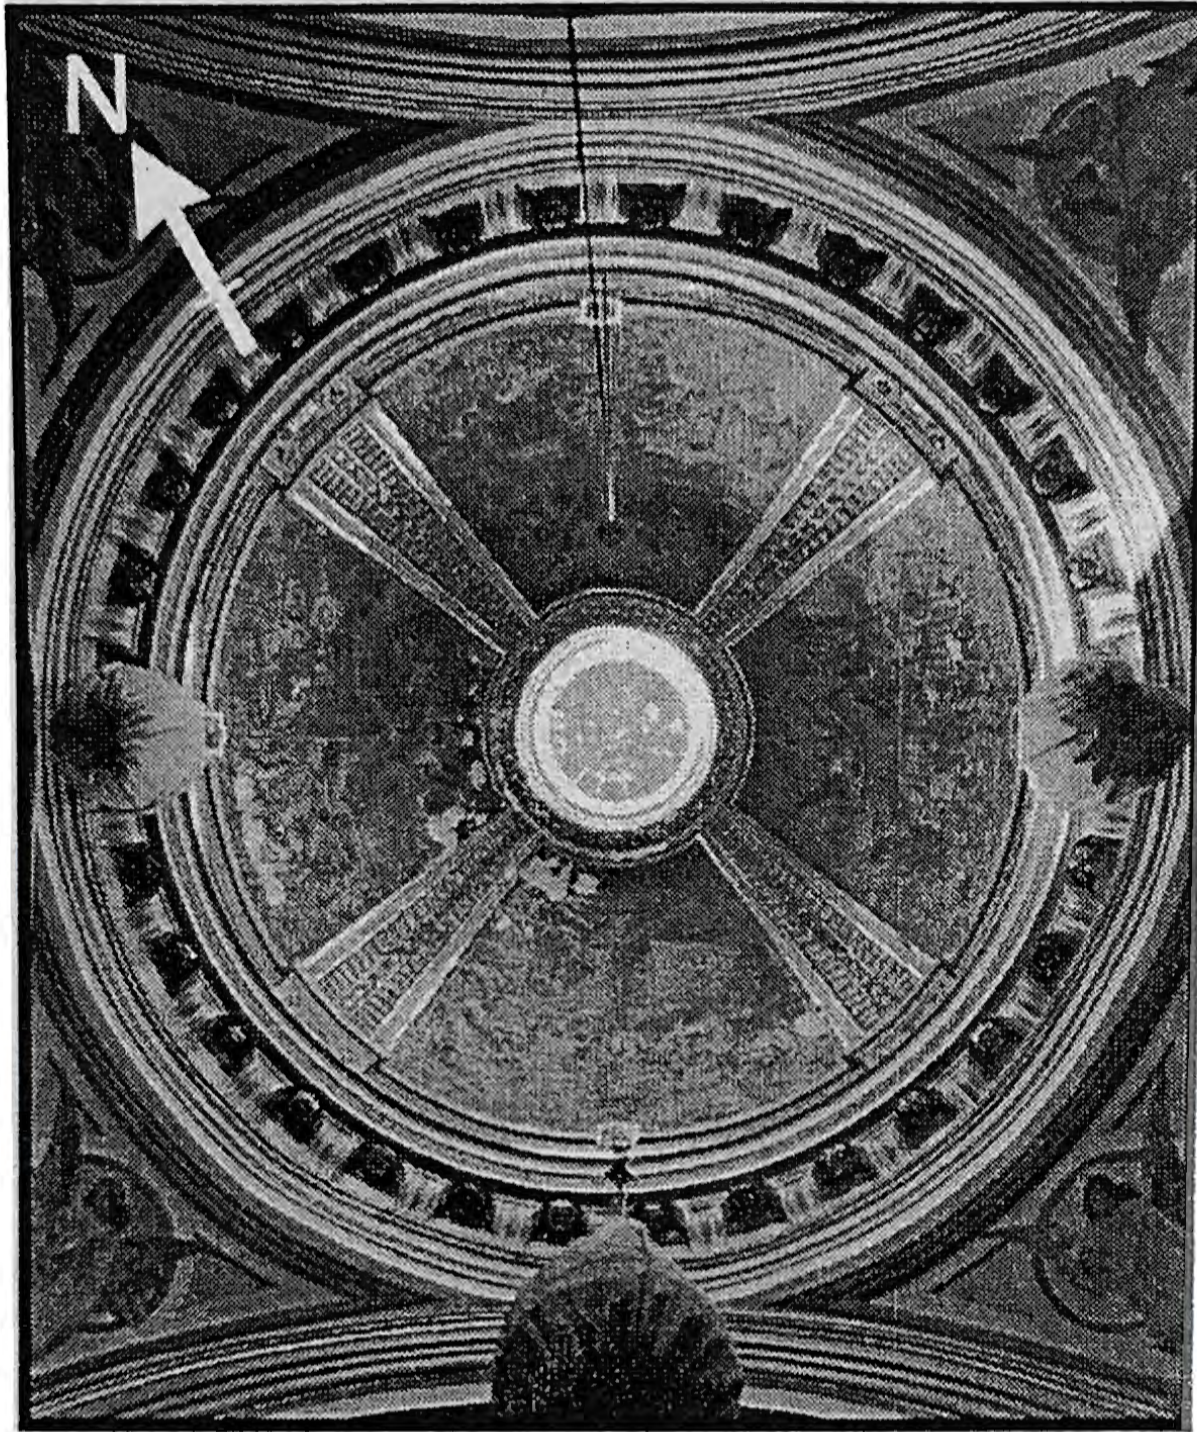
The general condition of the entire cycle looks precarious with the south half being the most affected. A general view is seen in figure 3.

Figure 3: Overall view of the dome.

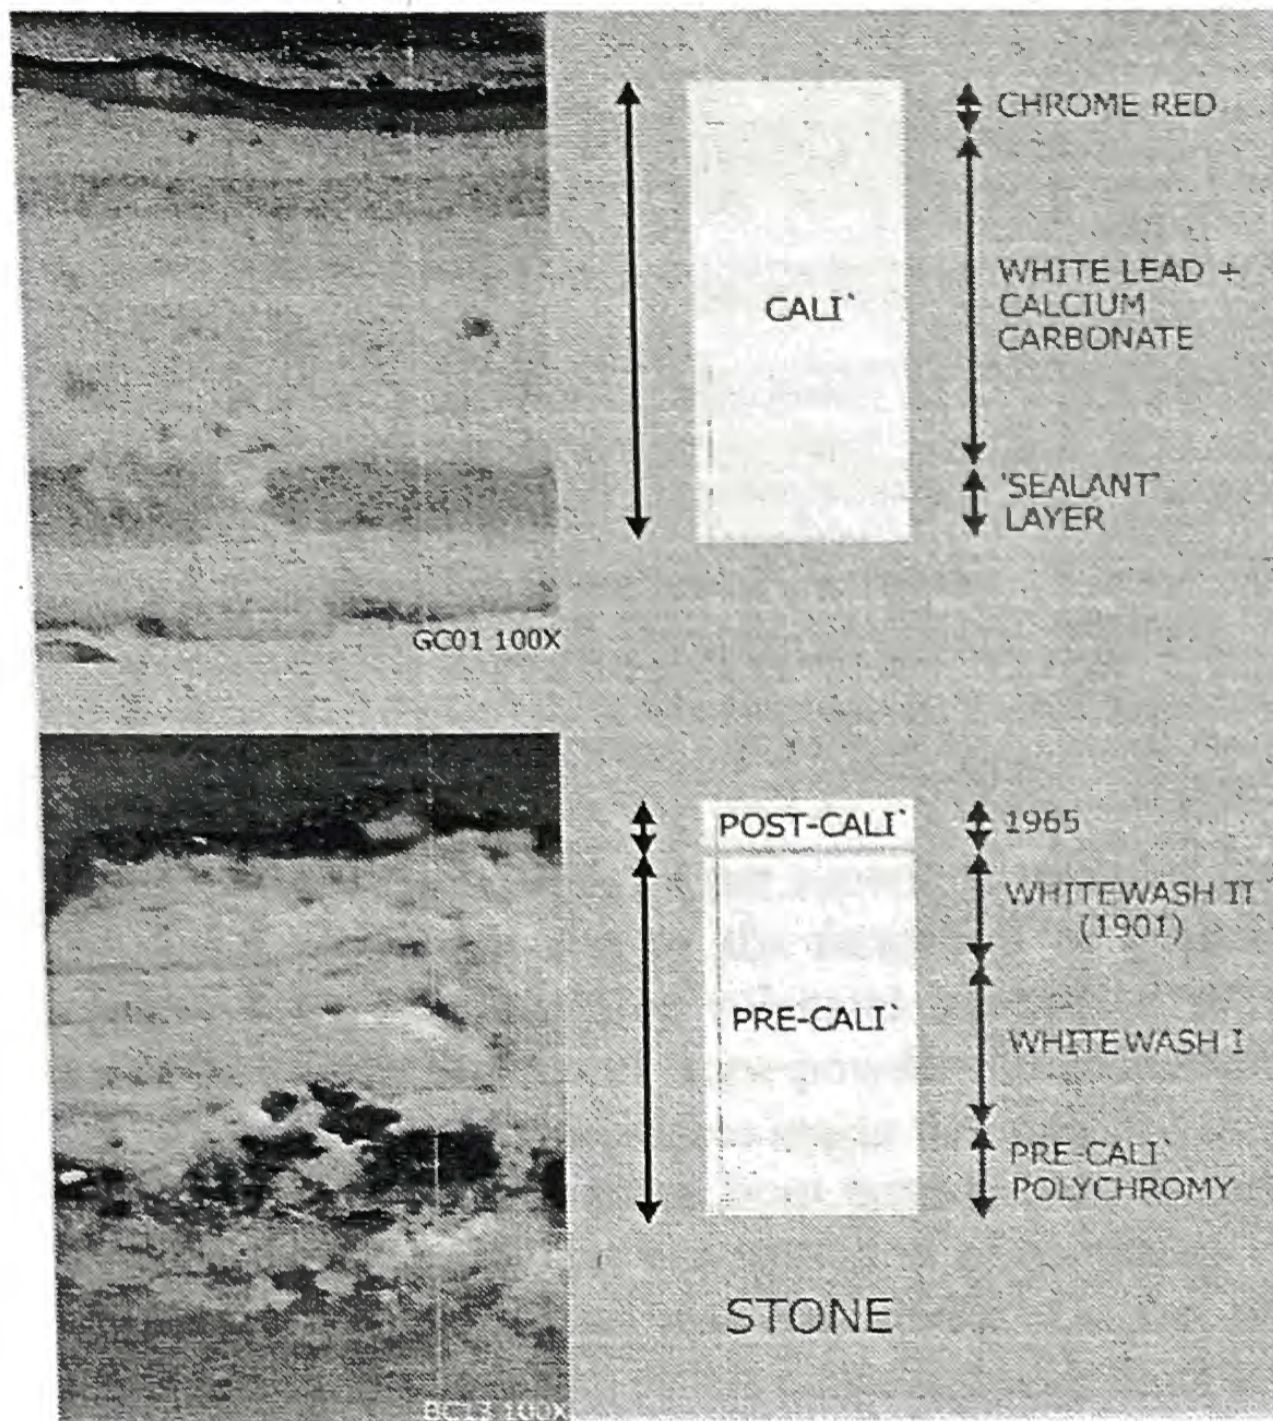
Cross-sections of the paintings revealed a total of 16 layers. The combination of visual observations, archival research and laboratory analytical techniques demonstrated that the layers roughly belonged to three different periods, including what is being referred to as a pre-Calì period (fig. 4). Some interesting findings, which arose from the stratigraphic and instrumental analyses, included:

Figure 4: Cross-sections of two samples (GC01 and BC13). These two cross-sections should be seen in sequence, with the exception of the post-Cali layer.

- Over this polychromy, seven or eight layers, mainly composed of white lead bound with linseed oil, were applied during at least two different whitewashing phases (I and II on fig. 4). The last four layers contain an amount of zinc oxide and can be dated back to 1901 thanks to a receipt found in the parish archives listing zinc white as one of the materials purchased then.

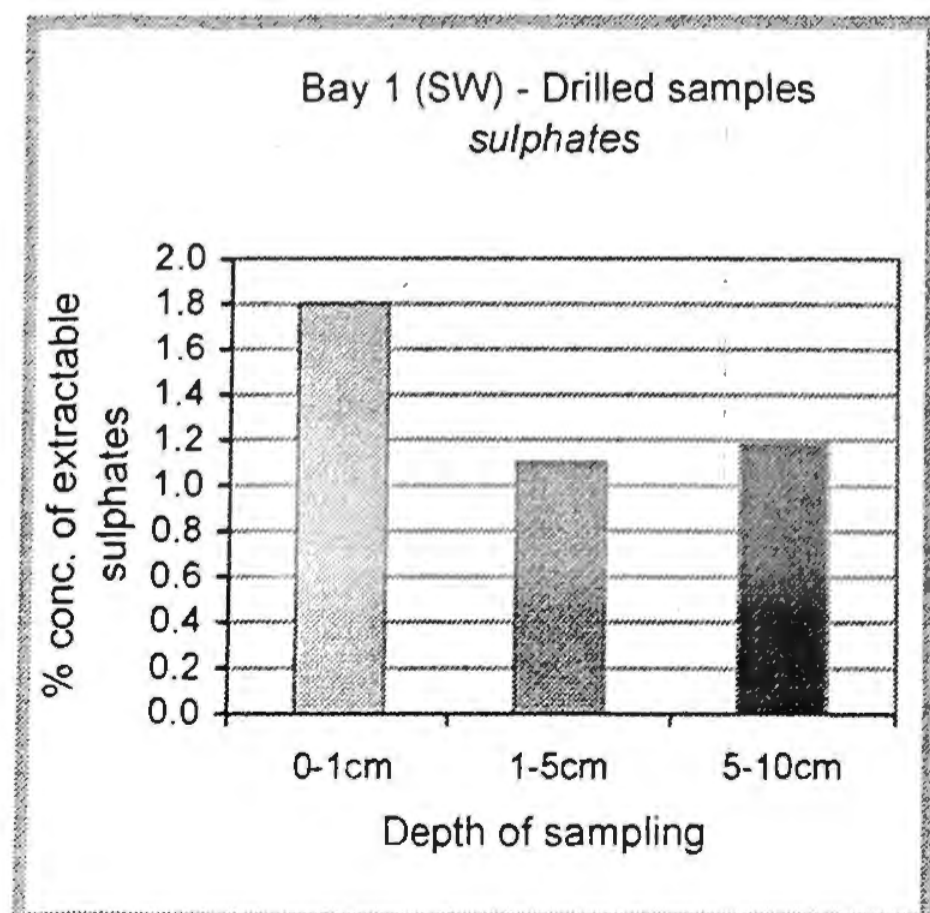
The data obtained from the analysis of the superficial samples (tab. 2) showed that the most important decay process is due to the formation of gypsum. IC shows that the percentage concentration of extractable sulphates reaches a maximum of 43.5% for efflorescences and 26.2% for samples of stone powder. Drilled samples (figs 5 and 6) show that the concentration of sulphates decreases inside the masonry to a value of around 1%, similar to that found in the samples taken from outside (tab. 2, sample GC S 33). Bay 4 (southeast) is the bay with the highest concentration of sulphates in the range of 0-1 cm, whereas bay 3 (northeast) is the one with the lowest. On the other hand, IC analysis showed that the deposit over the drum reliefs contained high amounts of sulphates (11.5%) and calcium (6.8%), whereas the mineralogical phases found through XRD identified calcite and minor amounts of anglesite (lead sulphate). Gypsum was also identified by SEM in a white deposit found on the back of a detaching stone flake. Surprisingly for a marine environment, chlorides were low with a maximum concentration of 3.3%.

Considering that no gypsum was identified amongst the constituent materials, with the exception of the repair plaster pre-dating 1903, it is plausible to think that an external source of gypsum or sulphur dioxide is responsible for the large amount of gypsum found on the painting. Such salt probably formed as a consequence of the interaction between atmospheric pollutants, introduced by infiltrating water, and limestone. The results of the analysis of SO_2 diffusion tubes positioned inside and outside the dome are still under study, however a preliminary evaluation does not seem to point to high SO_2 levels, in spite of the proximity of the church to the two local power generating stations (fig. 1). The source of SO_2 might have ceased with the closing down of the nearby dockyard, which was located in the creek just below the church. On the other hand, the monitoring of the internal Relative Humidity (RH) and temperature shows a relatively stable and low RH profile.

Figure 5: Percentage concentration of extractable sulphates from drilled samples in bay 1 (SW).

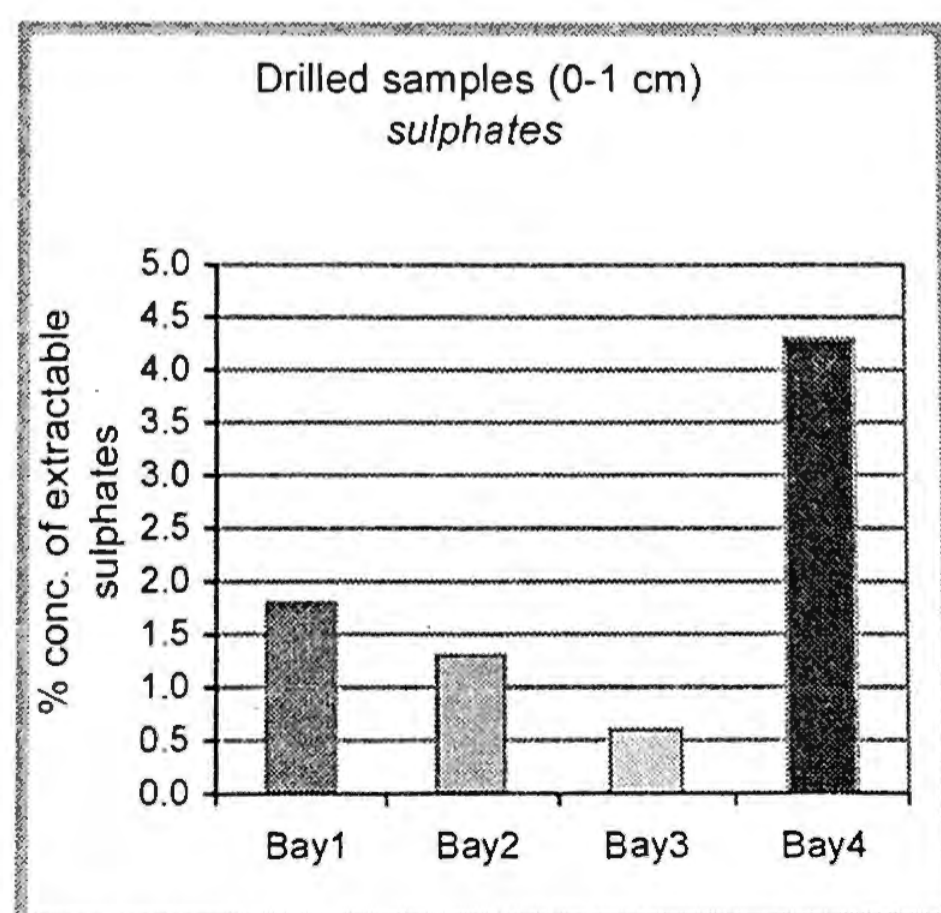
Figure 6: Percentage concentration of extractable sulphates from drilled samples collected at the depth range of 0-1 cm in all four bays.
