MINISTRY FOR TRANSPORT,
INFRASTRUCTURE AND CAPITAL PROJECTS

Triton Fountain Restoration & Inauguration

January 2018

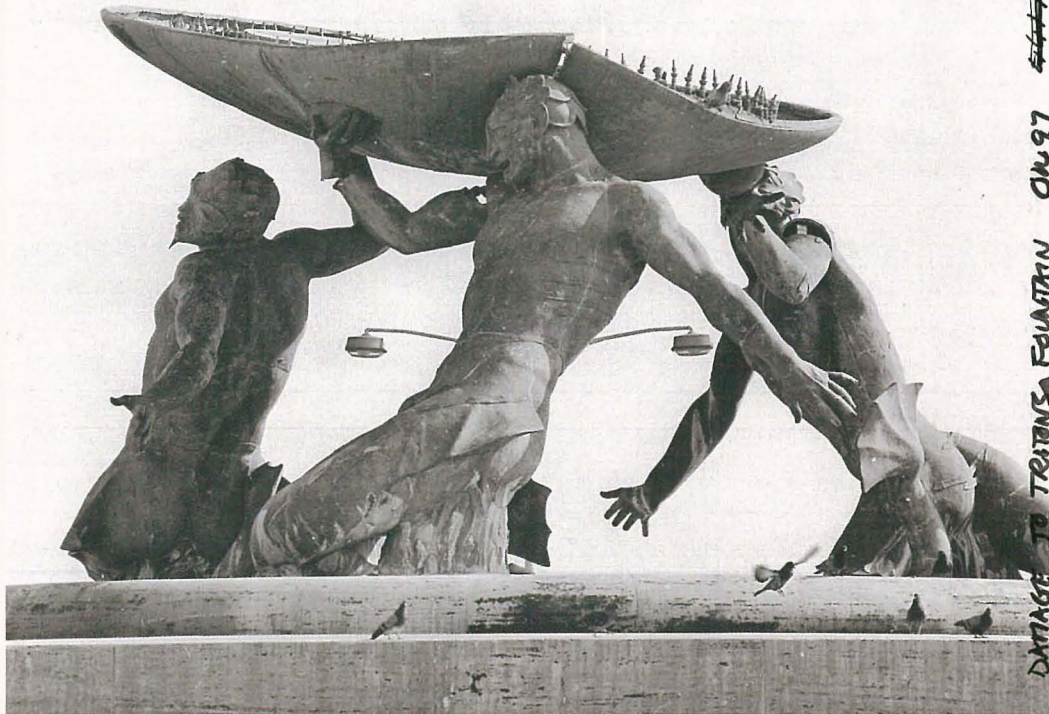
Structural Collapse on Wednesday 1st March, 1978

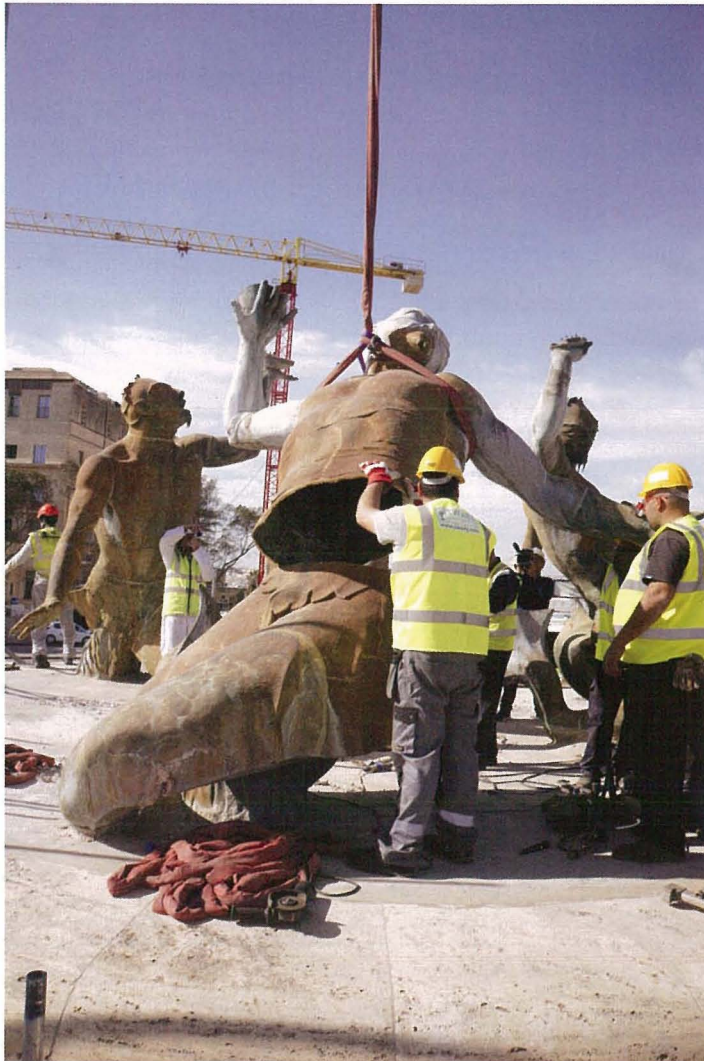
Hoisting part of a dismembered upper torso

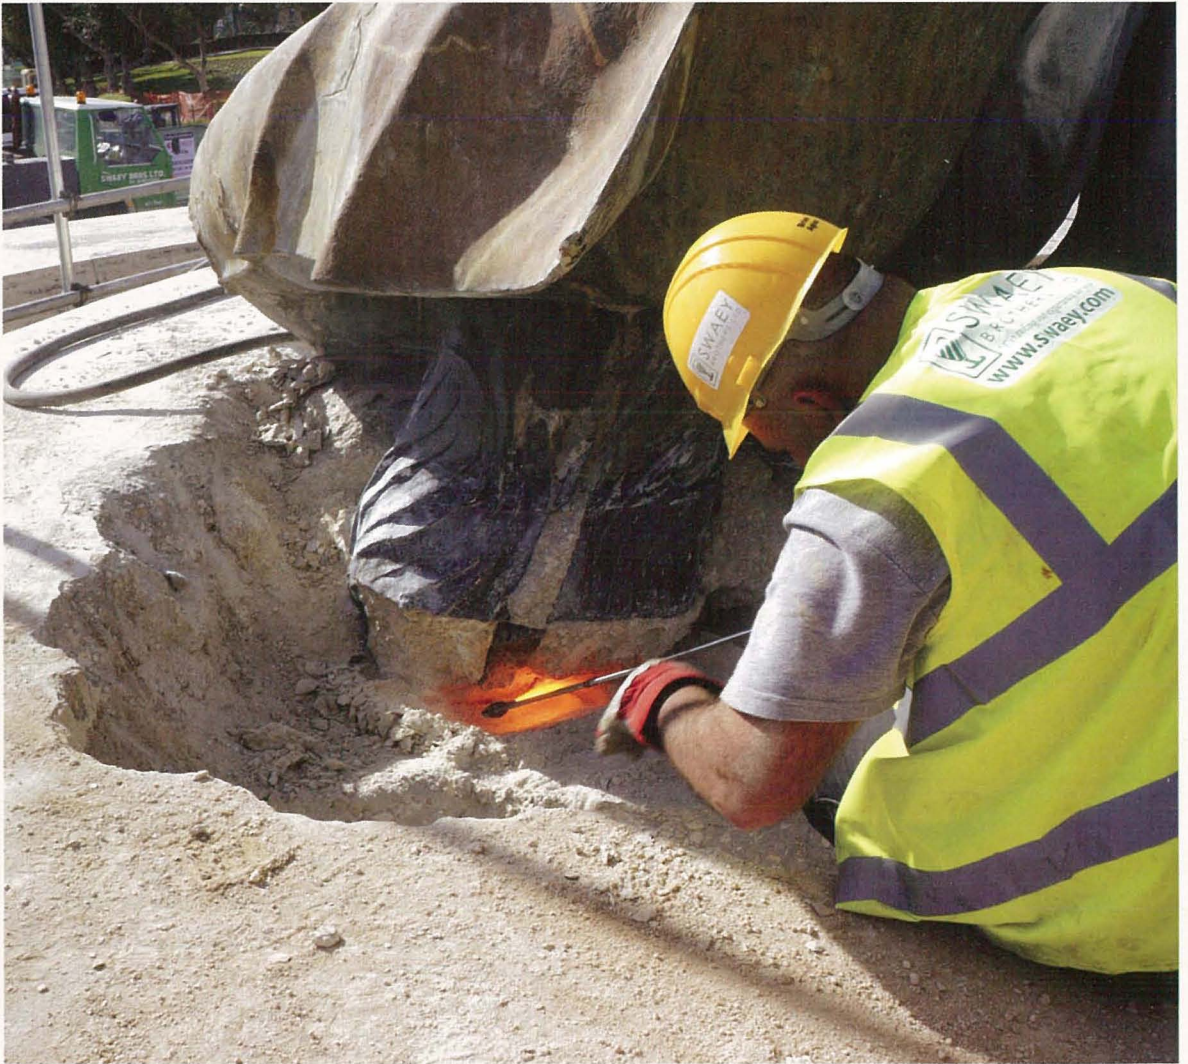
Detaching the steel reinforcement from the concrete screed

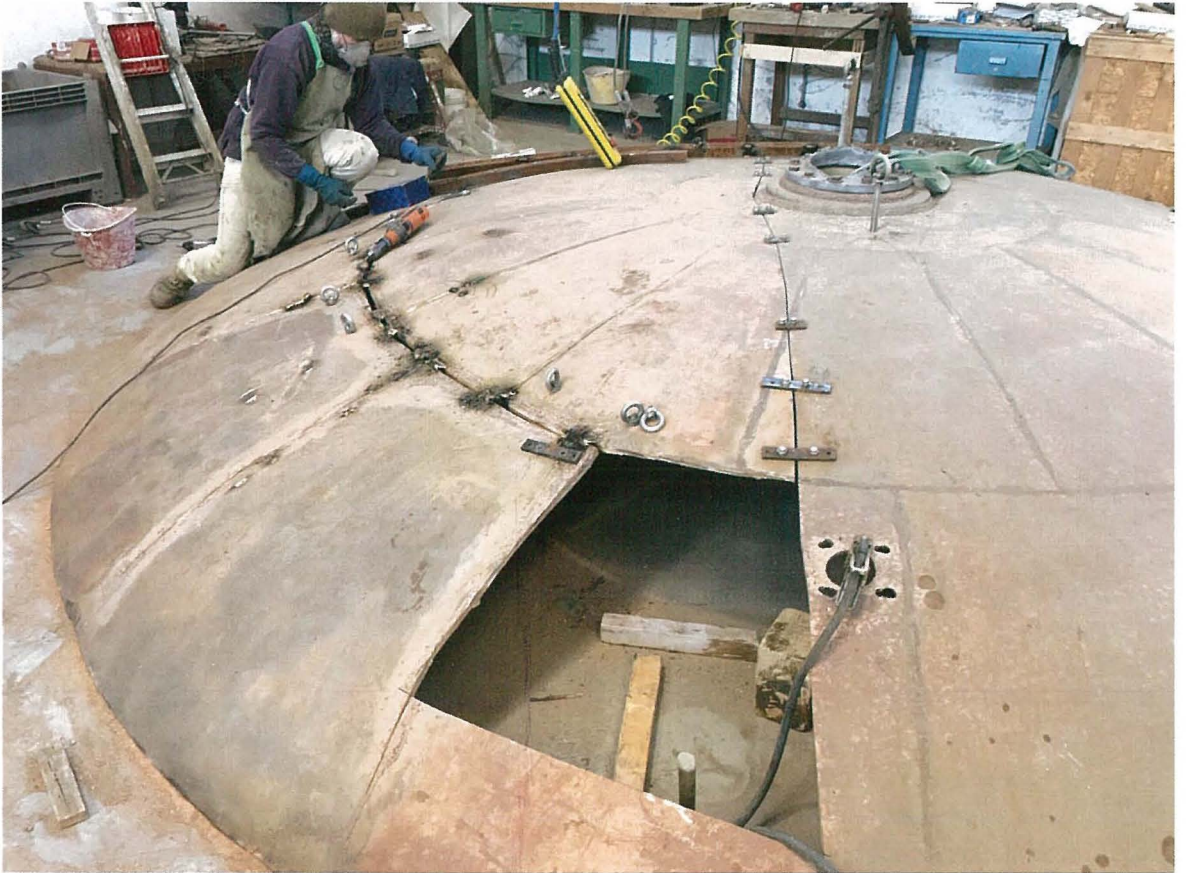
The basin on top of the tritons was badly warped: by over 300mm at certain points, and was having a negative effect on its function as a water retaining and cascading element. To level the edge of the basin, a brass border had been welded to the lip, however this proved not to be sufficient and a second brass border had been soldered to the entire circumference of the basin. This again was not as effective as it was intended to be and this was corrected by the casting of a levelled reinforced concrete border along the irregular circumference of the basin.

The basin was divided in two halves during which process the casting was revealed to be sound and devoid of porosity and other defects that plagued the tritons. The good quality of the casting was probably due to a different casting technique employed for the basin owing to its relatively plain profile, unlike the tritons. The main problem in the basin was the very serious deformation from warping.

The *Bacino Superiore* being re-formed from warping

This proved to be excellent news since the foundry confirmed that it was feasible to address the warping issue through fairing. Although this is an arduous job, it was worth the effort since ensured the conservation and the retention of the original basin. A healthy section of the basin was identified and a template was designed to faithfully record its profile. Each warped portion of the basin was cut through its welding seams and subsequently pushed and pulled as necessary to fit the template.

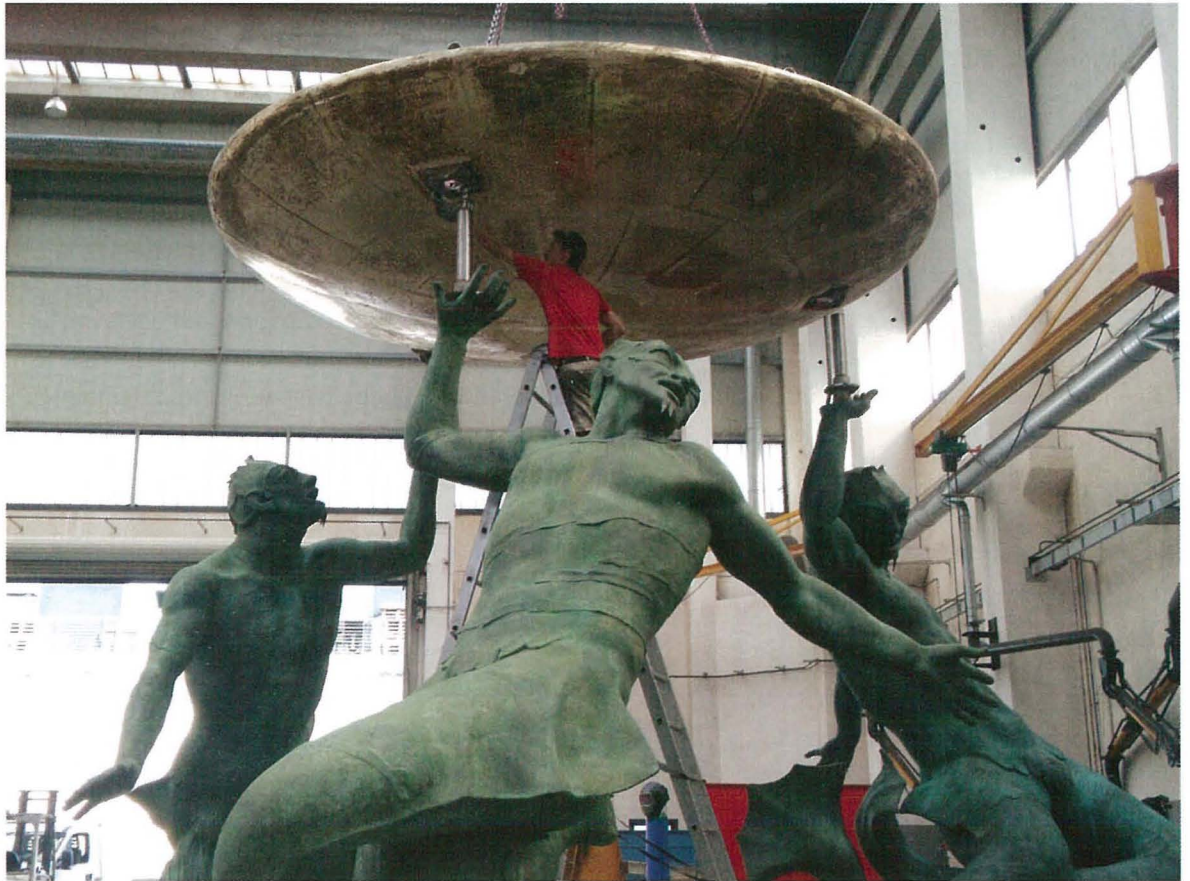
Patinated sculptural group being positioned in Vicenza, Italy

The armature within each figures was specially designed to follow the internal contours of the figures. The structure within was designed to be both a load bearing element and to transport the water up to the basin. Furthermore, the interior of the arms also had to serve as a passage for the electrical connections needed for lighting. Once set, each of the statues' detached parts were re-fitted. The sculptural group was eventually assembled in the engineering works according to the dimensions recorded on 3D-scan. Once deemed satisfactory, the group was dismantled and the patina was applied according to the scientifically determined original samples.

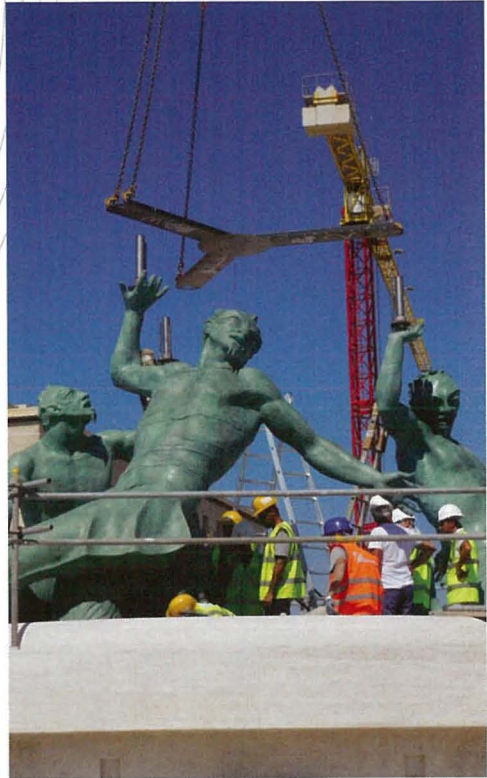
Calibrating the tritons according to template

The process of erecting the sculptural group *in situ* followed more or less the same procedure that had been performed in the workshop. The main difference was that it had to be located in accordance with the original precise position recorded by the 3D scanning. The base plates welded to a template were prepared by the Vicenza based engineering works. These were shipped to Malta and set in the form-work base of the tritons. Once set, the tritons were lifted and placed on their respective base plates. Their position was then calibrated by means of a template which ensured that their position was identical to the original position and orientation. The basin was then lifted, set in place and its position calibrated.

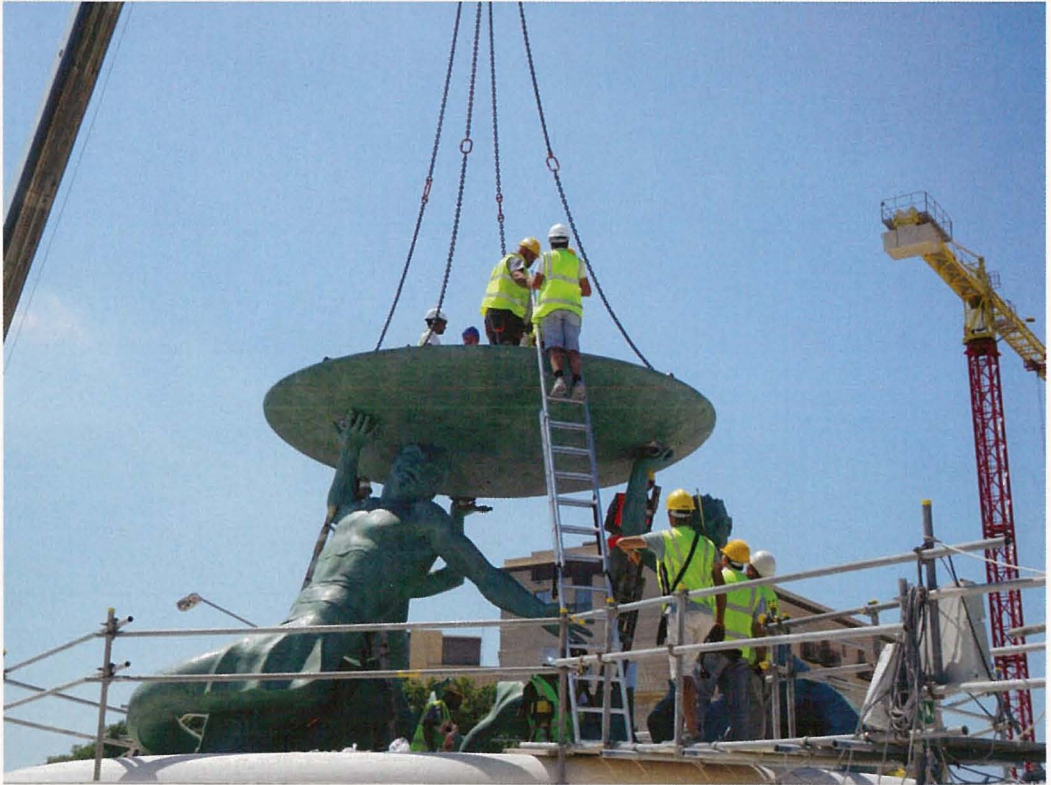
The sculptural group being reassembled

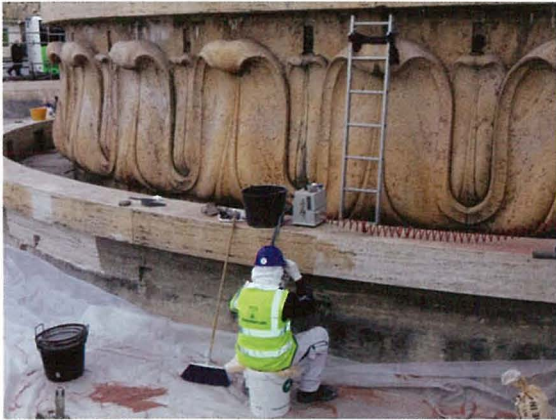
Top left: Micro-sandblasting of *vaschetta* travertine

Stains were removed by means of poulticing that extracts the salts and other pollutants from the pores of the travertine and by micro-blasting that removes stains from the surface of the travertine. The former was used for the carved relief

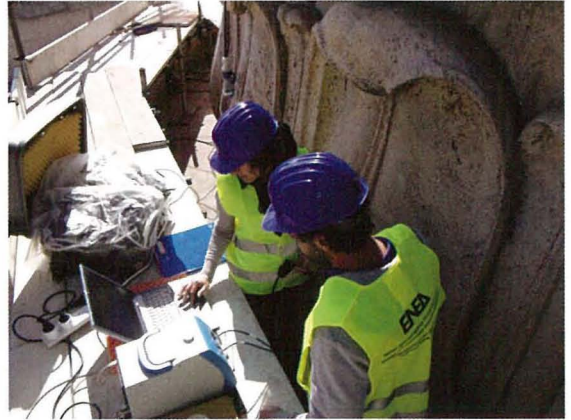
Top right: Diagnostic testing

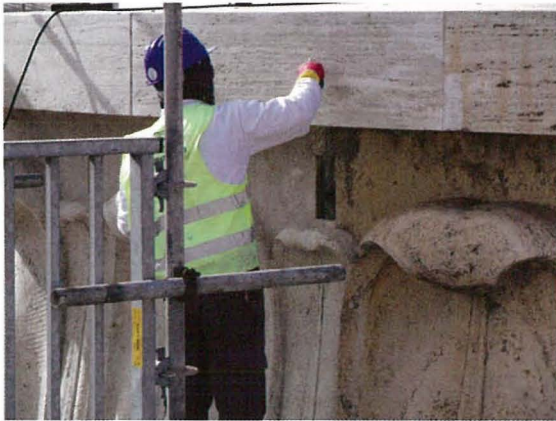
Bottom left: Plastic repair

Detached parts of the travertine were generally noted at the edges of the carved slabs, as this is the most fragile part of the blocks. Most losses occurred in the centre of the small stylised lilies in the foliage band. The lost material was recreated using plastic repair techniques reinforced with carbon fibre. Broken parts of the *vaschetta* were rebuilt by piecing-in, care being taken to match the vein and geomorphology of the original travertine.

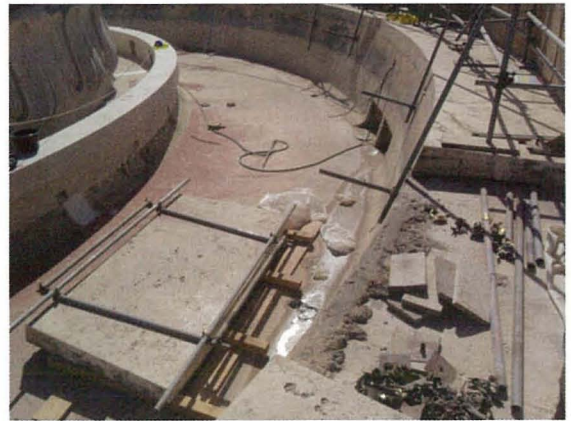
Bottom right: Re-alignment of travertine blocks on *Sedia Belvedere*

Two of the larger travertine blocks of the *sedia belvedere* were lifted to remove rusty metal spacers that had dislodged 17 of the 32 slabs. All were re-aligned to form a perfect circle.

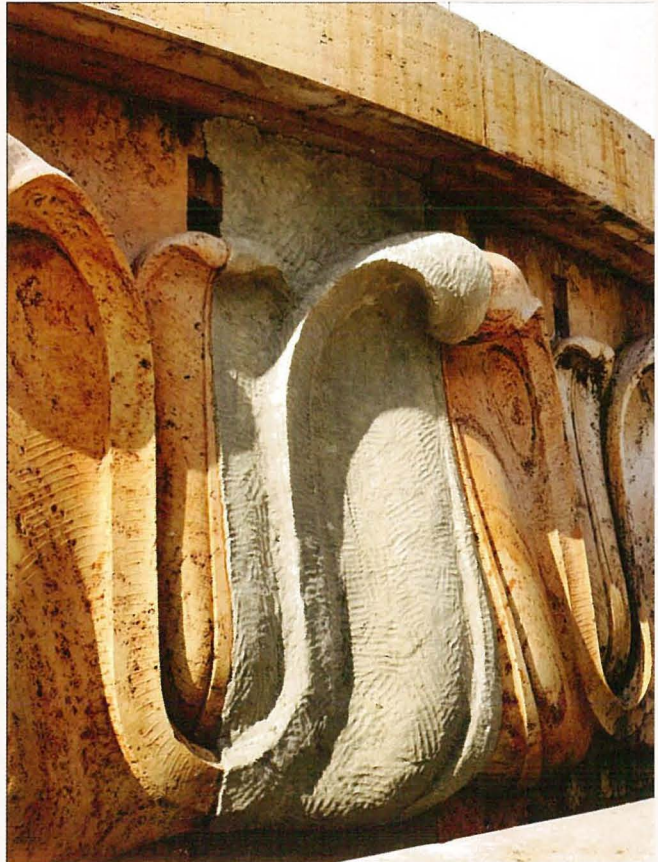
**Cleaning the travertine:
poulticing**

Before and after cleaning the travertine

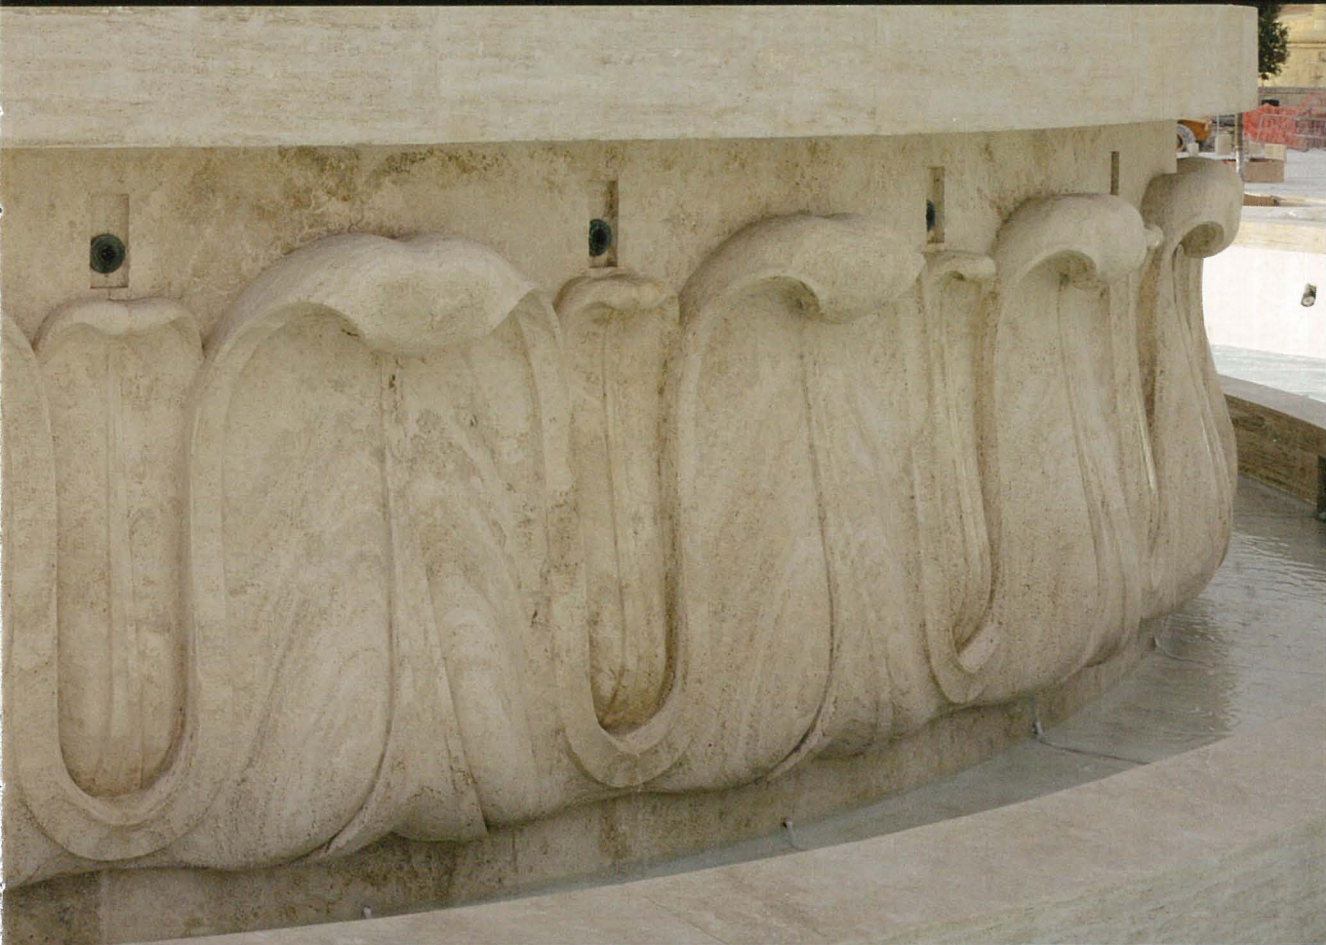
The restored travertine foliage
