Account of an Informed Bat Exclusion at the Temple of Deir el-Shelwit, Luxor, Egypt

Jennifer Herrick Porter & Katey Corda

KEYWORDS Egypt, preventive conservation, painted reliefs, stone conservation, bats

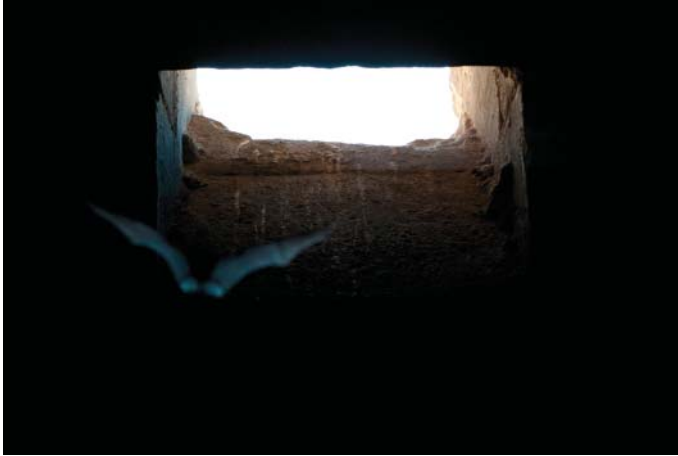
FIGURE 1 *Asellia tridens* in Deir el Shelwit.
Image: Owen Murray/© American Research Center in Egypt 2012

The bats were photographed during the survey, both to document the infestation and to identify the species present. Images were sent to Dr Christian Dietz, bat biologist at the Department of Animal Physiology, University of Tübingen, for identification (Figures 6 and 7). Based on the photographs, Dietz was able to identify the species as *Asellia tridens*, the trident leaf-nosed bat. Dietz observed no other species in the photos, which concurred with observations made during the survey.

Asellia tridens is a common, insectivorous, desert-dwelling bat which occurs throughout North Africa, the Middle East, and into Central Asia (Dietz, 2009). It is listed as a 'species of least concern' by the International Union for Conservation of Nature and Natural Resources (i.e. not endangered or threatened) (Kock et al., 2008), and while well studied and documented in other regions of the world, very little information is available about the specific behaviour of *Asellia tridens* in Upper Egypt — a condition common to other local bat species (Dietz, 2012). Therefore, all assumptions about the *Asellia tridens* living in Deir el-Shelwit were based on their documented behaviour in other regions, which Dietz extrapolated to fit with the environmental and seasonal conditions specific to the Luxor area. Even this small amount of information was enough to significantly affect the exclusion plan, and will be discussed where relevant below.

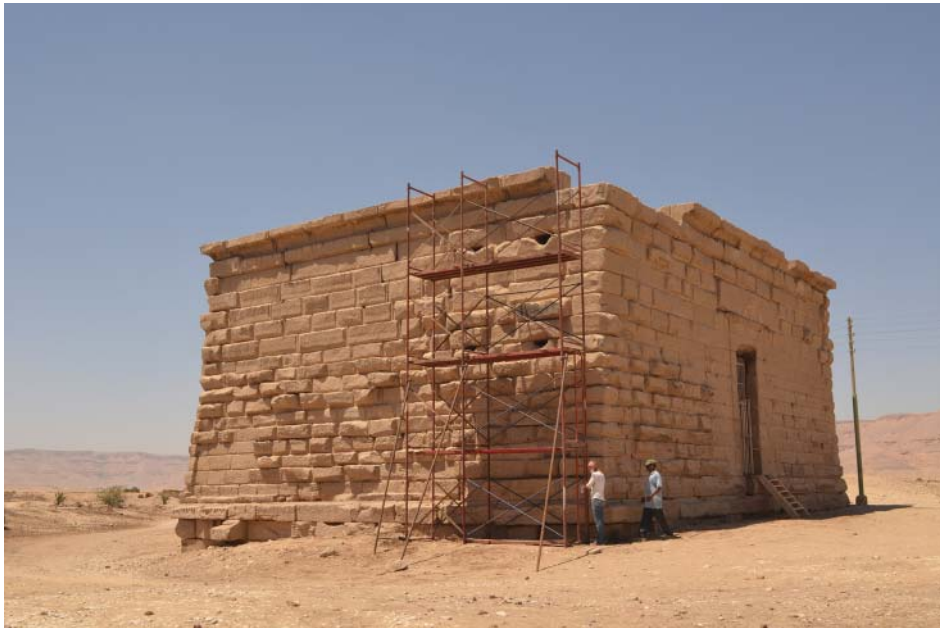
FIGURE 2 Exterior of Deir el Shelwit, facing north.
Image: © American Research Center in Egypt 2012

Deir el-Shelwit is a Roman-era (first–second century CE) sandstone temple on Luxor's West Bank (Zivie, 1977: 154, 157) (Figure 2). Although located in one of the most visited areas in Egypt, the temple remains isolated from tourist activity, which is concentrated around better-known sites such as the Valleys of the Kings and Queens, approximately 5 km away. The temple has never officially been open for visitation by the public, and in fact has been locked for a number of years.

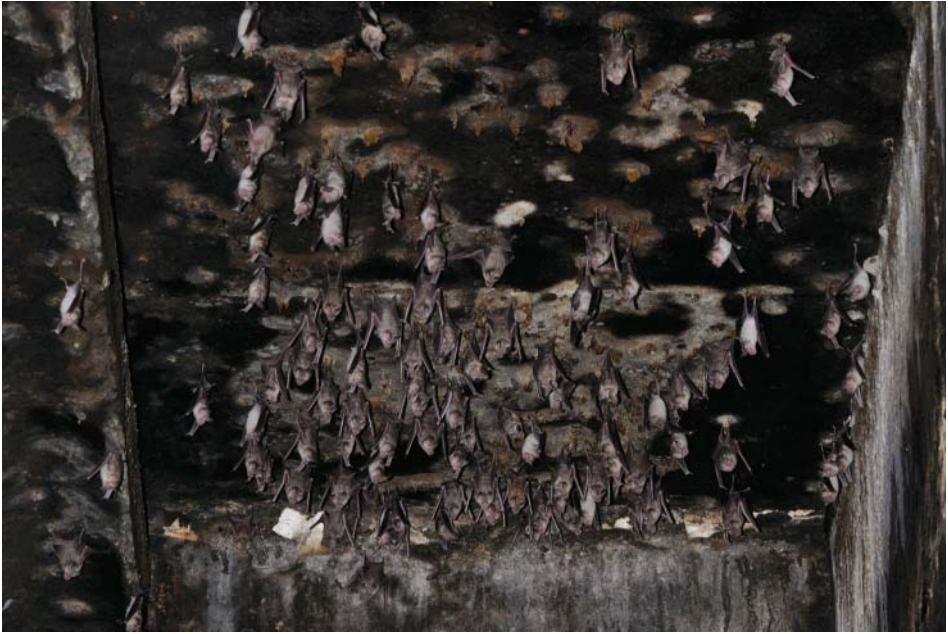
FIGURE 6 Part of the *Asellia tridens* colony roosting in corridor of Deir el Shelwit. Note excrement staining and accretion on walls and ceiling.

It proved difficult to determine exact roost locations because the bats continually fled from one chamber to another. Guano deposits proved to be the best indicator of roost locations, corroborated by the bats' repeated movements to specific areas corresponding with these deposits. Eventually it was possible to map a number of main roost locations throughout the temple. The colony size was estimated at three to five hundred individuals, and no flightless young were observed. It appeared that only one species of bat was present, and the concerted movements of the group suggested that they were all individuals of a single colony.

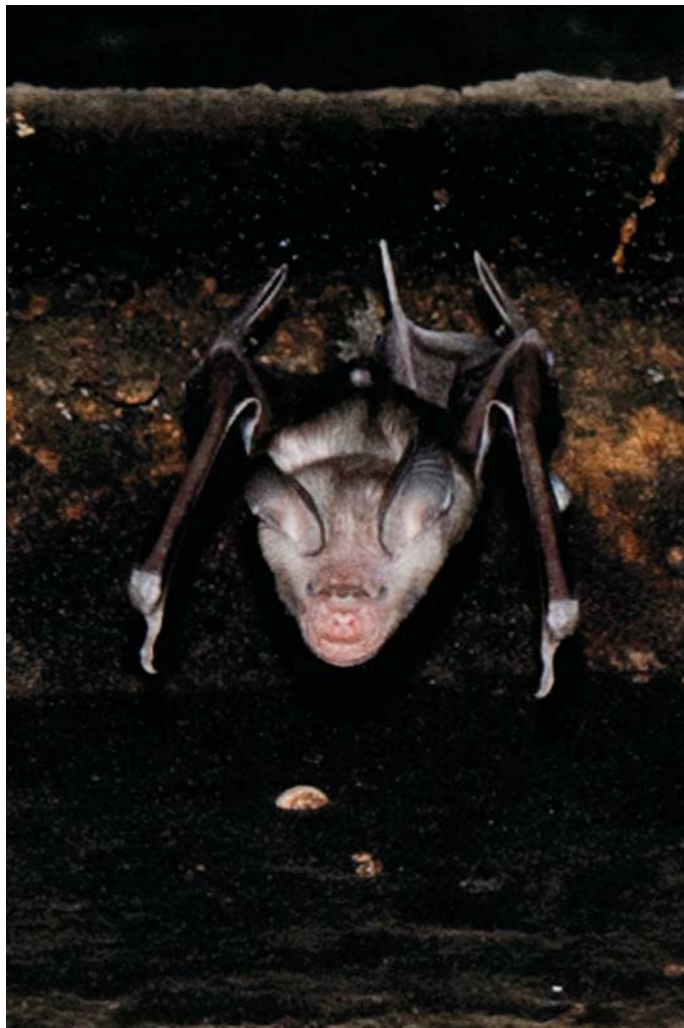
FIGURE 7 Detail of a Deir el Shelwit *Asellia tridens*.

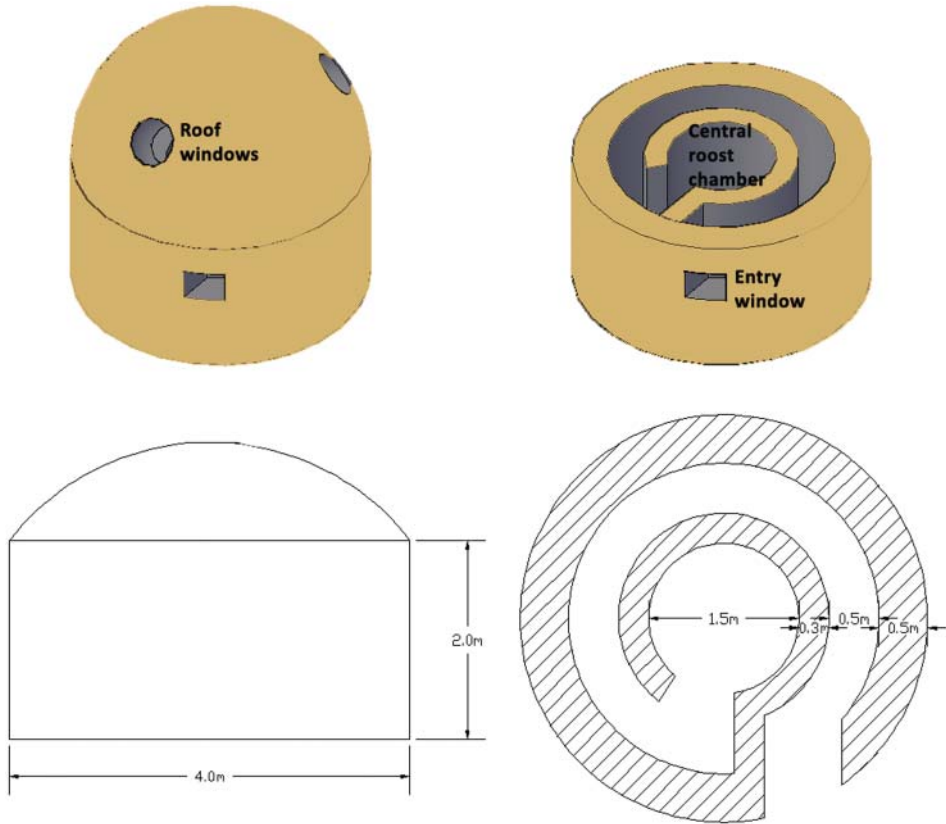
FIGURE 8 Proposed bat house design.

The bat house designed for Deir el-Shelwit will have a long corridor providing access to a high-ceilinged central chamber for roosting (Figure 8). It will be built of adobe (earthen brick), a locally obtained, low-cost material with good insulating properties, which will aesthetically integrate the structure into its surroundings. The design incorporates the following factors:

- thermal insulation: the adobe brick walls will be 0.3–0.5 m thick; the entry corridor wraps around the central chamber to increase insulation, with a double roof serving the same purpose
- air flow: the entry window in the outer wall and smaller windows in both roofs should provide low, but sufficient levels of airflow
- light: the windows will be small and unaligned; thus, no direct light can enter the central roosting chamber
- protection: there will be no openings at ground level, thereby reducing access to the roost by local ground-dwellers, including humans
- location: the house will be built as near as possible to the temple, far from trees, wires, roads, and paths (Figure 9); and
- guano deposition: this is the only unresolved aspect of the house, and it is hoped that either it will be resolved naturally or that periodic cleaning can be undertaken.

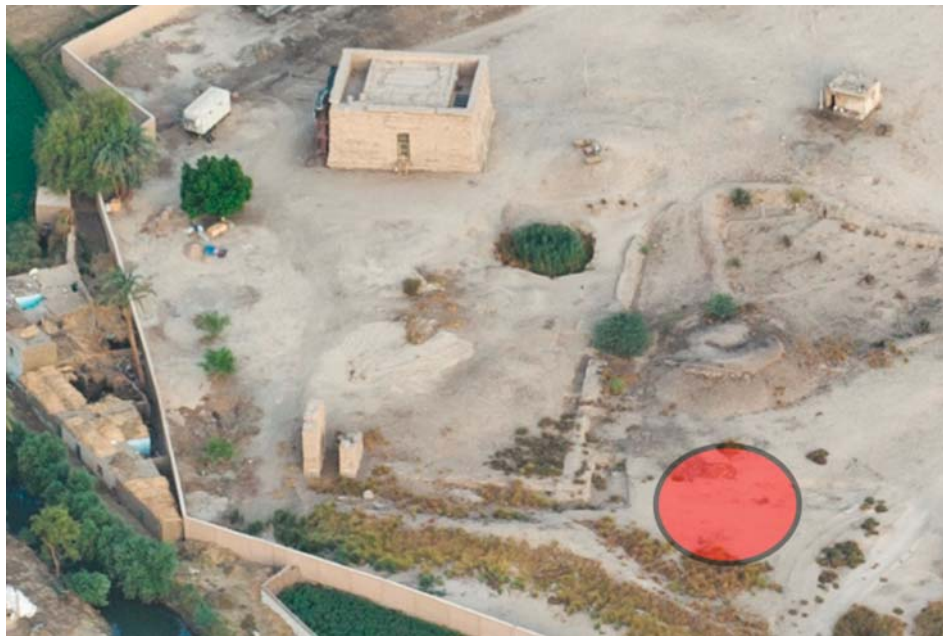
FIGURE 9 General proposed location for bat house, indicated in red.
