# Sheltering archaeological sites in Malta: lessons learnt

The purpose of this paper is to review the performance of the protective shelters installed over three archaeological sites in Malta over the past decade, and to draw some key lessons learnt that may be useful to others when considering whether to adopt a similar solution. The conservation threats to the Megalithic Temples of Malta are introduced and defined—these range from material issues (loss of surface) to structural issues (cracking and dislodgement of stones leading to structural instability and collapses). Causes identified specifically included fluctuating environmental conditions: wetting and drying cycles and thermal fluctuations, combined with the salt-laden Mediterranean island environment. The recognition during the late twentieth century of these issues as key factors in the deterioration of these structures, and the strategy that was developed in response, are outlined. A key component of this strategy was the installation of protective shelters over three of the main megalithic sites. The process through which the design requirements for the shelters were defined is reviewed. The performance of the shelter

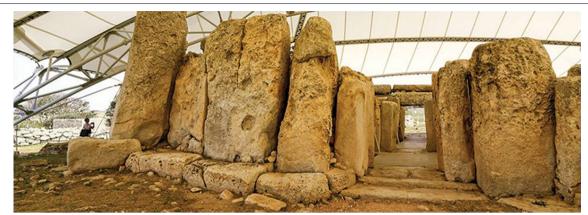
Fig. 3 The Haġar Qim Temples with shelter

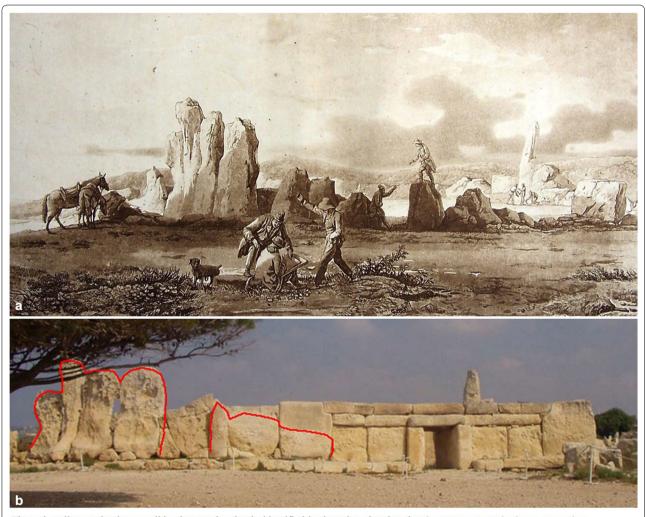
The red outline marks the megaliths that can be clearly identified in the print, showing that these were exposed prior to excavation.

Fig. 4 Façade of Ħaġar Qim: a 1787 print b photograph prior to shelter construction

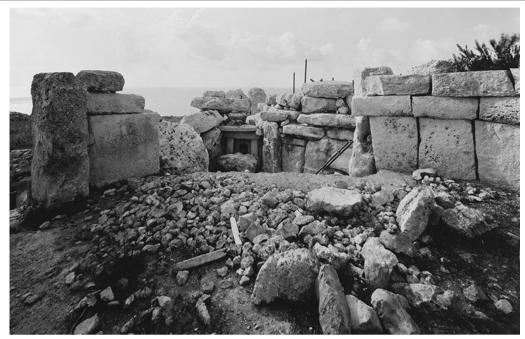
Fig. 5 Collapse of part of Mnajdra Temples, 1996, following heavy rainfalls with loss of structural stability

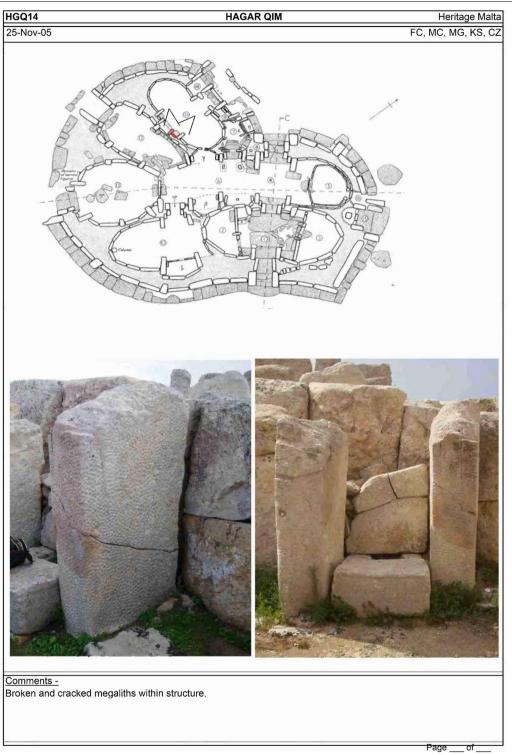
Fig. 6 Sample of Condition Assessment (2005–2006) record sheets

A Condition Assessment of all the stones of all the Megalithic Temples, including Ħaġar Qim, Mnajdra and Tarxien, was conducted in 2005–2006, consisting of the methodical visual inspection and documentation of structural issues and material deterioration at each site. This had a twofold aim: to be able to compare with post-sheltering condition assessments (currently again under way) and to aid in developing methodologies to tackle particular categories of problems (all issues were divided into related categories e.g. structural; infill, ground; surface weathering) and therefore facilitate targeted conservation interventions, for issues (already mentioned) which the shelter itself would not address.

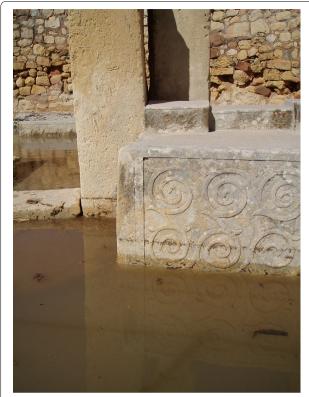
**Fig. 7** Persistent flooding within the Tarxien Temples after heavy rains regularly reached 30 cm in depth
