DEVELOPMENT OF A GYPSUM-BASED GROUT FOR THE STABILISATION OF GYPSUM-BASED PLASTERS

Gvantsa Potskhishvili¹, Chiara Pasian², Francesca Piqué³

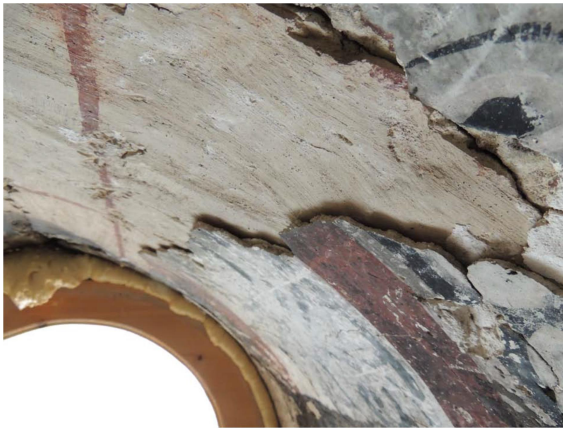
Figure 2. Delamination of the gypsum-based plaster; west apse, Ateni Sioni church, Georgia. © Francesca Piqué, 2012.

The wall paintings condition assessment performed in the church showed the presence of large lacunas, of recent losses and of severe problems of lack of adhesion (i.e. delamination). In most of the cases, the delamination occurs between the stone and the plaster(s), i.e. the primary and the secondary supports. The most severely delaminated areas, being unstable, are located in the upper parts of the apses, on the horizontal and semi horizontal surfaces of the vaults and in the areas where there are joints between different plaster types (on horizontal, semi horizontal and vertical surfaces) (Figure 2). When not clearly visible, the delamination was located in the stratigraphy by tapping, and its severity assessed according to the vibration and the sound produced.

A thorough graphic and photographic documentation was produced to illustrate the extent and gravity of this precarious situation and the need for a stabilisation intervention. One of the possible interventions to be designed is that of grouting.

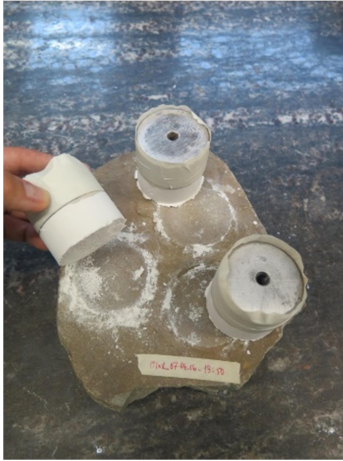
Figure 3. Assessment of the adhesion of the grout to the tuff stone support. © Gvantsa Potskhishvili, 2015.

Adhesion of such selected grouts was then assessed in the laboratory onto the two materials lacking adhesion in the Church of Ateni: gypsum plaster and tuff stone. To assess the adhesion to the plaster, a gypsum plaster prepared in the laboratory was applied on a brick tile and a boundary was placed around the tile itself; fluid grout was poured on the plaster and allowed to harden for 10 days. 50 mm diameter circular incisions were carved from the surface down to the brick. Metal plugs were glued on such incisions and pulled off with a dynamometer to measure the force needed for the failure to occur. To assess the adhesion of the grout to the tuff stone support, cylindrical plastic moulds 50mm diameter x 20mm height leant on the stone were filled with fluid grout (Figure 3). After 10 days of hardening, metal plugs were glued to the surface of the grout cylinders and then

pulled off with a dynamometer. It was found that the adhesion properties of the gypsum-based grouts (Mix 1 and 2) were not satisfactory, as in both cases the failure occurred between the grout and the stone support/gypsum plaster with a minimal force applied. Therefore the formulations needed to be refined (*Stage 2*, Section 3.2), since a good adhesion to both interfaces (plaster and stone), in fact, is one of the most important requirements for a grout, and crucial in the case of the Ateni Sioni Church.
