PROXIMITY REMOTE SENSING: PRELIMINARY RESULTS AT THE BATIA CHURCH (TORTORICI, SICILY)

Abstract. The paper presents the results of scientific investigations carried out at the Batia Church located in the small village of Tortorici (Messina, Sicily). We performed several geophysical surveys and reconstruct 2D and 3D digital models of the monument using digital photogrammetry. From the 3D model accurate digital elevation models. A detail mapping was carried out using the derived 3D digital model identifying mayor fractures as well as quantifying the extent of original pain and the modern interventions.

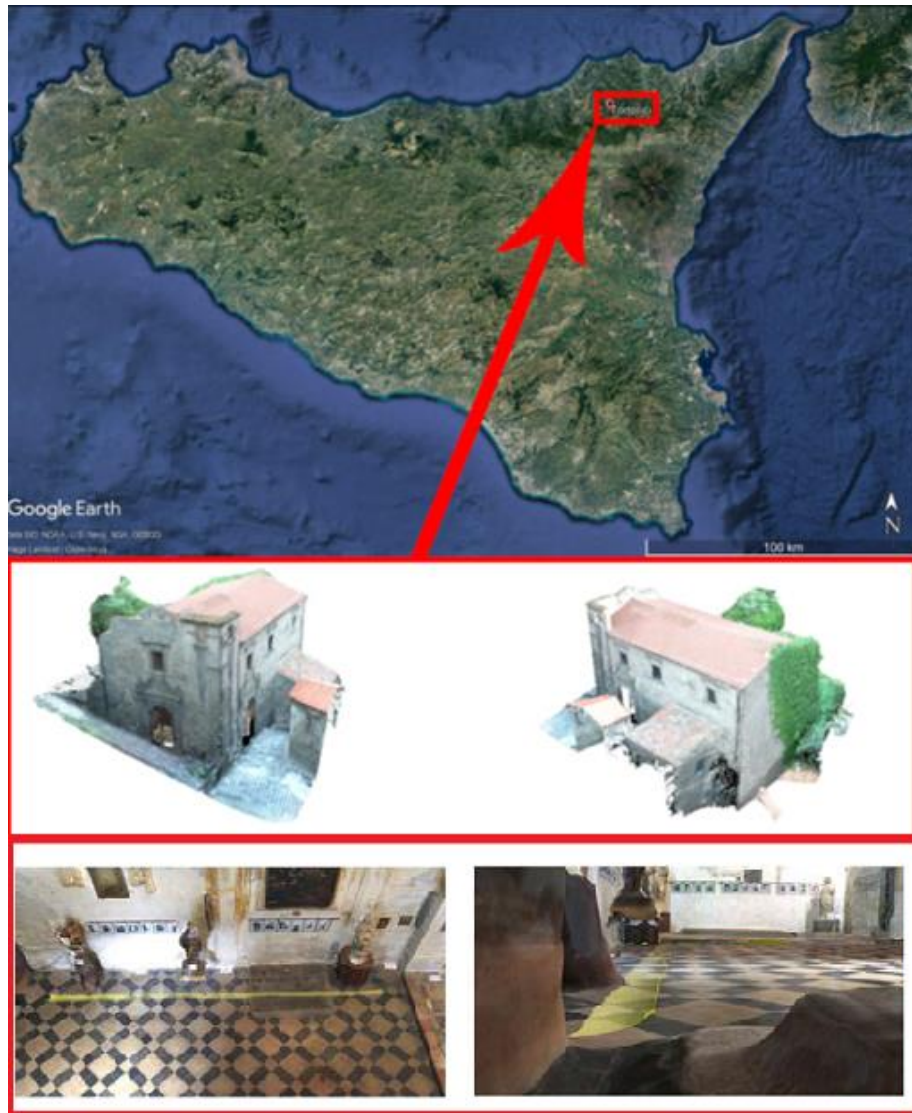
Figure 1: Location of the test site (top panel) and digital 3D model of the external part of the church

Previously a Ground Penetrating Radar survey has been performed in the church [1] and it identified a potential anomaly that has been related to foundation of an old structure as well as some burial sites. Figure 1 show the location of the test site and the reconstructed 3D digital model. It has been reconstructed by the use of photogrammetry. The development of the 3D model was carried out with free and open source licensed software such as VisualSFM, Meshlab and Blender. The final model (obtained by fusing the internal an external part) is perfectly scaled and measurable with a millimetric

The photogrammetric process consists of several phases of processing (see [2] for details). Various markers have been placed throughout the area of interest (mainly on the ground) and the relative spatial coordinates have been detected through accurate measurements. To create the model presented in Figure 1, approximately 1500 images were acquired during two separate campaigns. The images were collated at different distances about 70% overlap forward and 60% overlap sideways.

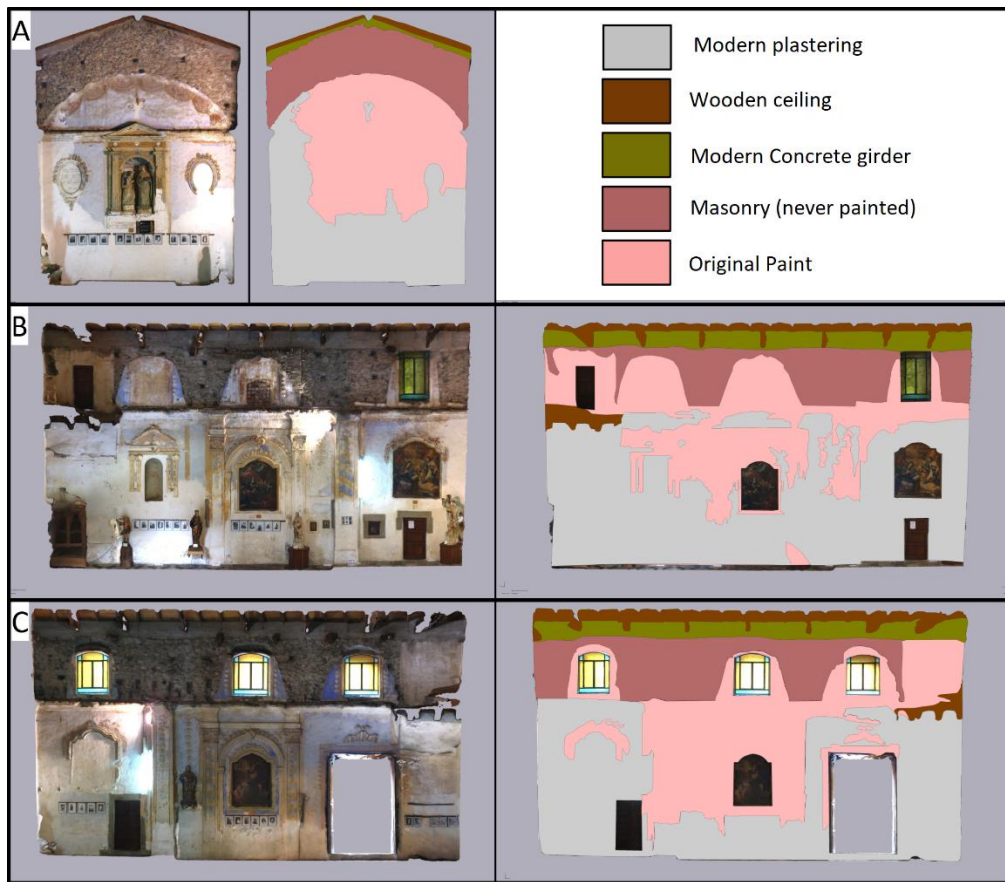
The digital 3D model was used to map several features of the monument. Figure 2 shows the mapping carried out on the model. In particular we were able to map and distinguish the parts that undergone through recent restoration (e.g. new ceiling; modern plastering etc.). This process was done for the three main wall of the church and samples were also collected to perform future analysis on the materials to identify nature of pigments and also information on the masonry materials using during the construction.
