Identification of Physical Structure

Conversion of Battery & Medical Facility into a  
Secure College with Community Facilities

Tal-Ferha Estate  
Għargħur

October 2015

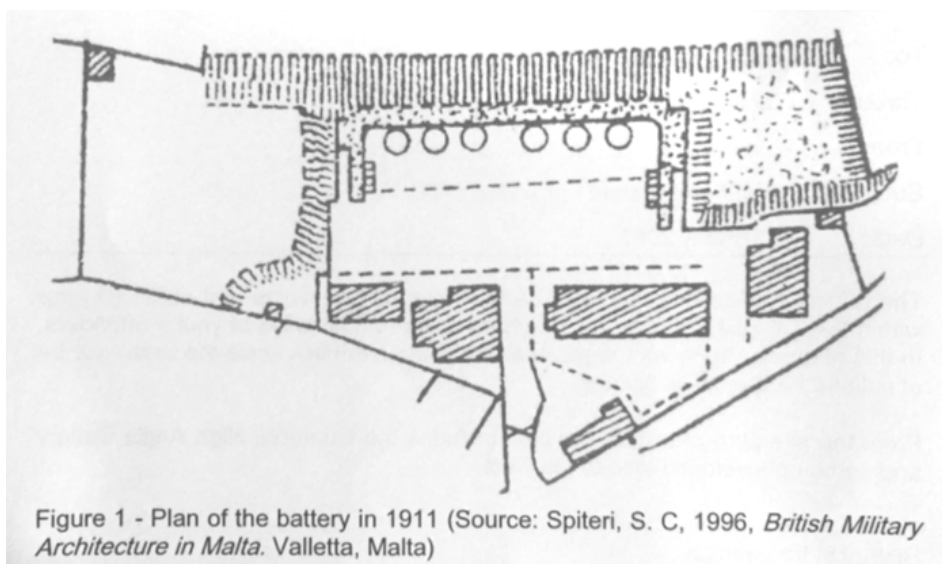
Figure D.A.1: Plan of the Battery in 1911

- a. The site was known as the Gharghur High Angle Battery, which was completed in 1900 and formed part of the Victoria Lines defences. The intention of the high angle battery was to be placed out of sight and screened from enemy view (Refer to Spiteri, 1996 and Figure D.A1);

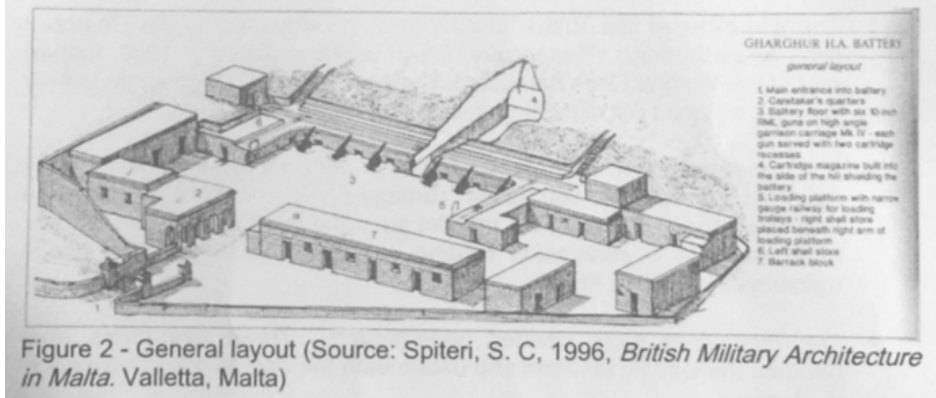
Figure D.A2: General layout

- b. The Gharghur H.A. Battery was armed with six 10-inch RML guns mounted on special high angle carriages. It consisted of an open unfortified position having six parallel guns mounted on a level platform. In front stood a continuous loading platform with two narrow gauge tramways for loaded trolleys. (Refer to Spiteri, 1996 and Figure D.A2);

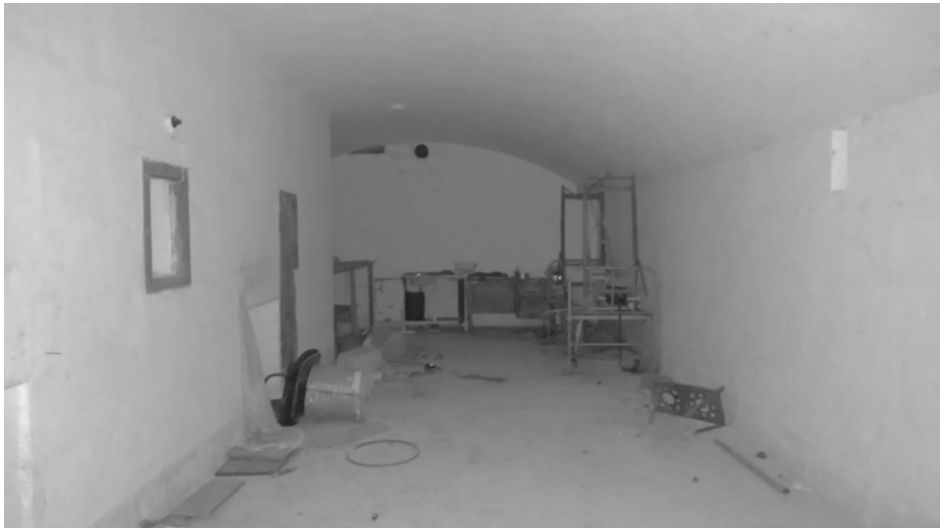
Figure D.13: Underground space formerly used as a cartridge store

- c. The magazines were situated underground. The magazines were situated beneath the loading platform and underneath the sloping ground in front of the battery;

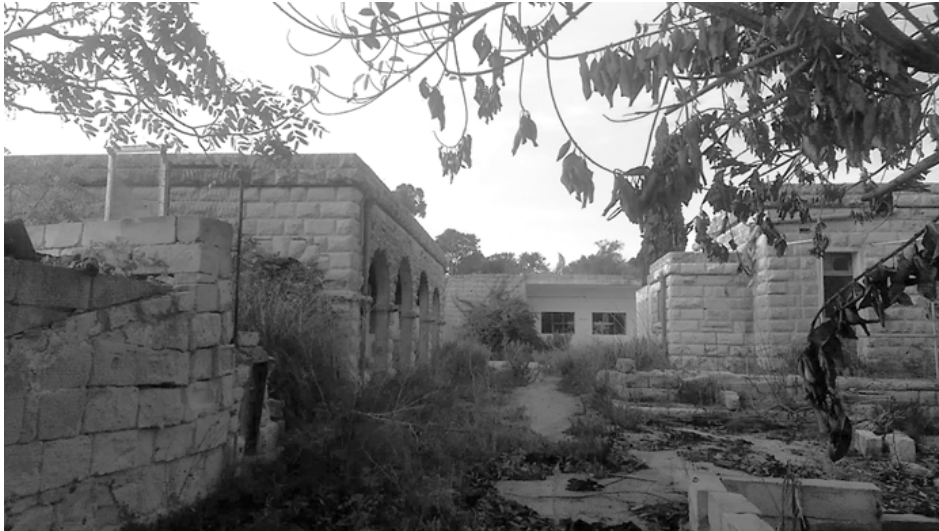
Figure D.18: Tal-Ferha Estate as per current period

Despite these efforts to rehabilitate the property, the estate has not been used ever since 2004. The site was prone to dumping, vandalism and squatters. In fact, nowadays it can be found in a derelict state.

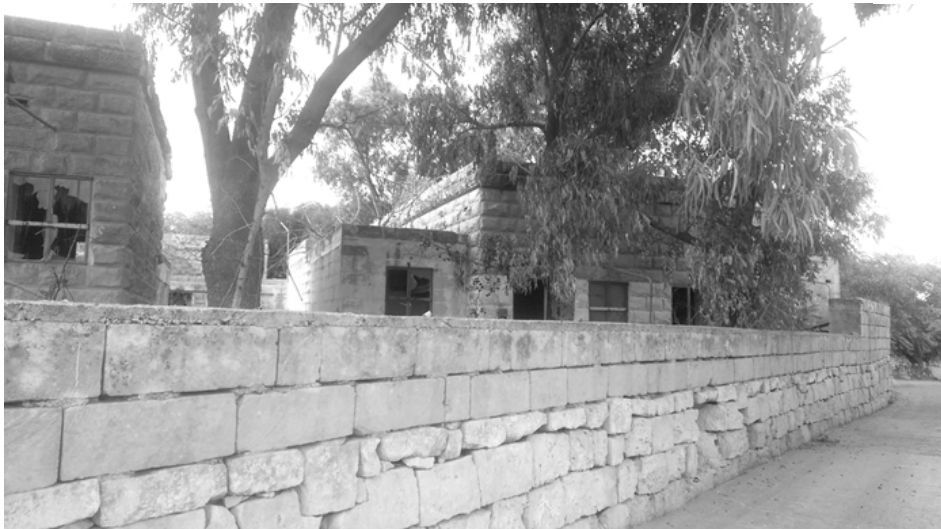
Figure D.25: Part of boundary wall enclosing property

The estate is characterised with rusticated façades (tal- ġidra), typical of the British era. The existing façades are in a relatively good state of repair: little to no open joints can be seen and the stonework is still in good shape. Nevertheless, cleaning from biological growth and vegetation shall be required to prevent rapid deterioration. On the other hand, the boundary wall enclosing the estate is in a poor state of repair and requires immediate attention. Severe alveolar and powdering has resulted in the loss of stonework (Figure D.25).

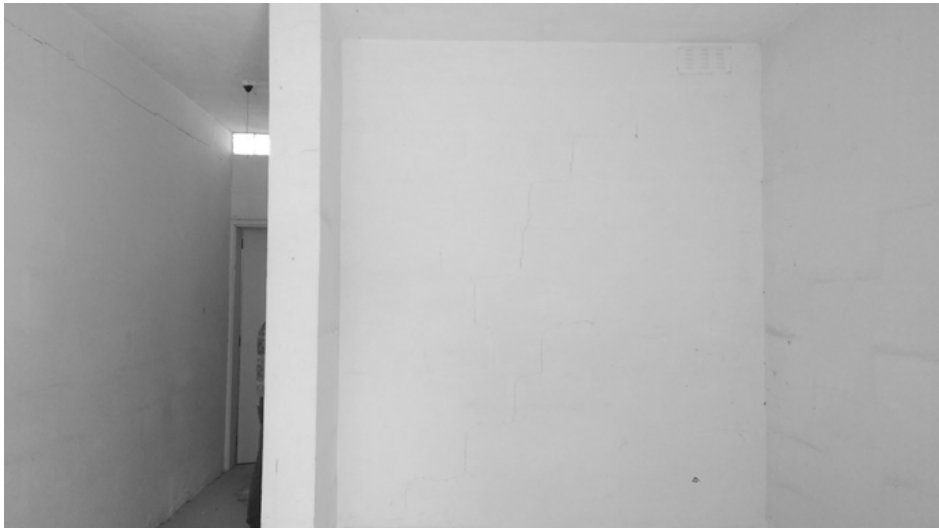
Figure D.26: One of the small apartments is still in a relative good state of repair

The building fabric and roofs of some internal spaces are surprisingly in a good state of repair (Figure D.26), despite the estate being abandoned in 2014. Yet other rooms have suffered neglect and require considerable repair works due to the following:

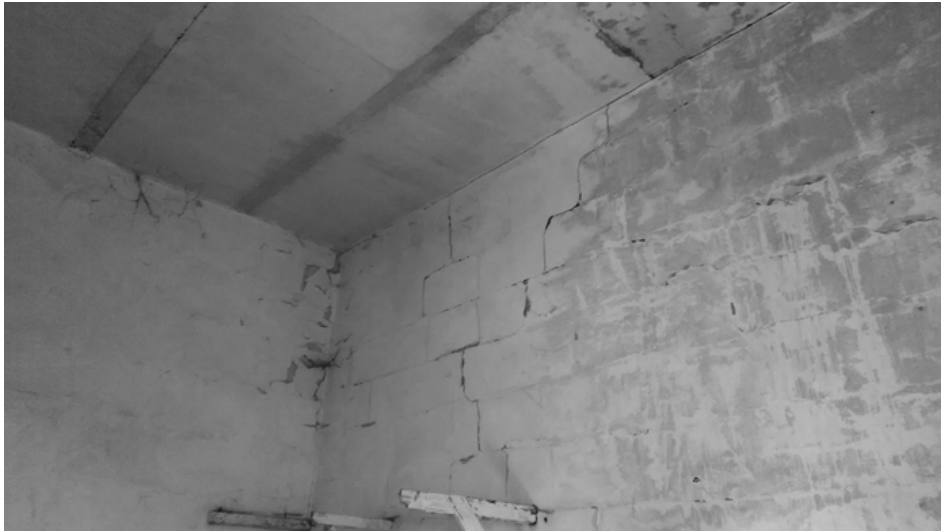
Figure D.27: Cracks in walls

- Cracks have propagated in walls (Figure D.27) due to settlement in the foundations, some of which are particularly acute (Figure D.28);
- Flaking paint on walls due to humidity and rainwater ingress (Figure D.29 and Figure D.30);
- Spalling of concrete column bases due to rising damp (Figure D.31);
- Spalling of concrete beams (Figure D.31), concrete roofs (Figure D.32) and corrosion of steel beams (Figure D.33) due to rainwater penetration;
- Collapsed roof in one of the porticos (Figure D.34).

In view of the existing cracks in a number of buildings due to settlement, it is recommended that a widespread geotechnical investigation is carried out to determine the nature of the subsoil beneath these buildings. The outcome of the geotechnical investigation can have a bearing on the methodology adopted, thus it is essential that this investigation is carried out prior to any further works.

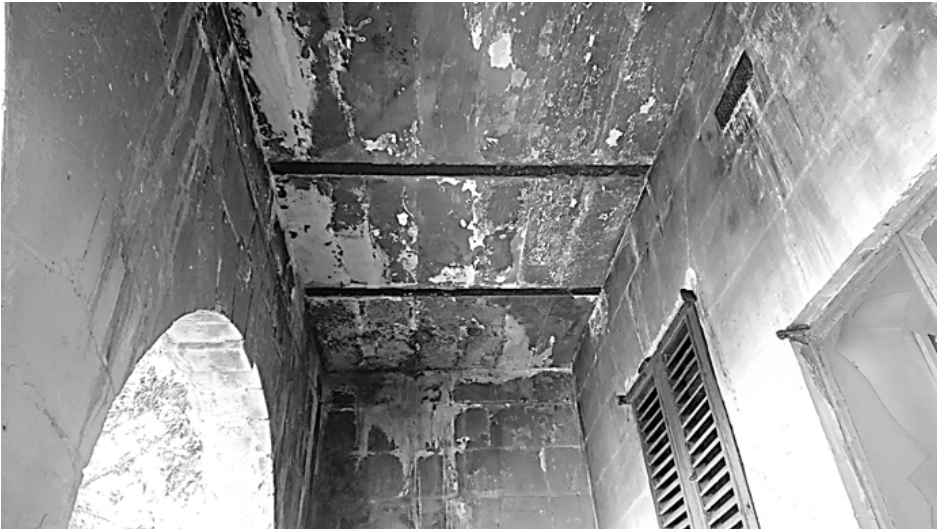
Figure D.35: Carbonised walls and ceilings

A number of rooms have been exposed to fire. It is not known when the fire accidents have occurred nor why, however the carbonised black walls and ceilings are clear evidence of this (Figure D.35). The black crust on the stone walls can lead to further deterioration mechanisms, such as flaking and salt efflorescence, if left untreated. The steel beams which

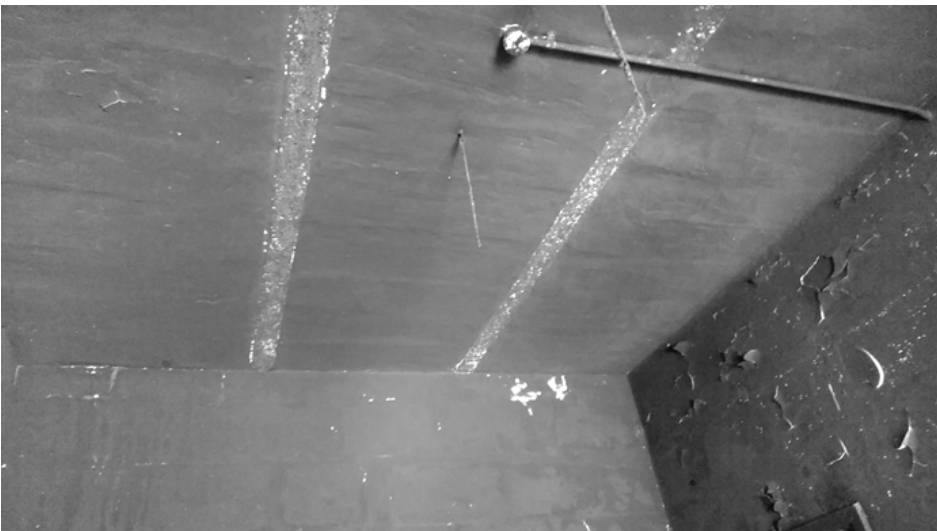
Figure D.36: Steel beams exposed to fire

support the roof slabs of these rooms may have lost some of their structural integrity due to heat (Figure D.36).

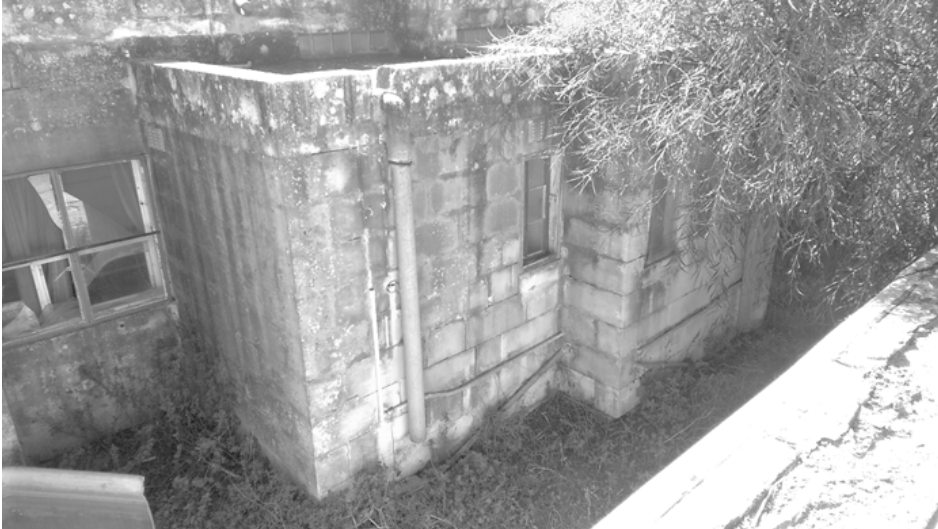
Figure D.37: Apertures with broken glass panes

It has been noted that most apertures in buildings are missing, have broken glass panes (Figure D.37) or require extensive repair. Other apertures have been barred with stone masonry blocks (Figure D.38). Furthermore, even though electrical and water supply was once available in this estate, most of the buildings need upgrading in this regard.

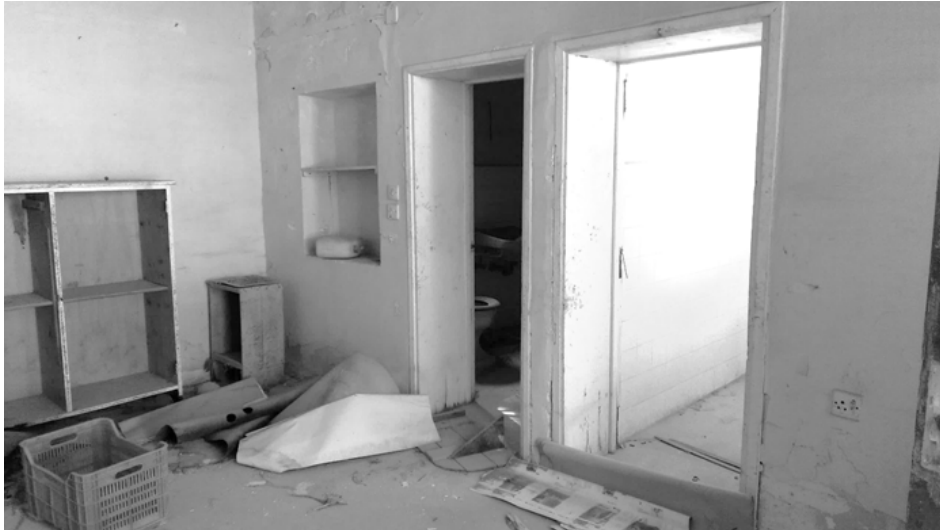
Figure D.41: Abandoned furniture

Furthermore, generous amounts of abandoned furniture (Figure D.41) and other objects can still be found inside the different buildings, indicating also the possibility of occupation by squatters following the closure of 2004. Illegal dumping can also be noticed in the front end of the site (Figure D.42).

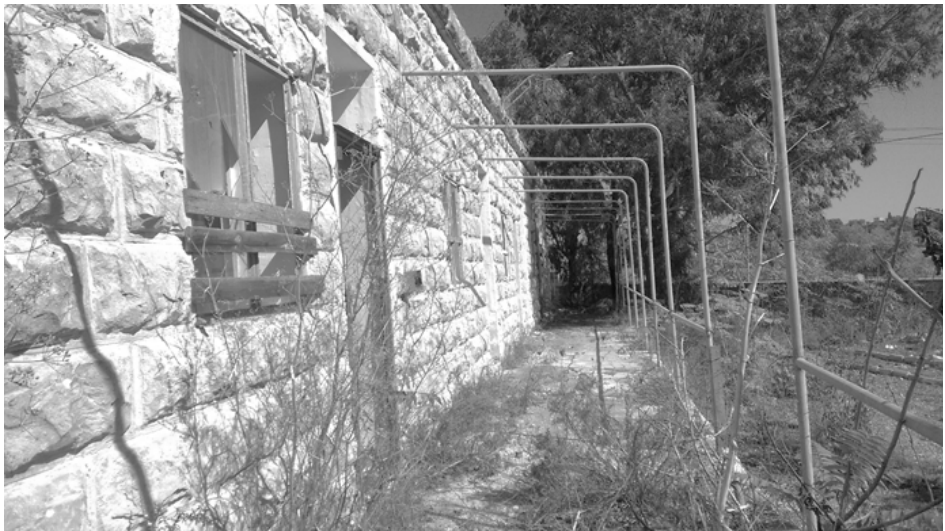
Figure D.50: Former barracks to be converted into classrooms

The former barracks (Figure D.50) located close to the main entrance shall accommodate the education facilities of the proposed college. The current 190 sq.m building shall provide space for up to six small classrooms, most of which shall have an adjacent bathroom and store. The education facilities (Figure D.51) shall be open for the use of the community when not in use by residents.

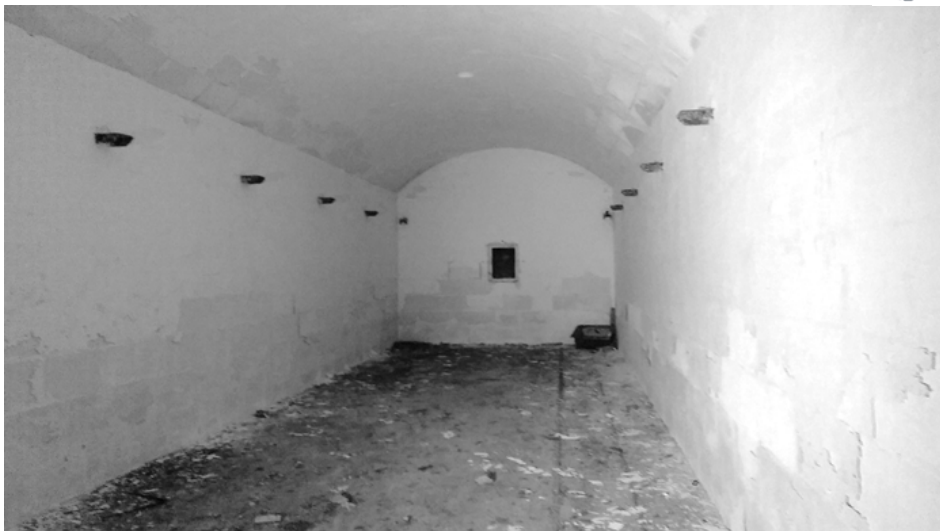
Figure D.55: Vaulted shell store to be transformed into an audio-visual room

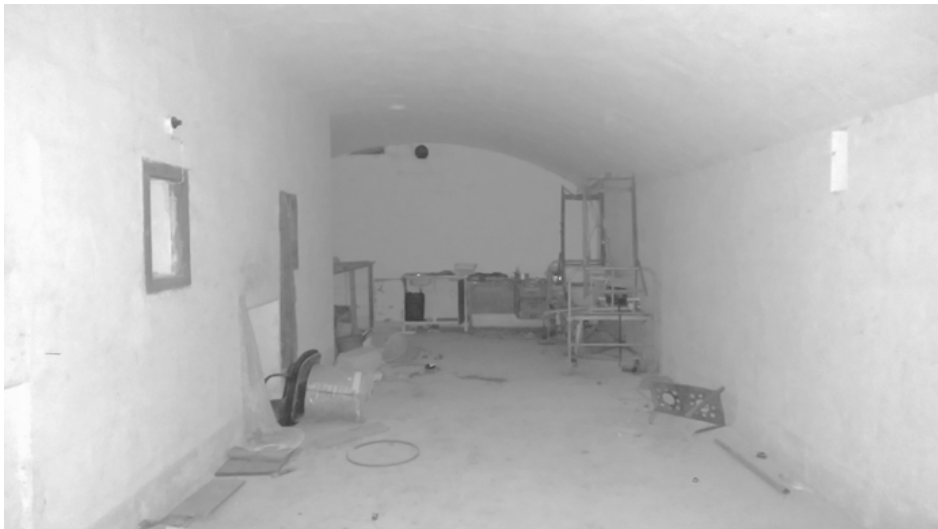
The former underground cartridge store shall be transformed into a theatrical space for small productions and drama classes. Its location immediately behind the community hall shall offer a direct link for the community to also enjoy this area.

Figure D.56: Proposed vaulted theatrical space
