## Huqoq – 2022

07/09/2023  
Preliminary Report

In May–July 2022, the tenth season of excavations was conducted at Horbat Huqoq (henceforth Huqoq) in Eastern Galilee (License No. G-4/2022; map ref. 245000–500/754300–650; Magness 2012 ([https://www.hadashot-esi.org.il/report\\_detail\\_eng.aspx?id=1959&mag\\_id=119](https://www.hadashot-esi.org.il/report_detail_eng.aspx?id=1959&mag_id=119)); Magness et al. 2013 ([http://www.hadashot-esi.org.il/report\\_detail\\_eng.aspx?id=3331&mag\\_id=120](http://www.hadashot-esi.org.il/report_detail_eng.aspx?id=3331&mag_id=120)); Magness et al. 2014 ([http://www.hadashot-esi.org.il/Report\\_Detail\\_Eng.aspx?id=12648](http://www.hadashot-esi.org.il/Report_Detail_Eng.aspx?id=12648)); Magness et al. 2016a ([http://www.hadashot-esi.org.il/report\\_detail\\_eng.aspx?id=25057&mag\\_id=124](http://www.hadashot-esi.org.il/report_detail_eng.aspx?id=25057&mag_id=124)); Magness et al. 2016 b ([http://www.hadashot-esi.org.il/report\\_detail\\_eng.aspx?id=25060&mag\\_id=124](http://www.hadashot-esi.org.il/report_detail_eng.aspx?id=25060&mag_id=124)); Magness et al. 2017 ([http://www.hadashot-esi.org.il/report\\_detail\\_eng.aspx?id=25304&mag\\_id=125](http

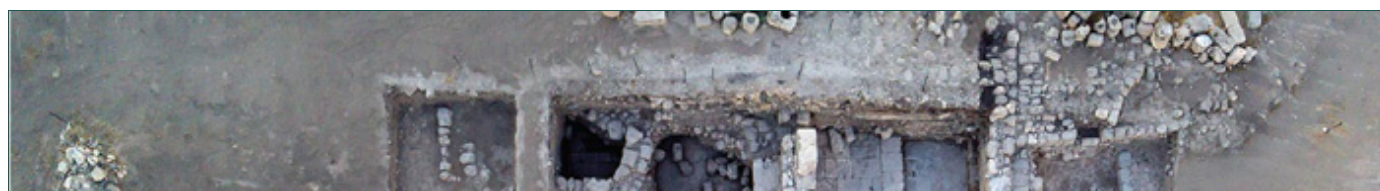
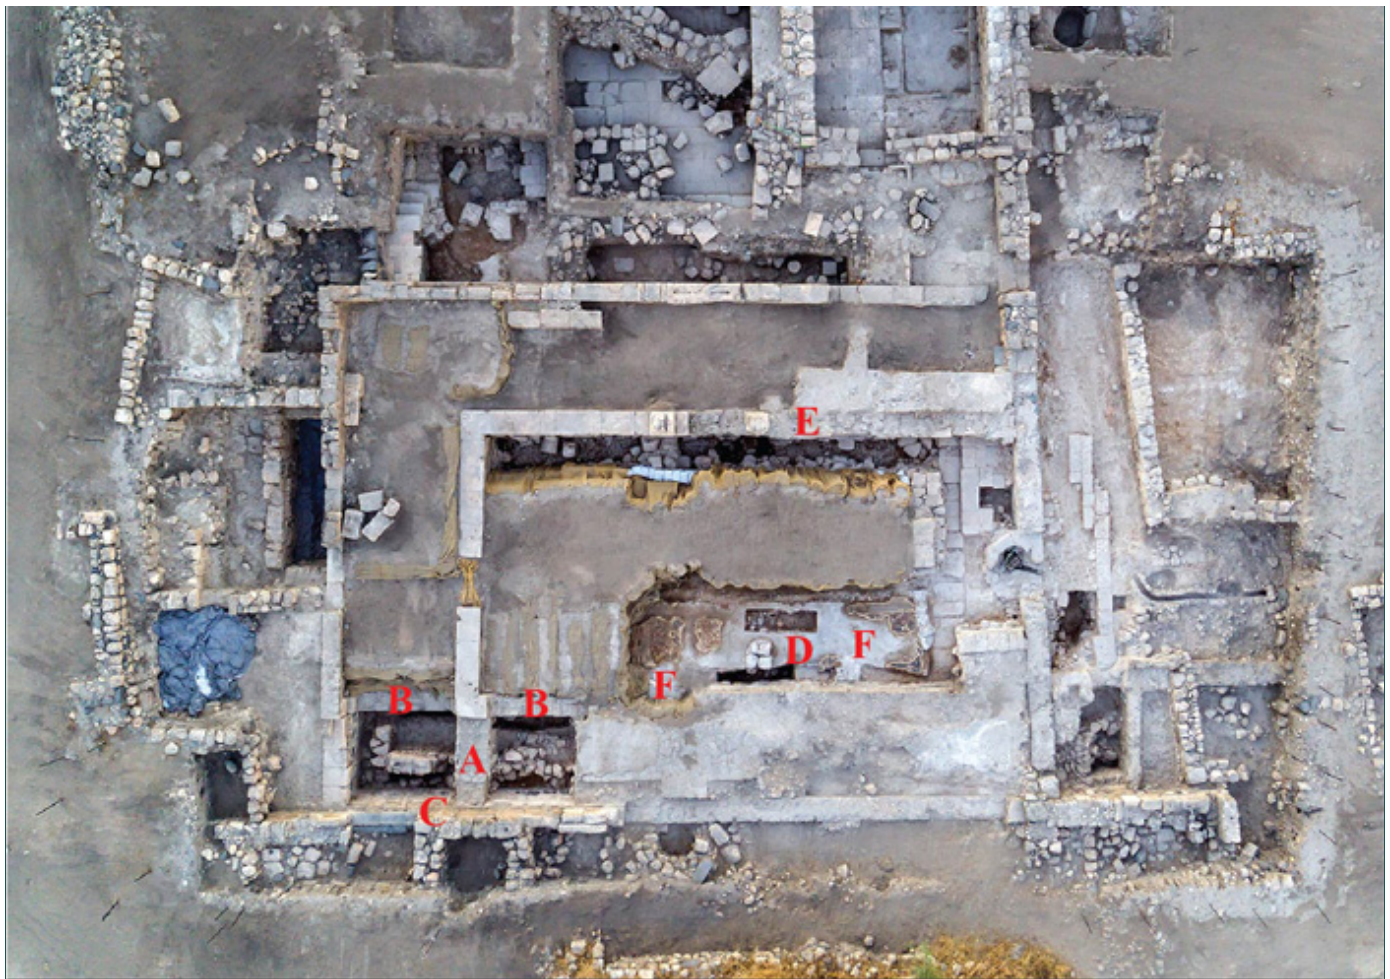
קירות קדומים לבית הכנסת הרומי המאוחר	A	Walls predating the Late Roman synagogue
יסודות הסטילובט המערבי מסוף ימי הביניים	B	Foundation of the Late Medieval west stylobate
הקיר המערבי של המבנה מסוף ימי הביניים	C	West wall of the Late Medieval building
בחנים בפן המזרחי של הסטילובט המערבי מסוף ימי הביניים	D	Buttresses against the east face of the Late Medieval west stylobate
הסטילובט המזרחי מסוף ימי הביניים	E	Late Medieval east stylobate
פסיפסים בסטרה המערבית של בית הכנסת הרומי המאוחר	F	Mosaics in the west aisle of the Late Roman synagogue

1. Area 3000 at the end of the 2022 season, aerial view to the east.

Excavations this season continued in Area 3000 (Fig. 1), where there are five main occupation phases: a Late Roman synagogue (late fourth–early fifth centuries CE); a Late Medieval public building (fourteenth–fifteenth centuries CE), which we now identify as a synagogue (Mizzi and Magness 2022); installations and a few scattered walls built after the Late Medieval building had gone out of use and was pitted and robbed out (sixteenth–eighteenth centuries CE); an open area with numerous *tabuns* associated with layers of ash and a few partition walls (eighteenth–nineteenth centuries CE); and houses belonging to the modern village of Yakuk from the Late Ottoman–Modern periods (nineteenth–twentieth centuries CE, up to 1948). In addition, walls belonging to pre-synagogue structures were discovered under the mosaic floor in the west aisle of the Late Roman synagogue and under the floor of the northwest aisle of the Late Medieval building, as well as outside the synagogue’s east wall, at the very bottom of the wall’s foundation trench. The following discussion describes the phases from the earliest to the latest, proceeding from west (subsumed under Area 3000N) to south (Area 3000S) to east (Area 3000E).

The remainder of the synagogue’s west aisle, south of the Elim panel uncovered in 2019, was excavated in 2022. Mosaic panels were uncovered in two places (Fig. 1:F; see below): a wreathed inscription flanked by kraters with vines forming medallions that frame animals at the north end of the excavation area, and a scene from Judges 4–5 at the south end of the aisle. Two small, fragmentary patches of mosaic were discovered between these, on the west side of the aisle. No other mosaics were preserved in this area. This provided an opportunity to open a sondage (0.8 × 2.5 m) below the bedding, which, unlike in other parts of the Late Roman synagogue, was a hard, concrete-like mortar laid over a dense, concrete-like layer containing unused tesserae and mosaic debitage. Underneath was a layer of cobbles, with a soft layer of soil below it mixed with numerous tesserae and mosaic clusters. The presence of unused tesserae, mosaic clusters and debitage under the bedding indicates the existence of an earlier, otherwise unknown mosaic floor, or, more likely, a repair to the mosaic, as suggested by the dislocation of the guilloche border at the southeast end of the west aisle (see below). Below the layer of soft soil was an earth fill that overlay part of the small segment of a north–south wall that was exposed in a sondage under the Late Roman synagogue’s west aisle. The latest ceramic types discovered below the bedding are local wares of the

Excavations under the floor in the north part of the west aisle of the Late Medieval building uncovered the foundation trenches of its west wall and west stylobate (Fig. 1:B, C). The former was filled with a thick packing of large stones, whereas the latter was filled with dark brown earth and stones. The stylobate blocks were laid on a foundation course of fieldstones and reused architectural elements from the Late Roman synagogue, including a limestone pedestal and a broken column. The west stylobate of the Late Medieval building ran along the line of the west wall of the Late Roman synagogue, suggesting that the foundation course of the west stylobate was laid directly above the foundation course of the synagogue's west wall. However, the 2022 excavation did not reach deep enough to substantiate this hypothesis, nor did it allow identifying the foundation trench of the synagogue's west wall.

Farther to the south, on the eastern side of the west stylobate, excavations under the floor of the nave of the Late Medieval building revealed two additional buttresses (a third one was exposed partly in 2015 and partly in 2019) made up of mortared stones and architectural elements (Fig. 1:D). These abutted the inner face of the west stylobate and provided support for pedestals. The northernmost of these three buttresses was built on top of the northern half of the inhabited vine scroll panel, though its west end was laid inside the foundation trench of the west stylobate. The two buttresses to its south, however, cut through the mosaic bedding and the fills underneath it. It is apparent that the Late Medieval builders tried to preserve the mosaic floor wherever they could, thus ensuring its survival, but they damaged the floor at the westernmost edge, where they had to cut the foundation trench for the stylobate.

Excavations also resumed in the foundation of the Late Medieval east stylobate (Fig. 1:E). On its west side, three buttresses were built to support the three central—of a total of five—pedestals that sat on the stylobate. The buttress walls were built with one to two courses of repurposed architectural elements paired with two to four courses of small to

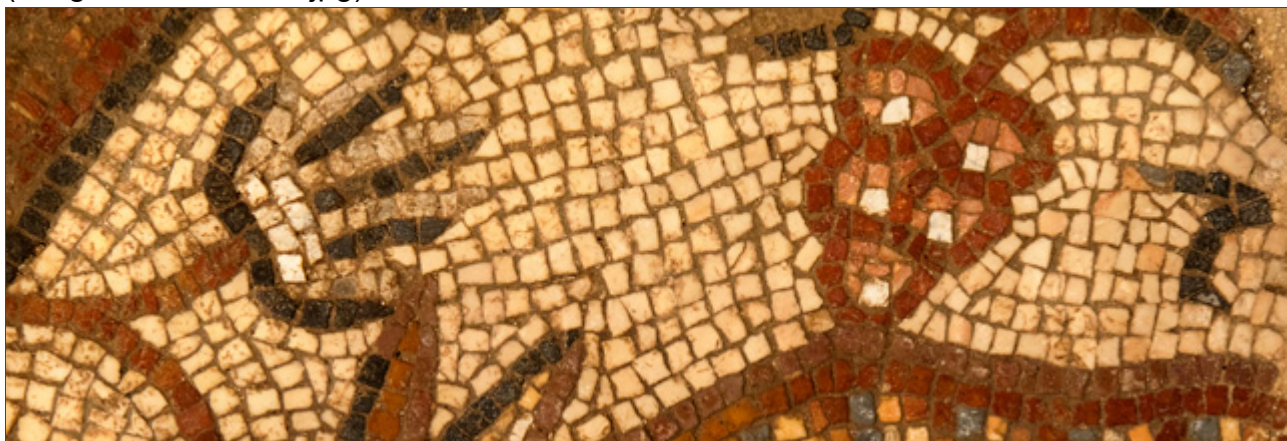
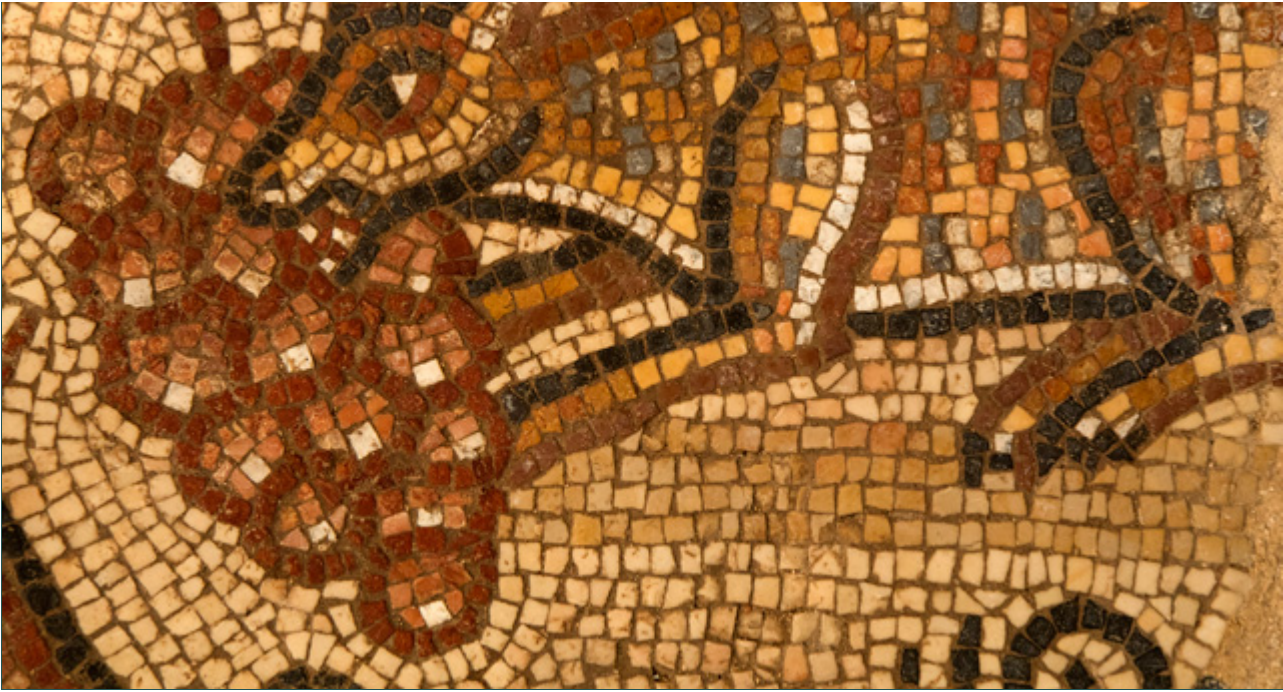
2. Mosaic showing fox eating grapes.  
(Images//G-4-2022-2.jpg)

Immediately to the south of the wreathed inscription panel is a second inhabited vine scroll panel. This panel was conceived as a pendant to the other inhabited scroll panel, although the vessel at the bottom of the south panel is not preserved. Two vines curve upward and intertwine to form two scrolls framing a fox (Fig. 2) and a hare nibbling on grape clusters. The top part of the panel is not preserved.

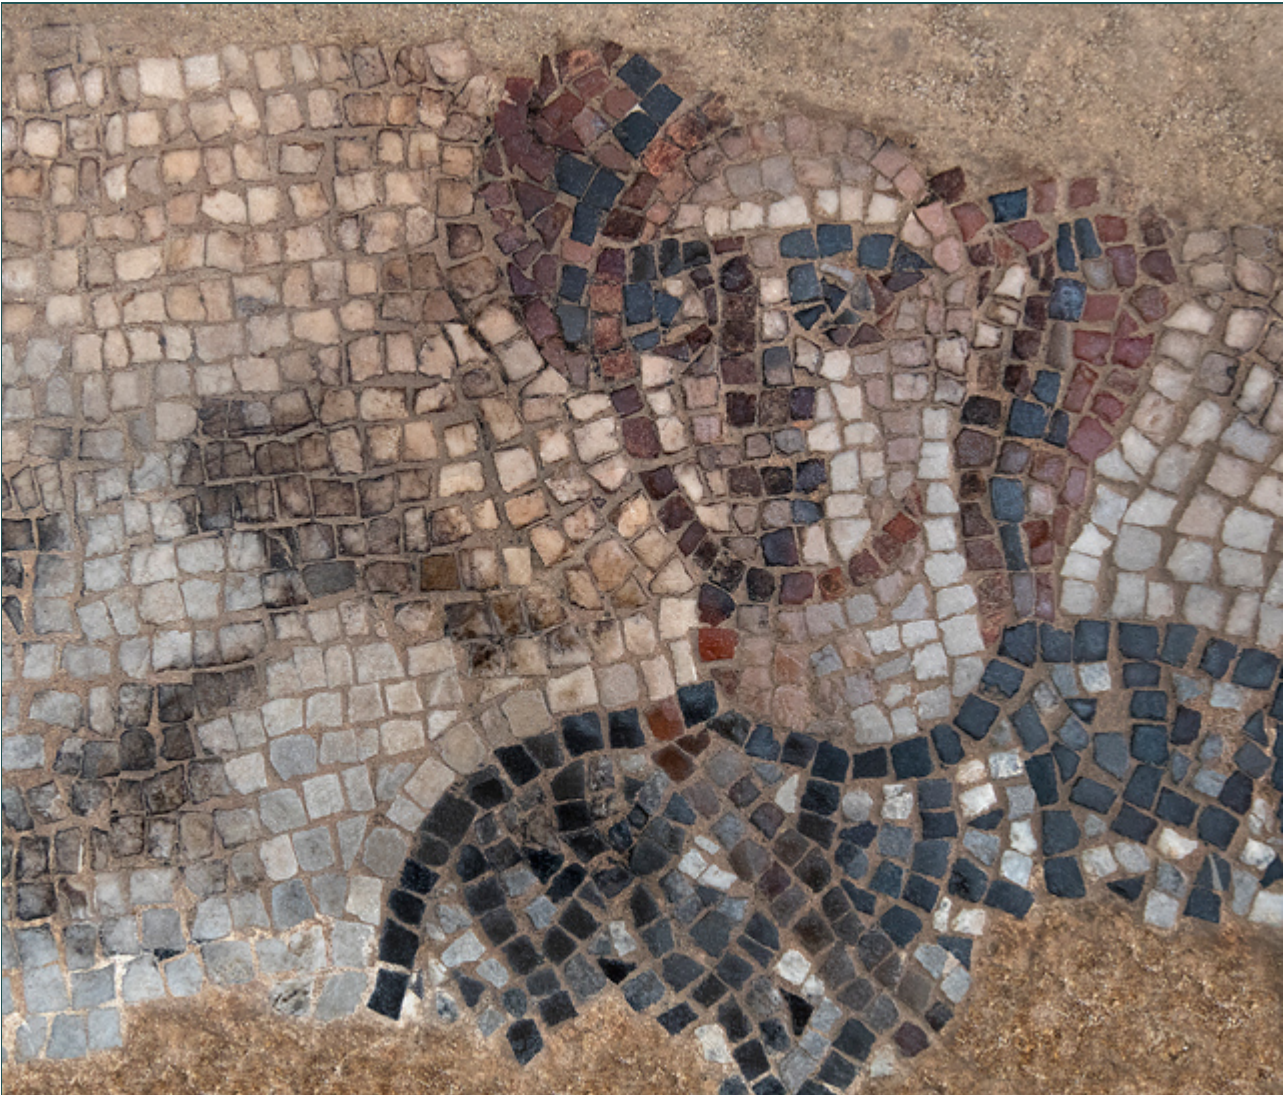
3. Mosaic showing the head of Barak son of Abinoam.

The scene in the top register of the panel depicts Deborah under a date-palm tree having summoned Barak son of Abinoam (Fig. 3), so that she might instruct him to lead the Israelites in battle against the Canaanite general Sisera and his army (Judges 4:5–9). The subject of the middle register appears to be Sisera in the tent of Yael, the wife of Heber the Kenite. It seems that Yael stands before Sisera, who is seated, offering him a drink of milk, as recounted in both Judges 4:19 and 5:25. The scene in the bottom register depicts Yael wielding the hammer that she uses to drive a large tent peg through Sisera's temple and into the ground (Judges 4:21 and 5:26–27). Sisera lies dead on his side, his head bleeding profusely into the earth. His weapons are scattered on the ground around him.

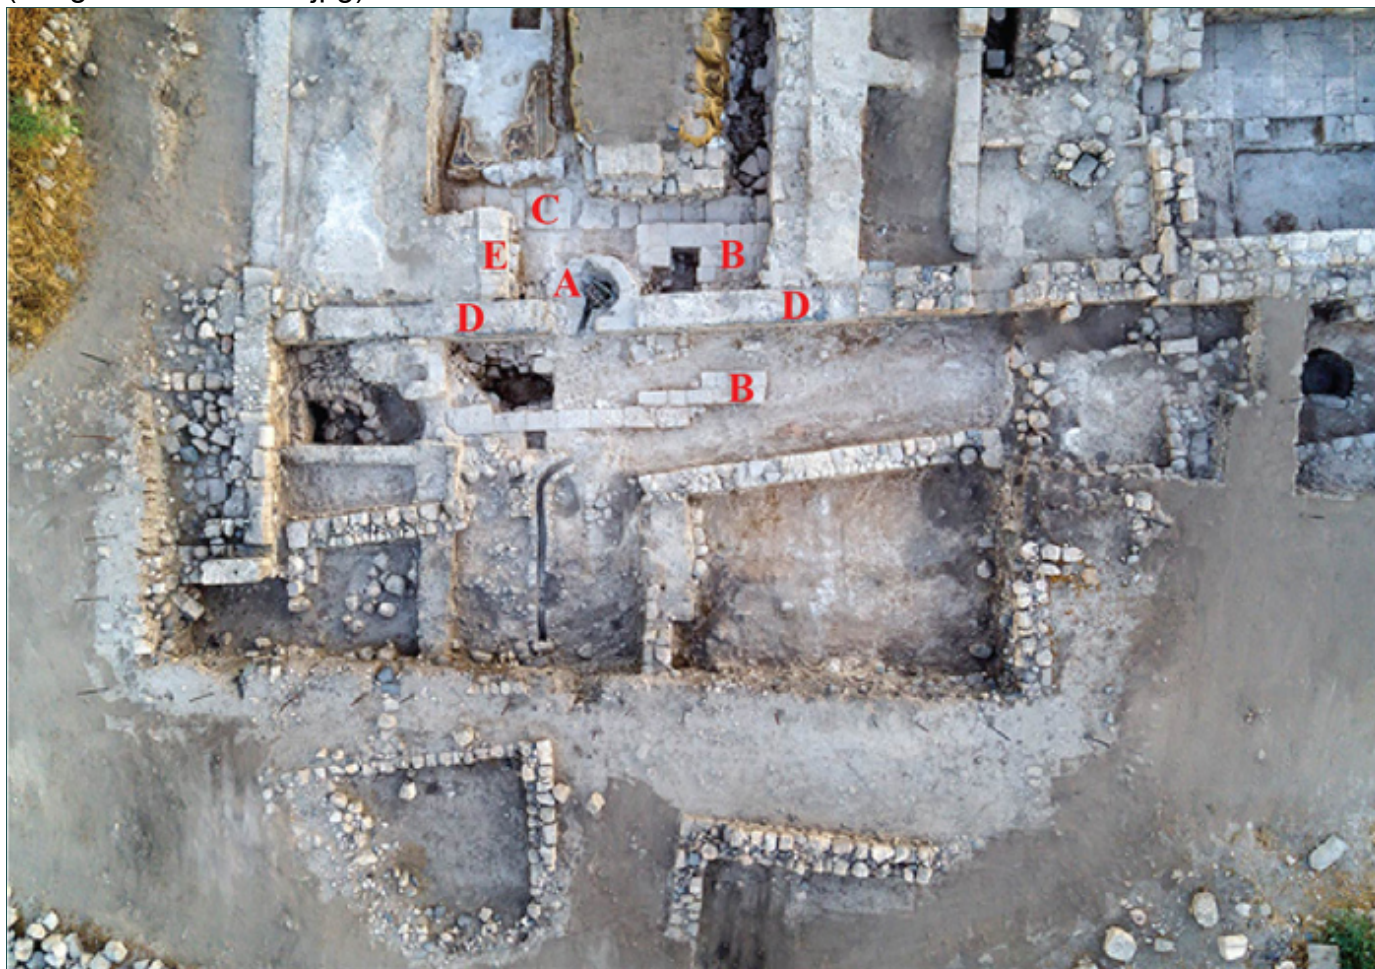
בור מים	A	Cistern
ריצוף חצר מן התקופה הרומית המאוחרת	B	Paving of the Late Roman courtyard
הקיר הדרומי של בית הכנסת הרומי המאוחר	C	South wall of the Late Roman synagogue
הקיר הדרומי של המבנה מסוף ימי הביניים	D	South wall of the Late Medieval building
מבנה דמוי מסוף ימי הביניים (פורק ברובו ב-2022)	E	Late Medieval pi-shaped structure (mostly dismantled in 2022)

4. Area 3000, south of the Late Roman synagogue, aerial view to the north.

### **Southern Courtyard of the Late Roman Synagogue (Fig. 4)**

New paving stones (Fig. 4:B) from the Late Roman courtyard were exposed in two areas south of the south wall of the Late Medieval public building, and within the pi-shaped structure of the same building. As in previous seasons, these sections of the courtyard pavement consisted of limestone ashlar laid in tightly packed rows. The pavement slopes down about 0.2 m from east to west, probably due to settling, as there is no evidence of a step between the rows of stones. The paving stones rest on a thin layer of compact earth, stone chips and small stones, which, in turn, rest on a layer of fieldstones. The fact that the paving stones end in an east–west line about 5 m to the south of the Late Roman synagogue's south wall suggests that there was a porch on this side, as in the Capernaum synagogue.

The excavation in the Late Medieval pi-shaped feature revealed that the cistern (Fig. 4:A) it enclosed was originally dug in the Late Roman period, when its opening was ringed by limestone blocks cut into a trapezoidal shape. It also revealed the continuation of the Late Roman synagogue's south wall, which was abutted by the courtyard pavement to the south. The wall consists of a row of limestone ashlar laid tightly together as headers, with a thin layer of packed earth in-between them. To the north, the wall was abutted by the mosaic floor of the Late Roman synagogue.

A sounding in the southern foundation trench of the Late Medieval building's south wall (Fig. 4:D), which cut through the stone pavement of the Late Roman synagogue, revealed that the foundations were constructed of large limestone blocks, fieldstones, and reused architectural fragments. Excavation in the pi-shaped structure at the south end of the building revealed no evidence of a later reconstruction, contrary to what we had concluded in 2019. The western half of the pi-shaped structure's north wall was dismantled to expose the mosaics at the south end of the Late Roman synagogue's west aisle.

Work in the pi-shaped structure (Fig. 4:E) also clarified the relationship of the Late Roman cistern (Fig. 4:A) to the Late Medieval building. The cistern was incorporated into the later building's south wall, to which it was bonded with fieldstones and mortar, and the original opening to the cistern, part of which had been robbed out, was rebuilt and raised to the level of the Late Medieval floor. A north–south channel fed the cistern from the south, while another water channel carried roof water away to the south. The latter was built on top of the paving stones of the Late Roman porch.

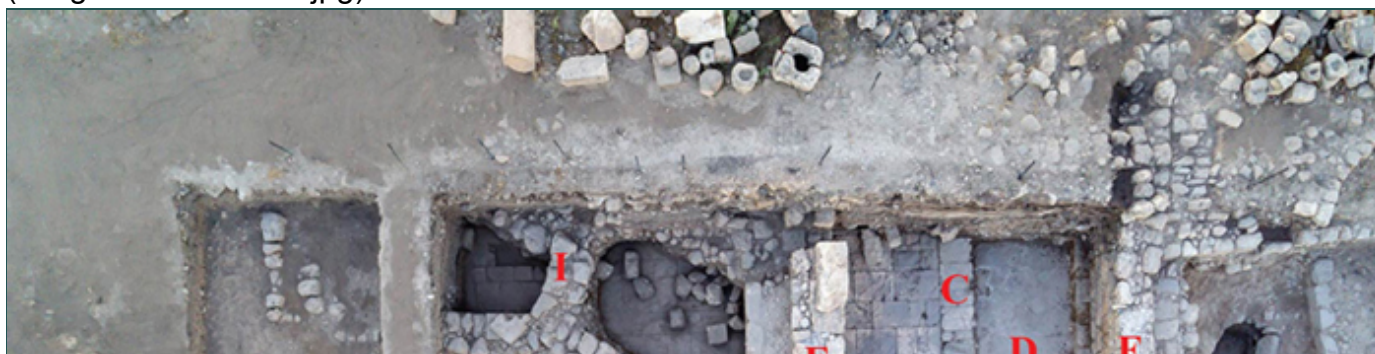
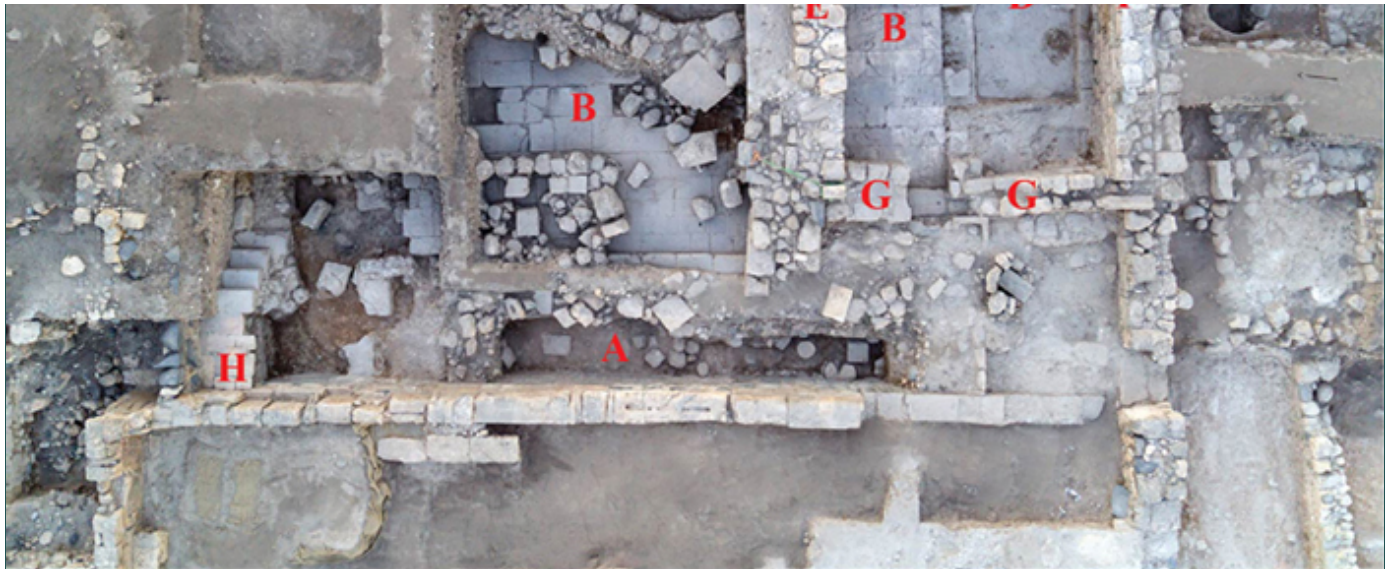
בור בדיקה לאורך הקיר המזרחי של בית הכנסת הרומי המאוחר	A	Sondage along the east wall of the Late Roman synagogue
הריצוף בחצר מהתקופה הרומית המאוחדת	B	Paving of the Late Roman courtyard
סטילובט מהתקופה הרומית המאוחרת	C	Late Roman stylobate
אכסדרת עמודים מהתקופה הרומית המאוחרת (הריצוף נשדד ; רצפות טיח הונחו בסוף ימי הביניים)	D	Late Roman portico (paving stones were robbed; plastered floor laid in the Late Medieval period)
הקיר הצפוני של המבנה המקומר מסוף ימי הביניים	E	North wall of the Late Medieval vaulted structure
הקיר הדרומי של המבנה המקומר מסוף ימי הביניים	F	South wall of the Late Medieval vaulted structure
הקיר המערבי של המבנה המקומר מסוף ימי הביניים	G	West wall of the Late Medieval vaulted structure
המבואה המוגבהת וגרם המדרגות המונומנטלי מסוף ימי הביניים	H	Late Medieval raised porch and monumental staircase
מבנים חצי-עגולים	I	Semicircular features

5. Area 3000, east of the Late Roman synagogue, aerial view to the east.

### **Eastern Courtyard of the Late Roman Synagogue (Fig. 5)**

The 2022 excavation exposed the remains of a large, paved courtyard extending at least 11.5 m to the east of the Late Roman synagogue (Fig. 5:B). The pavement continues into the unexcavated east balks of the area. In the gap along the synagogue's east wall, where the pavement no longer survives, layers of bedding—including a concreted plaster bedding and a yellow layer comprising soil and stone chips—indicate that the courtyard originally ran directly up to the base of the wall. Coins were associated with each of these features, including clusters of *minimi* in the plaster bedding below robbed-out paving stones, and a hoard of over 100 coins found in the fills above the pavement, which come from areas where the paving stones were missing or upturned. An east–west stylobate (Fig. 5:C) originally ran parallel to what seems to have been the south wall of the courtyard, creating a colonnaded portico (width c. 2.2 m; Fig. 5:D). The floor of this portico was also once paved, but the flagstones had been robbed out before renovations were made to the complex during the Late Medieval period, leaving only the concreted bedding below.

### **The Late Medieval Vaulted Structure (Fig. 5)**

During the Late Medieval period, a large, vaulted structure was built directly on top of the surviving southern portion of the Late Roman courtyard. The extant western part of this structure was originally built with its north wall placed on the courtyard pavement and supported by an exterior buttress (Fig. 5:E); its south wall built over the foundations of the courtyard's original south wall (Fig. 5:F); the southern half of its west wall placed

over the concreted bedding of the original portico pavement; and the northern half of its west wall, like the north wall, placed directly on the Late Roman pavement (Fig. 5:G). Extant entrances are indicated by a northern threshold in the east part of the north wall, a southern threshold in the south wall, and a slightly lower western threshold in the west wall. The floor in the northern half of the space delineated by these walls reused the surviving Late Roman pavement north of the surviving stylobate. In contrast, the floor in the southern half of this space—south of the stylobate, where the Late Roman pavement had been robbed out (Fig. 5:D)—consisted of a compact soil layer deposited on the concreted plaster bedding of the original paving and plastered over to create a sturdy walking surface.

It appears that the Late Medieval builders removed a strip of the Late Roman courtyard pavement (2.5–3.5 m wide) along the east wall of the synagogue. Furthermore, as with the floor and stylobate in the synagogue's interior, the Late Medieval builders raised this strip to create a narrow (c. 2 m wide) porch. The only portion of this porch that survives is a section outside the northeast corner of the Late Medieval building. The builders then constructed a monumental staircase made of three steps descending from this porch to the level of the original, Late Roman courtyard and re-used the courtyard's eastward continuation (Fig. 5:H).

To the north of the Late Medieval vaulted structure, two large semicircular features built of fieldstones and architectural blocks in secondary use were found (Fig. 5:1). These were likely connected with the numerous *tabuns* of the nineteenth century elsewhere in Area 3000. By the early-to-mid twentieth century, both features were covered with fills, and two walls that apparently belonged to the modern village houses were constructed above them. The Late Medieval vaulted structure was repurposed as a modern building that developed in multiple phases. This was done with the construction of a new, large north–south wall inside the western part of the room, thus shrinking the size of the building’s interior space; by building upon and filling in thresholds of the north and south walls of the building; by constructing pilasters to support structural arches in the new building; and by installing a series of fills and floors.

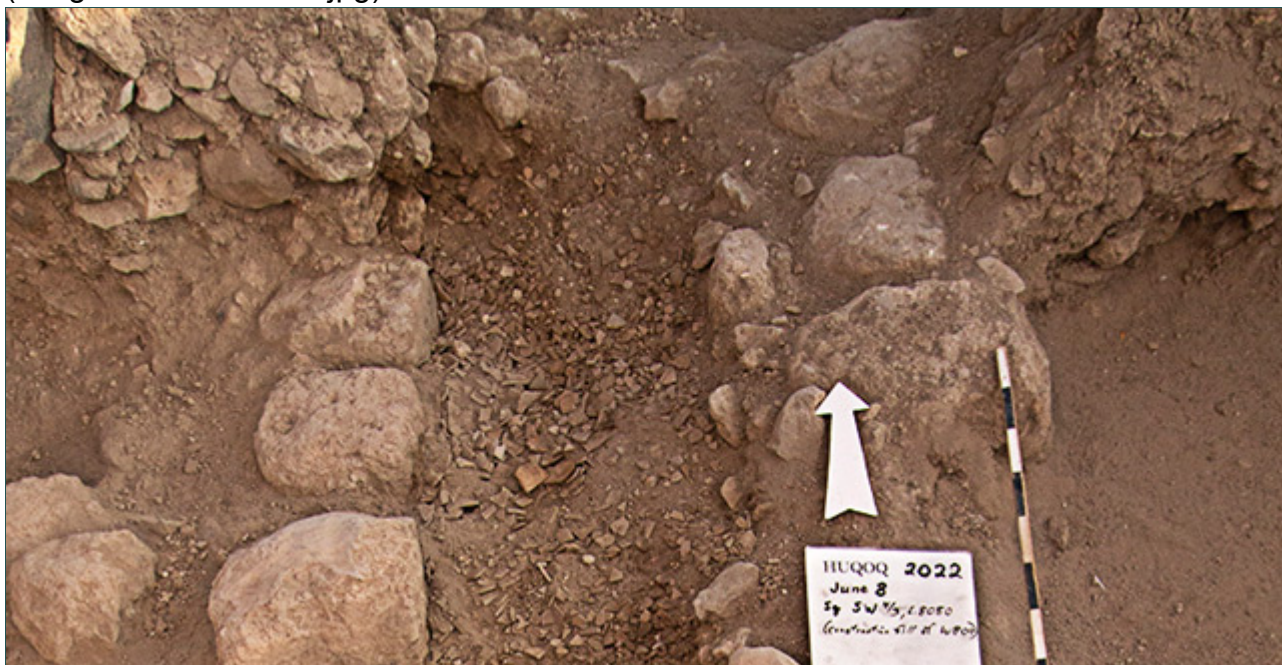
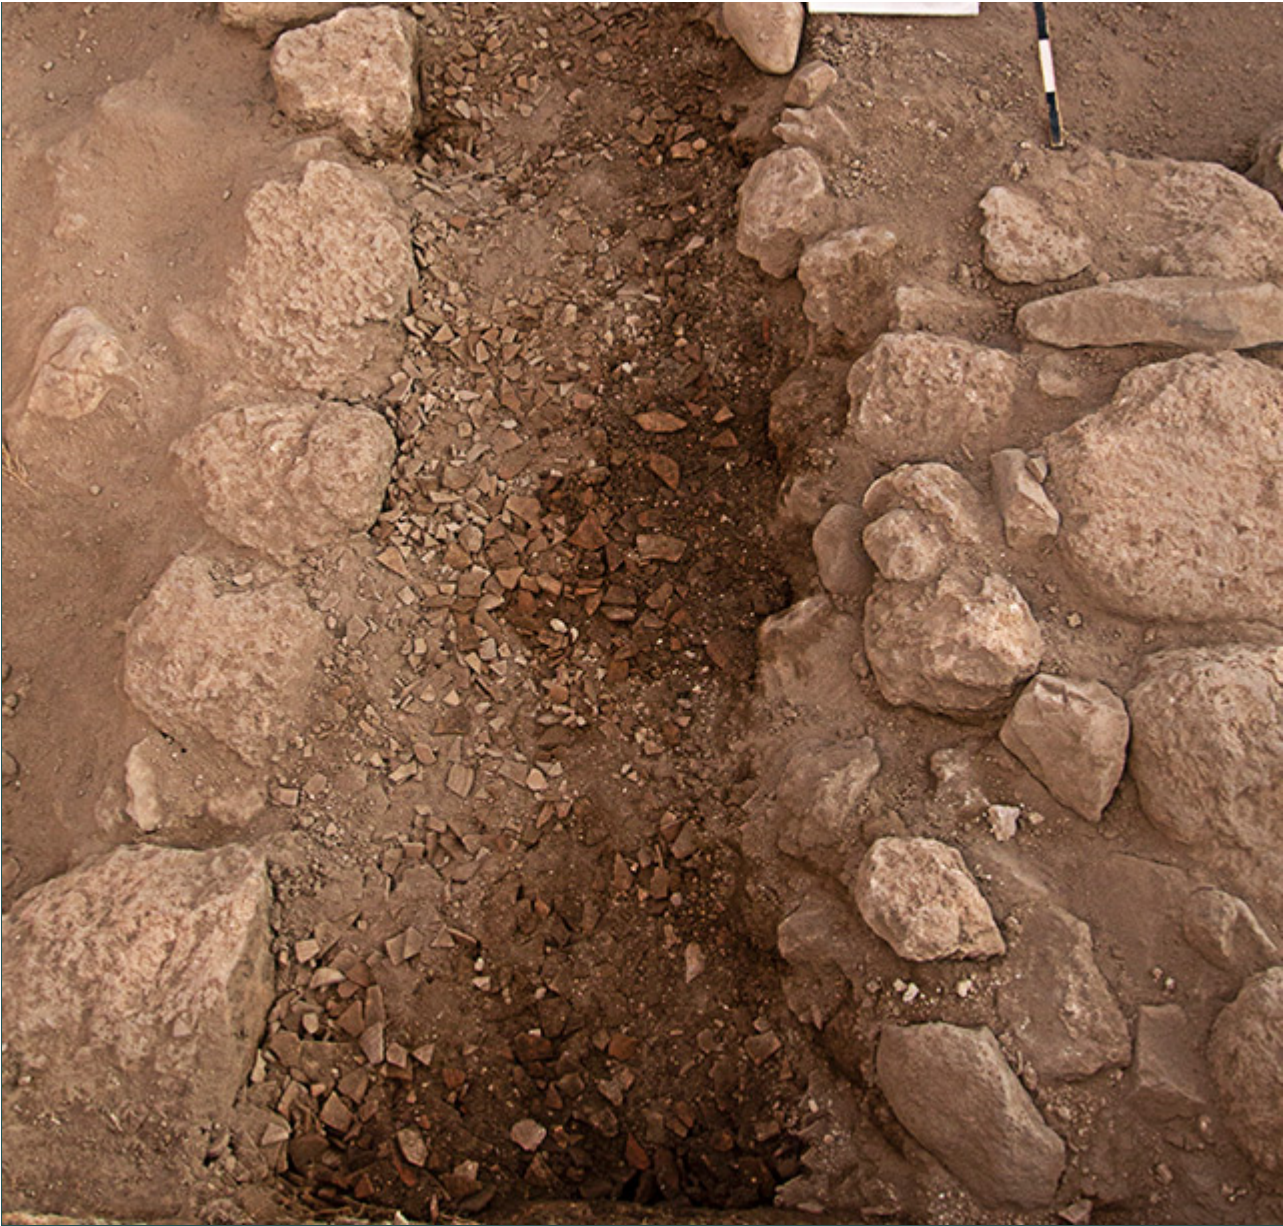
6. Foundation trench of the modern north–south wall filled with broken pottery.  
(Images//G-4-2022-6.jpg)

Similar to the Late Medieval walls that preceded it (e.g., the north wall), the new north–south wall was built directly on the floor of previous buildings—the Late Roman pavement in the north half of the Late Medieval vaulted structure, and a compact fill in the southern half of the structure, where a plaster surface had once been. Because this wall could not have a proper foundation trench, builders constructed a substantial foundation for it consisting of two parallel rows of large fieldstones (Fig. 6). The trench created by these two lines of stones was filled almost a meter high with pottery sherds, mostly of Late Roman–Byzantine bag-shaped storage jars. The new north–south wall was then built on top of this artificial foundation trench.
