Huqoq – 2023

25/08/2024
Preliminary Report

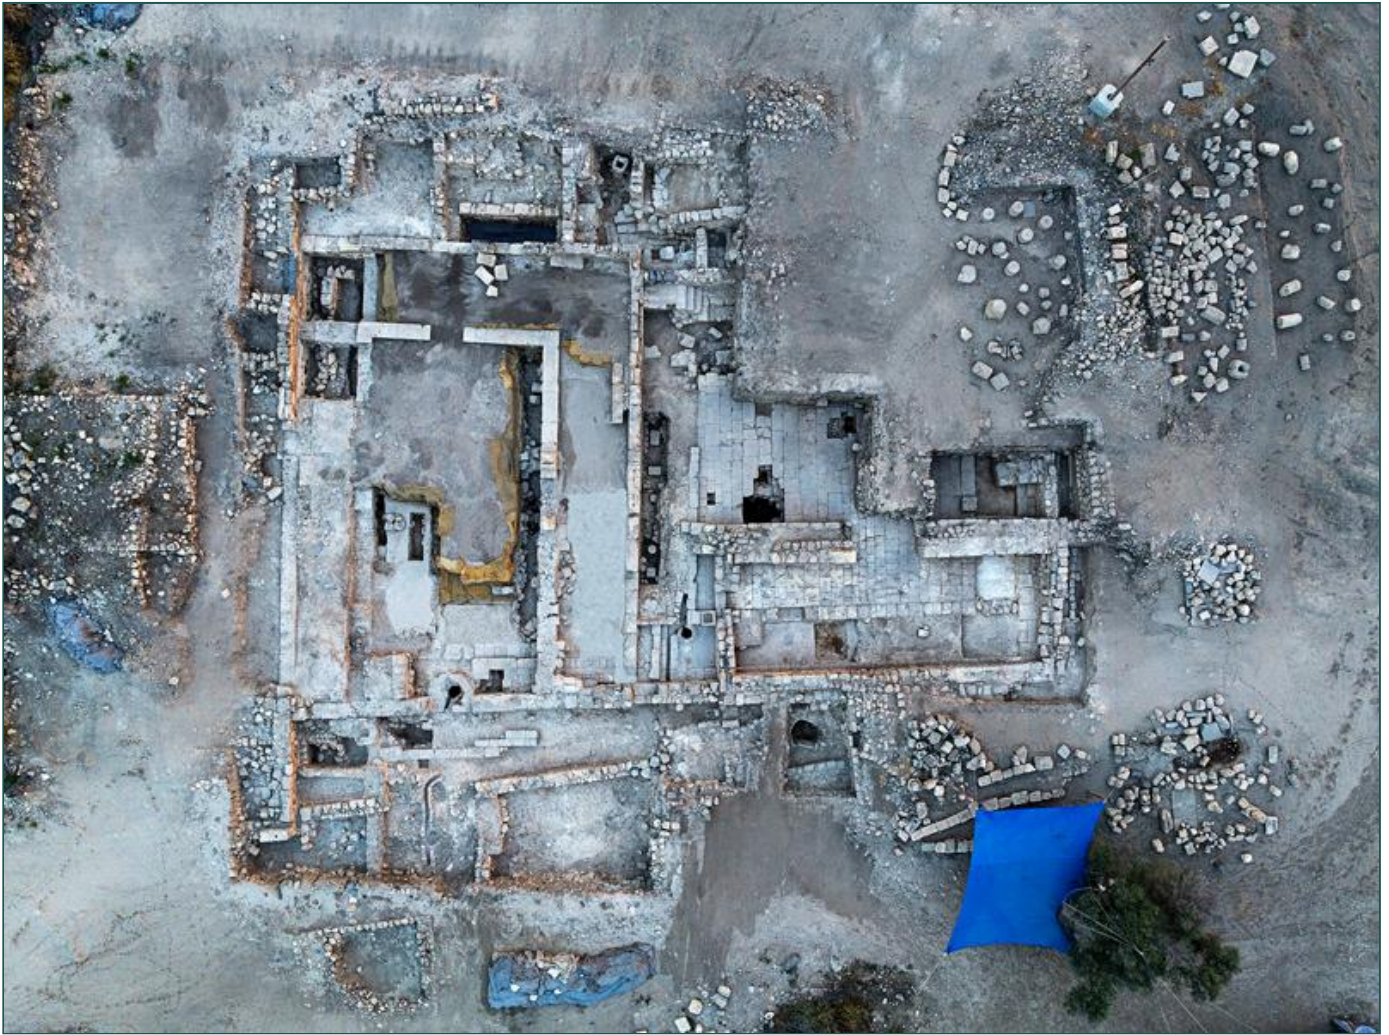
1. Area 3000 at the end of the 2023 season, aerial view looking north.
(Images//G1-2023-1.jpg)

Excavations this season continued in Area 3000 (Fig. 1), where there are five main occupation phases: (1) a synagogue and an adjacent courtyard to the east dated to the Late Roman period (late fourth–early fifth centuries CE; Fig. 2); (2) a late Medieval (Mamluk; fourteenth–fifteenth centuries CE) public building that we now identify as a synagogue (Mizzi and Magness 2022) and a massive vaulted structure built on top of the Late Roman courtyard (Fig. 3); (3) installations and a few scattered walls built after the late Medieval synagogue and vaulted structure had gone out of use and were pitted and robbed out (sixteenth–eighteenth centuries CE); (4) an open area with numerous *ṭabuns*, associated with layers of ash and a few partition walls (eighteenth–nineteenth centuries CE); and (5) houses belonging to the modern village of Yaquq from the late Ottoman–Modern periods (nineteenth century CE up to 1948).

1. Area 3000 at the end of the 2023 season, aerial view looking north. (Images//G1-2023-1.jpg)

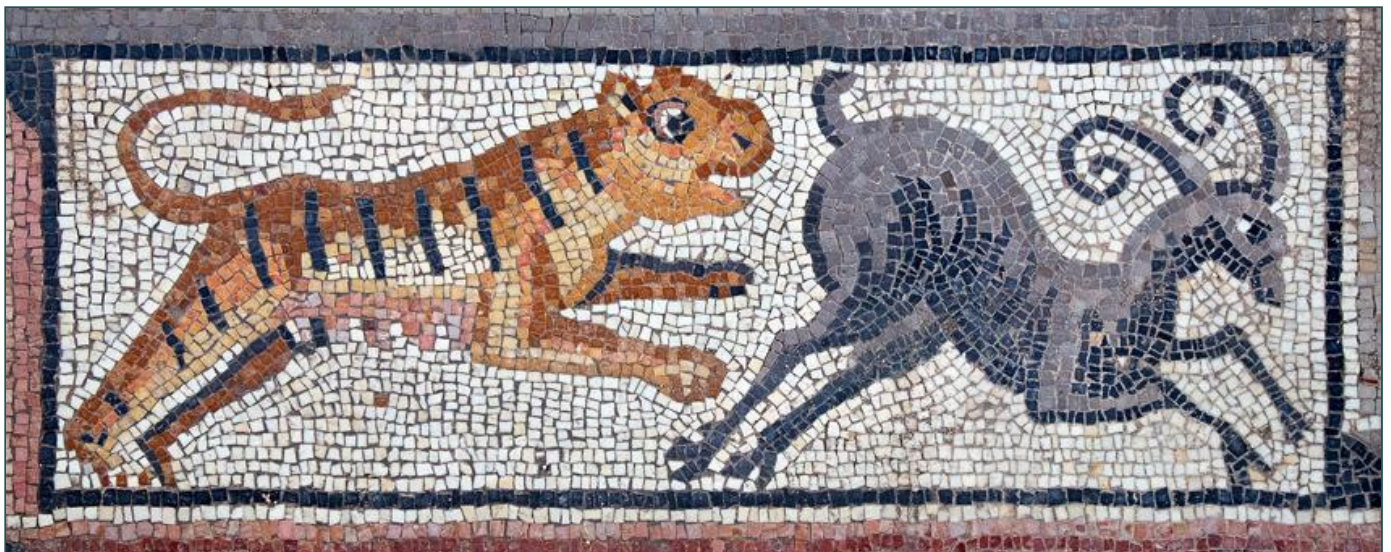
4. The 'animal chase' border of the mosaic.
(Images//G1-2023-4.jpg)

During the 2023 season, efforts were concentrated on fully uncovering, conserving and documenting the mosaics located at the southern ends of the nave and the east aisle, segments of which were uncovered in 2012, 2013 and 2017.

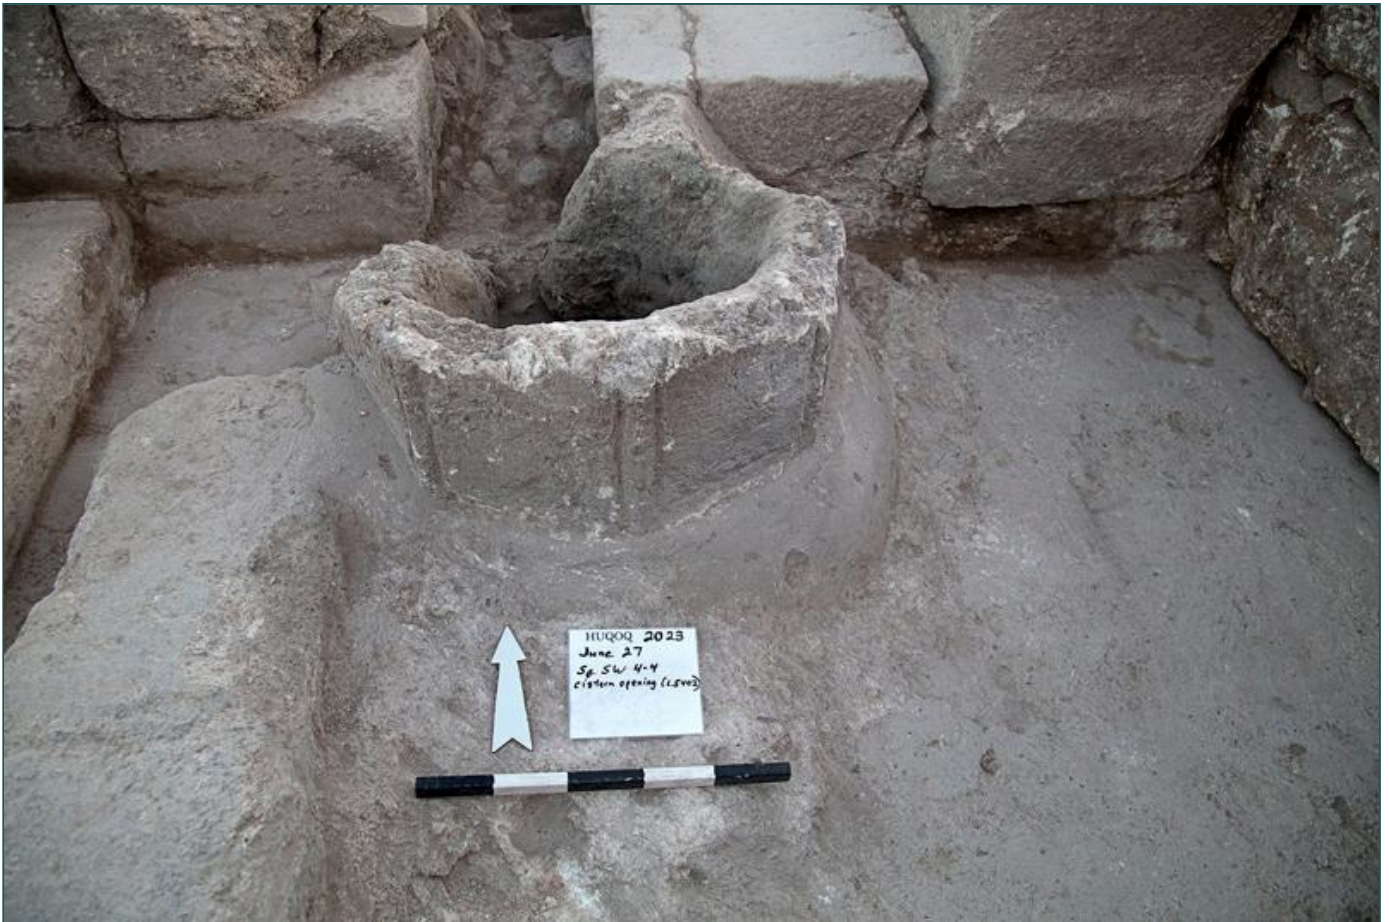
6. Late Roman-period cistern, looking north.
(Images//G1-2023-6.jpg)

The cistern, with the courtyard extending to its north and south, is hewn out of bedrock (Fig. 6) and was fed by a rock-cut water channel running from the southwest. On top of it was a monolithic limestone block (0.6–0.7 m high) carved into an octagonal profile when viewed from above. Each of the block's eight sides is carved with a framed panel design. The block was carefully placed on top of the cistern's opening and was plastered on the outside to create a seamless transition from the sloping bedrock base.

6. Late Roman-period cistern, looking north. (Images//G1-2023-6.jpg)

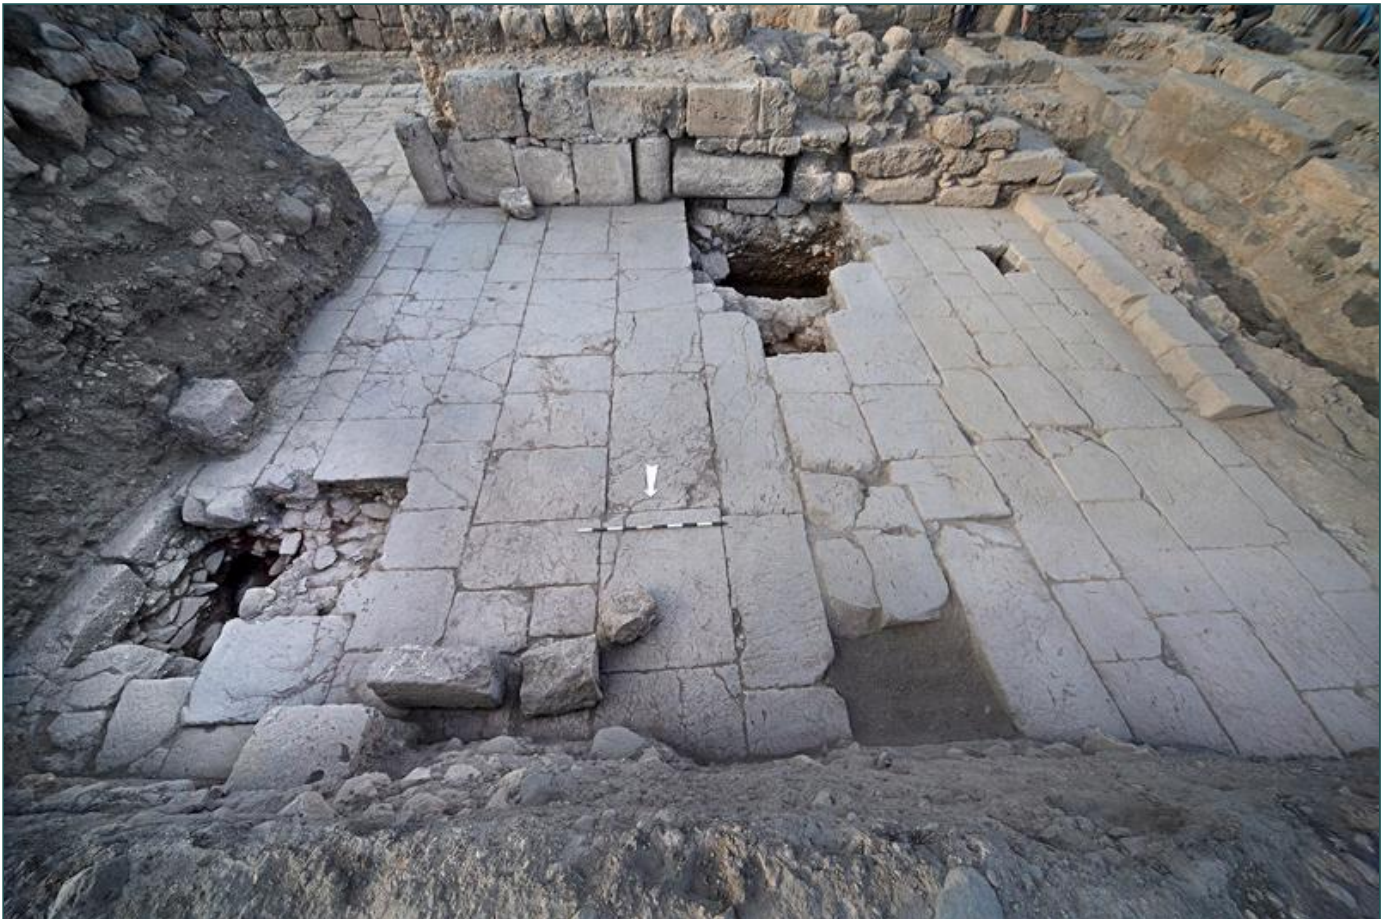
7. Soundings under the paving stones in the eastern courtyard, looking south.
(Images//G1-2023-7.jpg)

7. Soundings under the paving stones in the eastern courtyard, looking south. (Images//G1-2023-7.jpg)

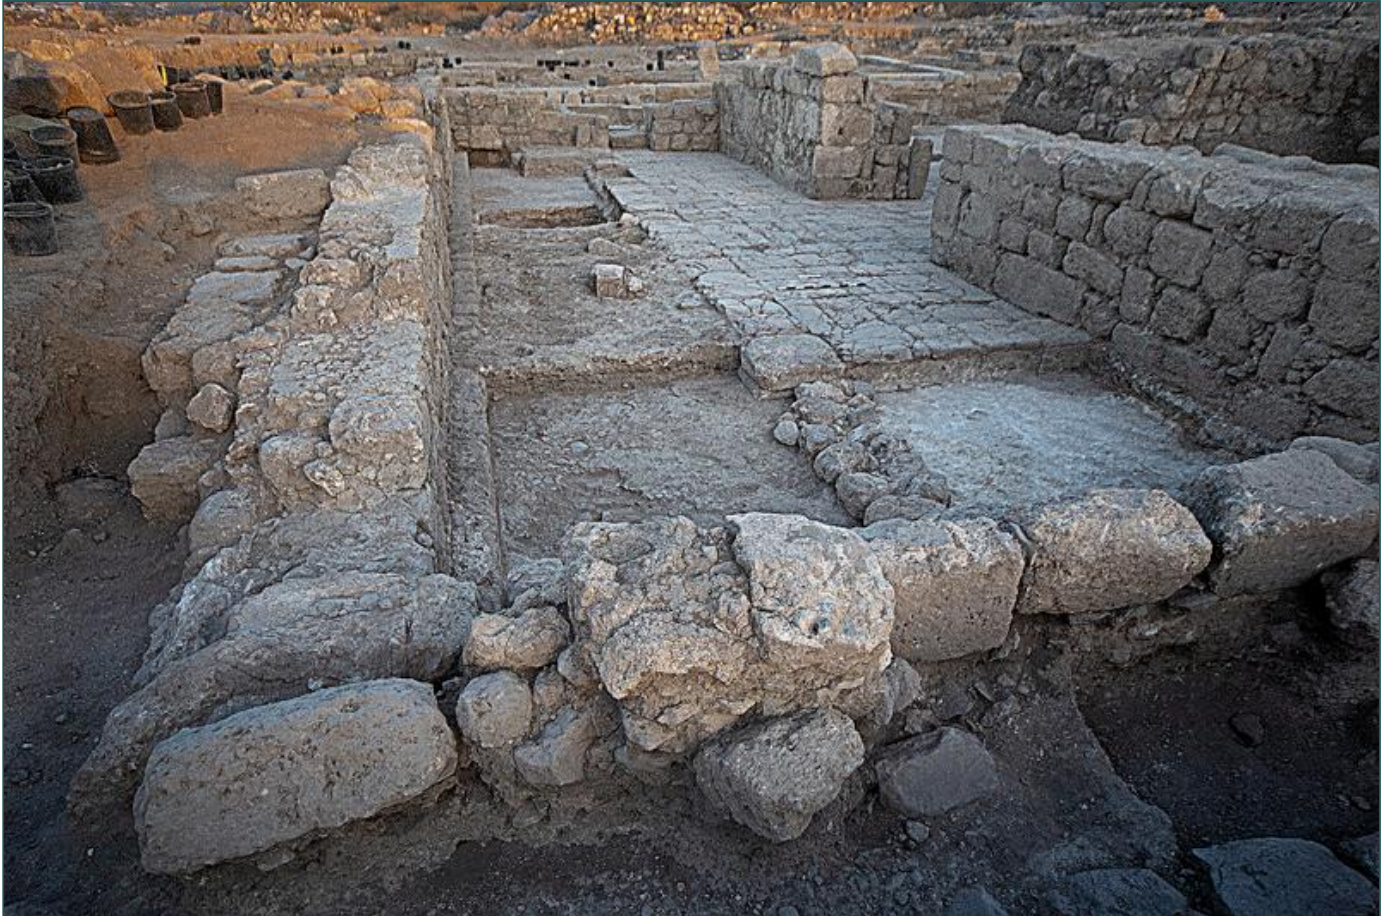
8. The late Medieval vaulted structure, looking northwest.
(Images//G1-2023-8.jpg)

The Vaulted Structure (Figs. 3, 8)

In the late Medieval period, a massive, vaulted structure (5.54–5.60 × 16.97 m), the function of which is unknown, was erected over the eastern part of the courtyard, including its south portico, its south stylobate and part of its interior pavement; its walls were erected directly atop the courtyard flooring, and it repurposed each of the latter

features as foundations. It reused the courtyard's original south wall as additional support for the vaulted ceiling and the courtyard's original east wall as its own. Wide openings (3.50–3.54 m wide) were installed in the structure's south and north walls, the latter flanked by columns supporting an arch. Another smaller opening, installed in the structure's western wall, led from the vaulted structure in the direction of the synagogue building. The original pavement of the Late Roman courtyard was still in use in the north part of the vaulted structure, whereas it seems that the paving stones of the southern and eastern porticos were robbed out some time before the late Medieval vaulted structure was built, with a thick layer of plaster laid down in their stead by the late Medieval builders. The Late Roman-period courtyard's south stylobate ran down the center of the vaulted structure, its pedestals and those of the southern end of the eastern stylobate cut down to the level of the stylobate blocks.

At some point, the vaulted structure appears to have been damaged, particularly at its northwest corner. Subsequently, it was repaired or renovated by the rebuilding of the northern part of the structure's west wall and the construction of buttressing along the northern face of the structure's north wall to support the weight of the vaulted ceiling.

8. The late Medieval vaulted structure, looking northwest. (Images//G1-2023-8.jpg)
