A fresh look at Haġar Qim and Mnajdra temples

Katya Stroud

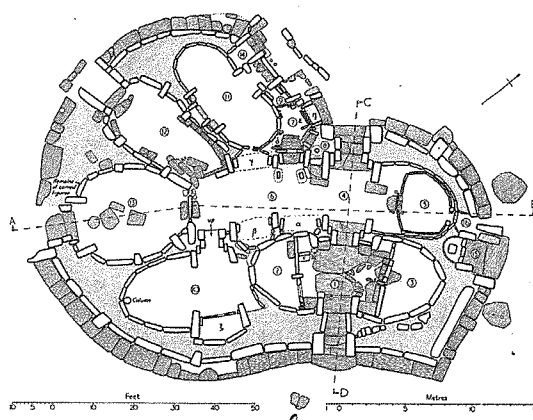
Fig. 1. Plan of main building at Haġar Qim. (After Evans, 1971)

Standing at the top of a ridge, the remains at Haġar Qim (Fig. 1) must have always been a conspicuous landmark, more so, in that they were never completely buried. Jean Houel's painting of the site in the 1780s, before its excavation by the Royal Engineers, shows that although the greater part of the site was buried, the larger megaliths were clearly visible protruding through the soil and debris (Plate 1).¹ This is what most probably led to an early excavation of the site. Houel's painting even shows two men examining items which

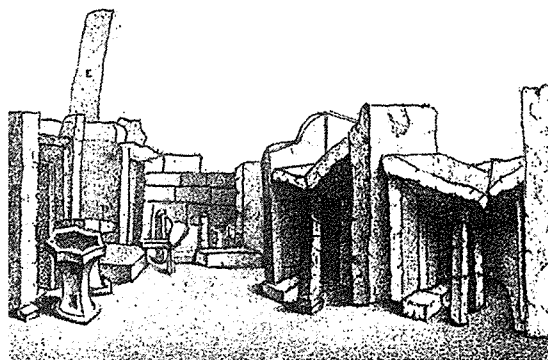
Fig. 3. Pilasters inserted to support broken table slabs at Haġar Qim in 1839. (Vance, 1842.)

The first restoration work at Haġar Qim may have been carried out during or just following the first excavation of the site. One of the lithographs by J. Basire, published in 1842 as part of Vance's report (Fig. 3), depicts stone pillars supporting a number of broken horizontal slabs. Judging by Basire's drawing and a photograph of the same area published in 1901 (Plate 2), these pillars were built in small worked ashlar blocks.

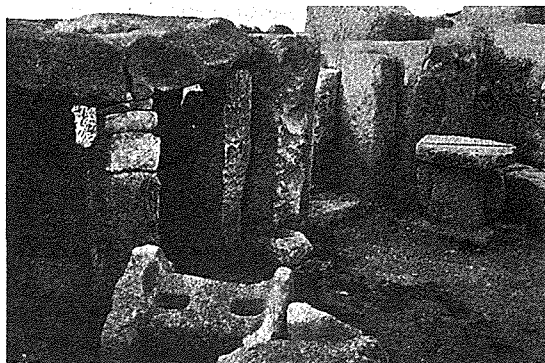
Plate 2. Pilasters inserted to support broken table slabs at Haġar Qim in 1839. (Mayr, 1901)

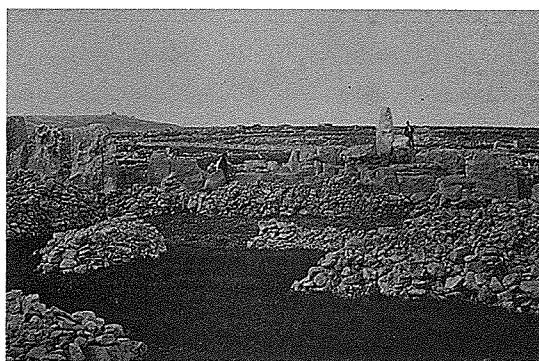
Plate 3. The forecourt at Haġar Qim before clearance in 1885. (Album of the Society of Archaeology, History and Natural Science of Malta, 1868)

Part of these works seem to have included extensive clearance of the area in front of the façade, as is indicated by a comparison between photographs taken in 1868 and ca. 1900 (Plates 3 and 4). Restoration works included the lifting of collapsed megaliths in various areas of the building, as well as the reconstruction in dry-stone walling of walls enclosing the whole area of the forecourt and the court at the rear of the main building at Haġar Qim. According to Albert de La Marmora these walls formed the *temenos* around the site and Caruana says that the dry-stone walls were built on ancient foundations since during the

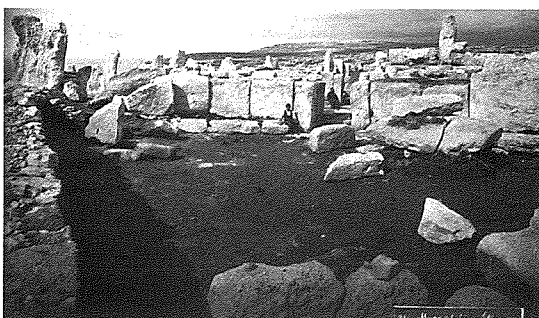
Plate 4. The same area after it was cleared. (Richard Ellis Ltd., ca. 1900)

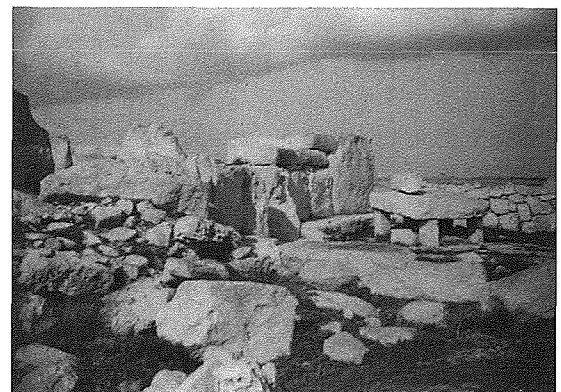
Plate 5. Façade of the main building at Haġar Qim after repair of the lintel and restoration of upper courses in 1910. (National Museum of Archaeology)

These excavations were also followed by extensive restoration works. At Haġar Qim some of the slabs lying on the ground in front of the entrance to the main building were lifted to form part of the top horizontal course of the façade, whilst the large slab found in the forecourt and believed to be the lintel of the entrance was raised on pillars and repaired (Plate 5).²⁰

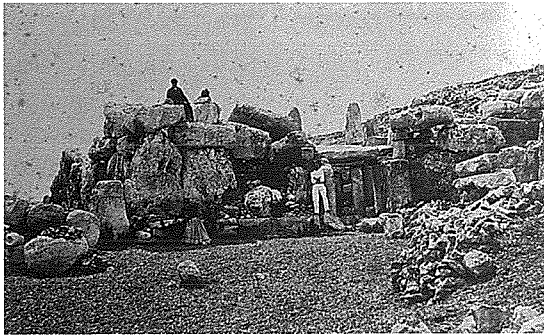
Plate 6. The façade of the South Temple at Mnajdra in 1868. (Album of the Society of Archaeology, History and Natural Science of Malta, 1868)

At Mnajdra Ashby mentions the restoration of the facade of the South Temple.²¹ Comparing photographs of the façade taken in 1868 (Plate 6) with those published by Ashby in 1913 (Plate 7) one can get an indication of what these restoration works actually involved. It seems that part of the south-west section of the façade was reconstructed by reintegrating a collapsed megalith.

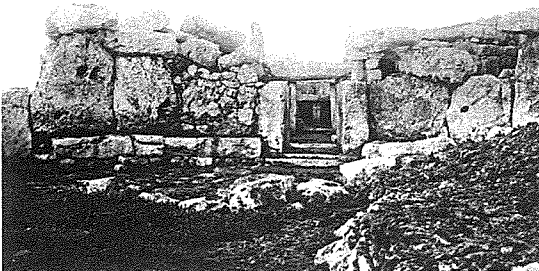
Plate 7. Restoration of the façade of the South Temple at Mnajdra in 1910. (Ashby, 1913)

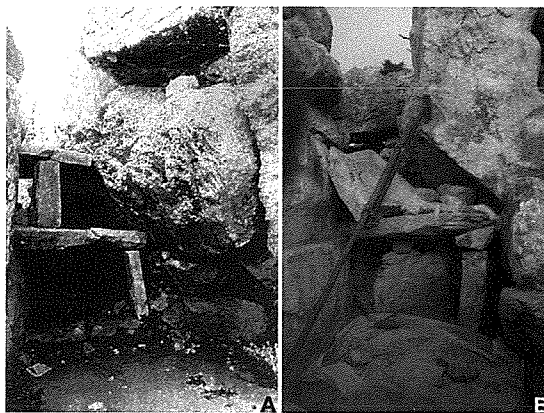
Plate 8. Part of the structure which collapsed at Mnajdra in 1994. (8a National Museum of Archaeology. 8b Marlene Borg, 1996)

In April 1994 part of the wall separating the South from the Middle Temple at Mnajdra collapsed (Plate 8). This was caused by the effect of heavy rainfall which led to the material beneath the floor of the Middle Temple becoming saturated and causing pressure on the structure which was supporting it. After a

study and assessment of the damage carried out by Prof. Alex Torpiano in collaboration with the Museums Department, extensive works to restore and consolidate the area of collapse were undertaken.

The collapsed megaliths were lifted and the exposed infill area was cleared and excavated. A new wall was constructed in concrete bricks so as to retain the infill beneath the floor of the Middle Temple and prevent it from exerting pressure on the original wall once this was reconstructed. The megalithic blocks were then replaced in their original locations covering the modern retaining wall.⁴⁰

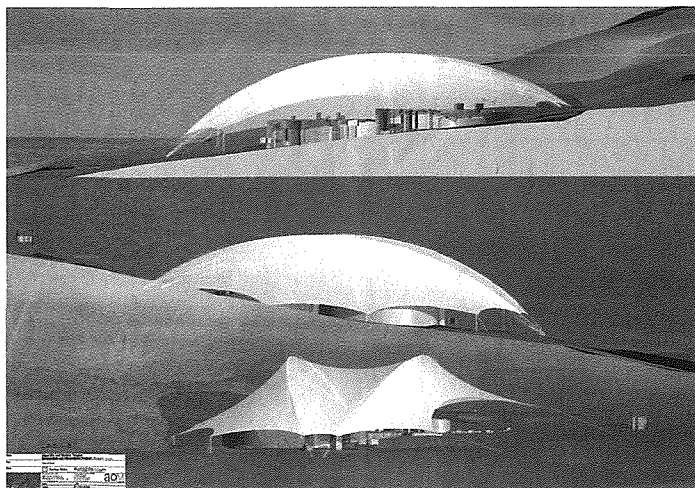
Plate 9.
Preliminary designs for the shelter at Haġar Qim (Walter Hunziker)

was extended to include Mnajdra. Following this, an International Design Competition was launched by the Ministry for Youth and the Arts in November 2003. The competition was judged in April 2004 and a Swiss architect, Walter Hunziker was chosen to design shelters for these monuments. European Union Structural Funds were captured to fund this project. (Plate 9).

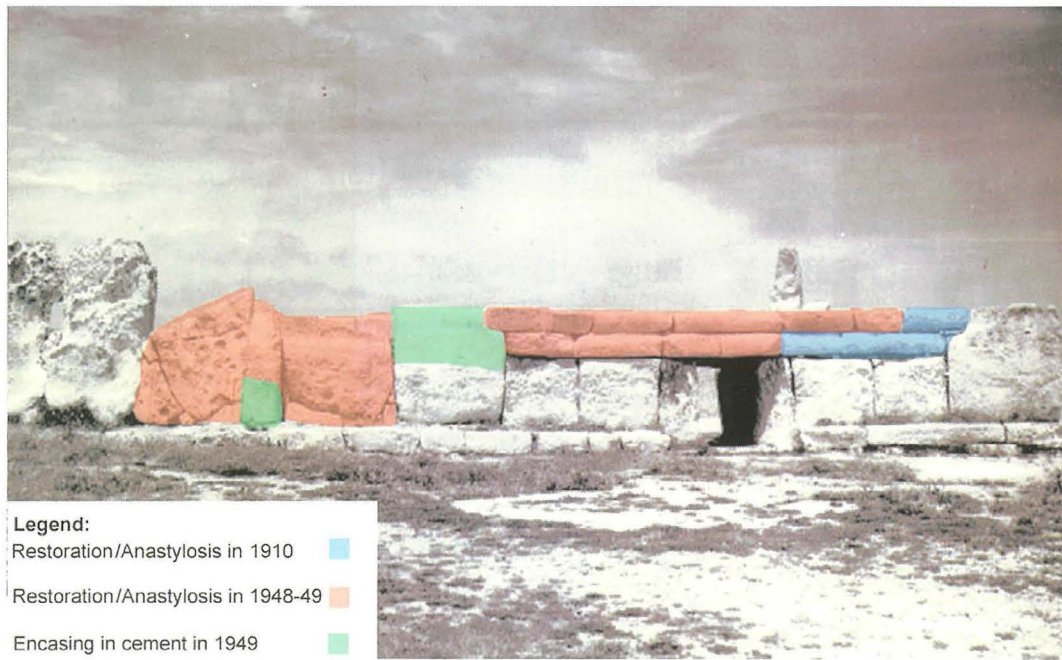
Plate 9. Different phases of restoration of the façade of Hagar Qim
