## Huqoq – 2018

Jodi Magness, Shua Kisilevitz, Dennis Mizzi, Jocelyn Burney,  
Karen Britt and Ra'anana Boustan

From May to July 2018, the eighth season of excavations was conducted at Horbat Huqoq in East Galilee (License No. G-16/2018; map ref. 24500–50/75430–65; Magness et al. 2018 ([http://www.hadashot-esi.org.il/Report\\_Detail\\_Eng.aspx?id=25419](http://www.hadashot-esi.org.il/Report_Detail_Eng.aspx?id=25419)); and see references in Magness et al. 2017 ([http://www.hadashot-esi.org.il/report\\_detail\\_eng.aspx?id=25304&mag\\_id=125](http://www.hadashot-esi.org.il/report_detail_eng.aspx?id=25304&mag_id=125))). The excavation was undertaken and underwritten by the University of North Carolina at Chapel Hill, Baylor University (Texas), Brigham Young University (Utah) and the University of Toronto (Canada). Additional funding was provided by the National Geographic Society, the Friends of Heritage Protection, the Kenan Charitable Trust, the Carolina Center for Jewish Studies, the Foundation for Biblical Archaeology (S. Bishop) and private donors. The excavation was directed by J. Magness with the assistance of S. Kisilevitz (assistant director), M. Golan (administration), J.

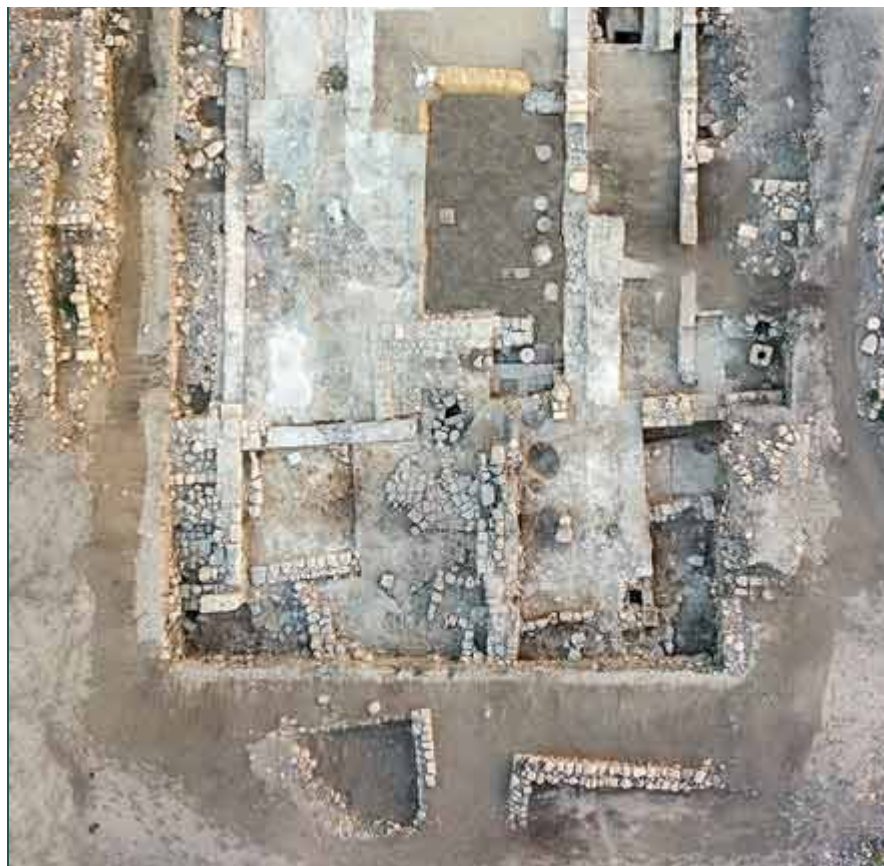
1. Area 3000 at the end of the 2018 season, aerial view to the north.  
(Images//G16-2018-1.jpg)

This season's excavation continued in Area 3000 (Fig. 1), where there are three main occupation phases: a synagogue from the Late Roman period (early fifth century CE), a medieval public building (twelfth–thirteenth centuries CE), which reused the Late Roman synagogue, and the post-Middle Ages (thirteenth–sixteenth centuries CE) and late Ottoman–modern periods (eighteenth–twentieth centuries CE, up to 1948), when the robbing out and pitting of the medieval public building were succeeded by the establishment of houses belonging to the village of Yakuk. In addition, walls belonging to a pre-synagogue phase were discovered under the Late Roman synagogue's north part.

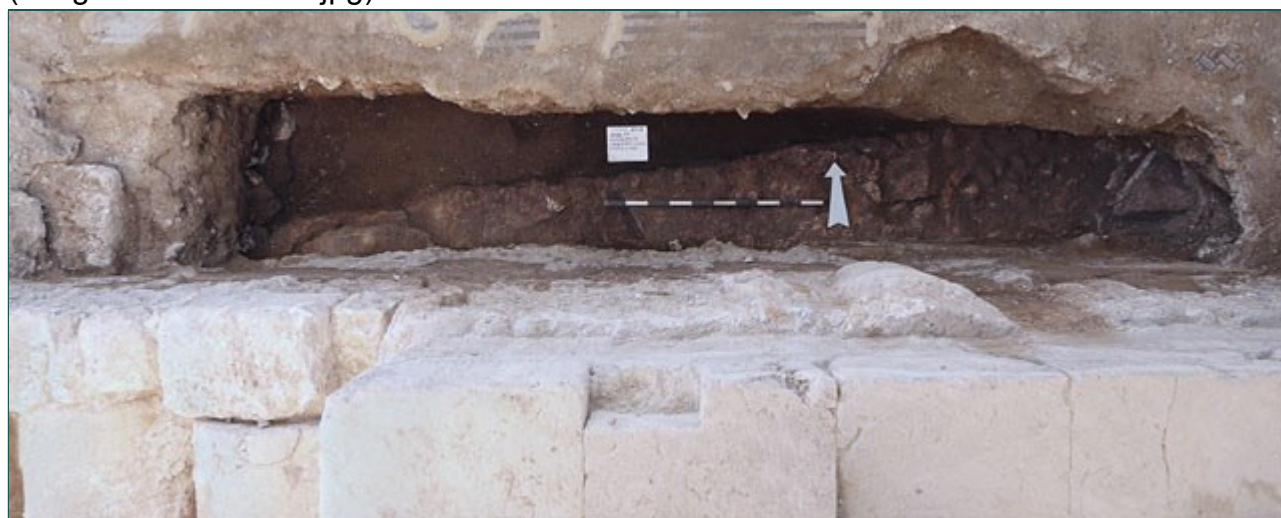
2. Foundation trench of the northern medieval stylobate and the top of the pre-synagogue wall (a bottom), looking north.  
(Images//G16-2018-2.jpg)

The Late Roman synagogue was not the earliest structure built in Area 3000. Under the foundations of its north and northeast stylobates, the tops of two walls built of small fieldstones and a few medium-sized stones were exposed (Fig. 2). Their northeast–southwest orientation differs from that of the Late Roman synagogue walls and stylobate. Although these walls are clearly earlier than the synagogue, they cannot be dated, as no associated surfaces were reached.

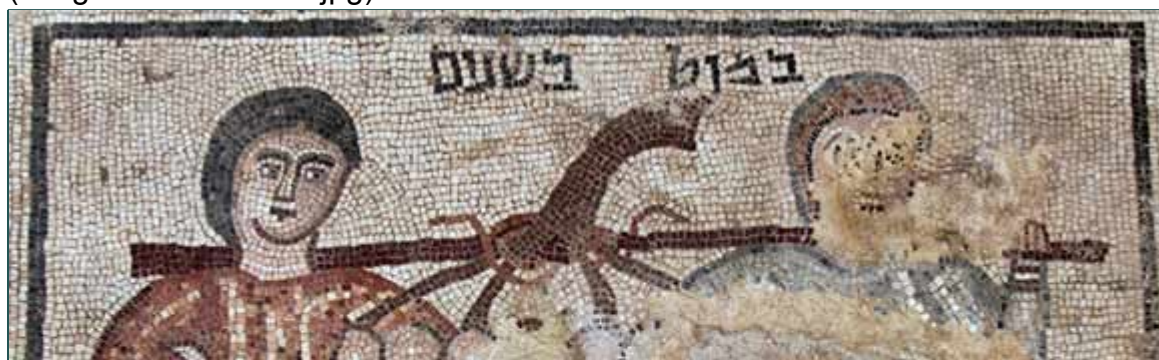
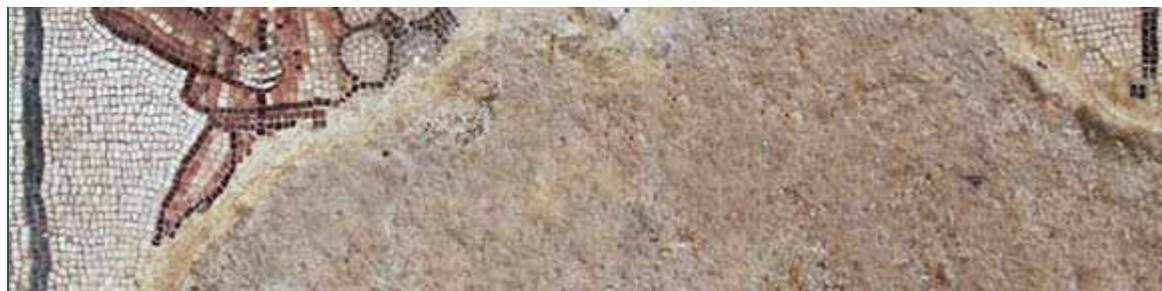
3. The Spies Panel mosaic in the Late Roman synagogue's north aisle, looking north.  
(Images//G16-2018-3.jpg)

The mosaic pavement in the north aisle was found in better condition and included several well-preserved panels. Nevertheless, it sustained heavy damage, apparently from the superstructure's collapse and, later, when it was cut by the foundation trench of the medieval stylobate. Most of the floor was covered by the same light brown fill, consisting of numerous small rocks and a few pockets of ash, as found overlying the mosaics in other parts of the building. Along the north and east walls, this fill covered a deposit of white earth—perhaps residue from fallen architectural elements—that overlay the mosaic floor.

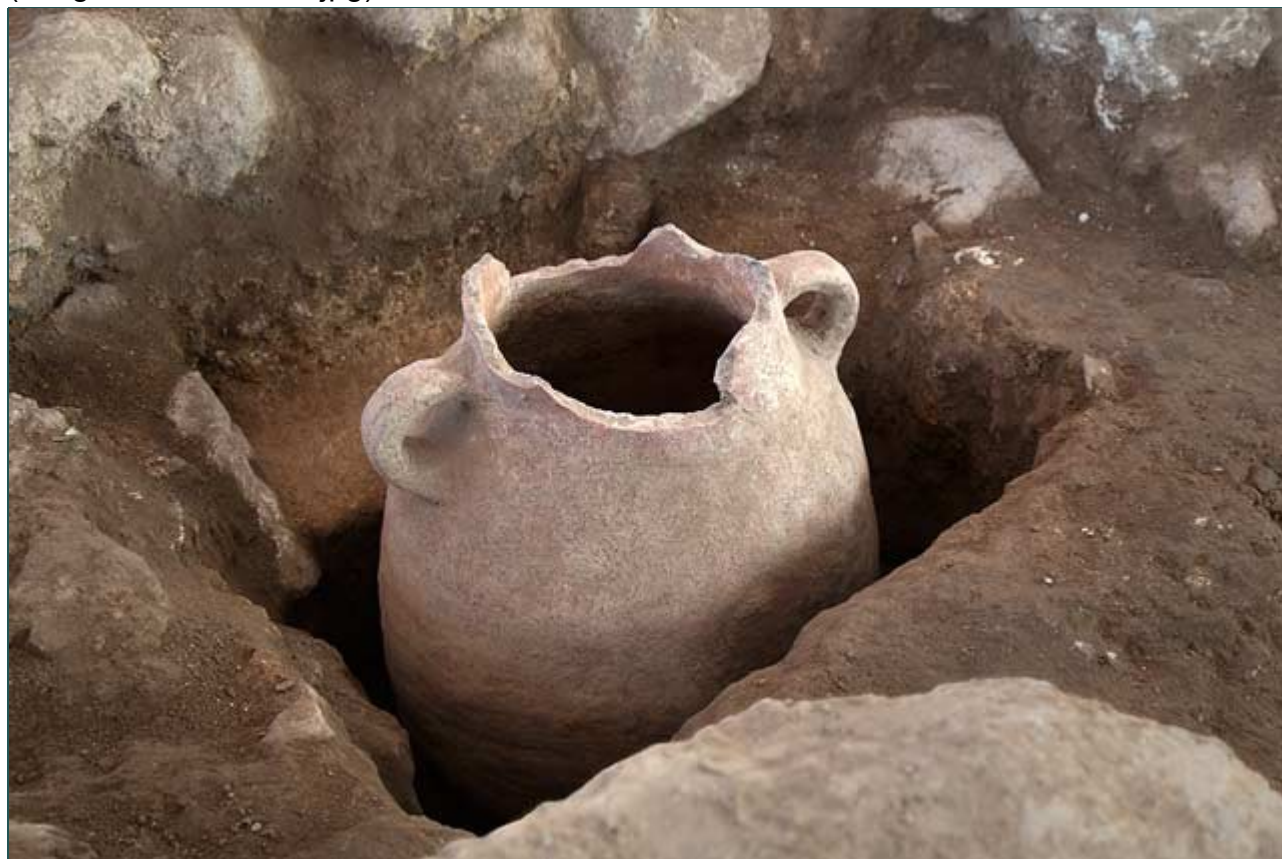
4. An intact Mamluk jar in a stone installation, looking northwest.  
(Images//G16-2018-4.jpg)

In 2018, much of the evidence for the post-medieval occupation came from the area to the south of the Late Roman synagogue. Two finds in particular relate to the Mamluk period (thirteenth–fifteenth centuries CE). The first is an intact Mamluk storage jar covered with reverse slip-painted glazed bowl, which was set into a built stone installation to the southwest of the medieval public building (Fig. 4); the jar sat on a layer of gray ash inside
