The Żejtun Roman Villa Conservation Project

The conservation and
research of the
Żejtun Roman Villa
is a project undertaken
by the University of Malta
in collaboration with
Din l-Art Helwa
and made possible through
the generous support of the
HSBC Malta Foundation

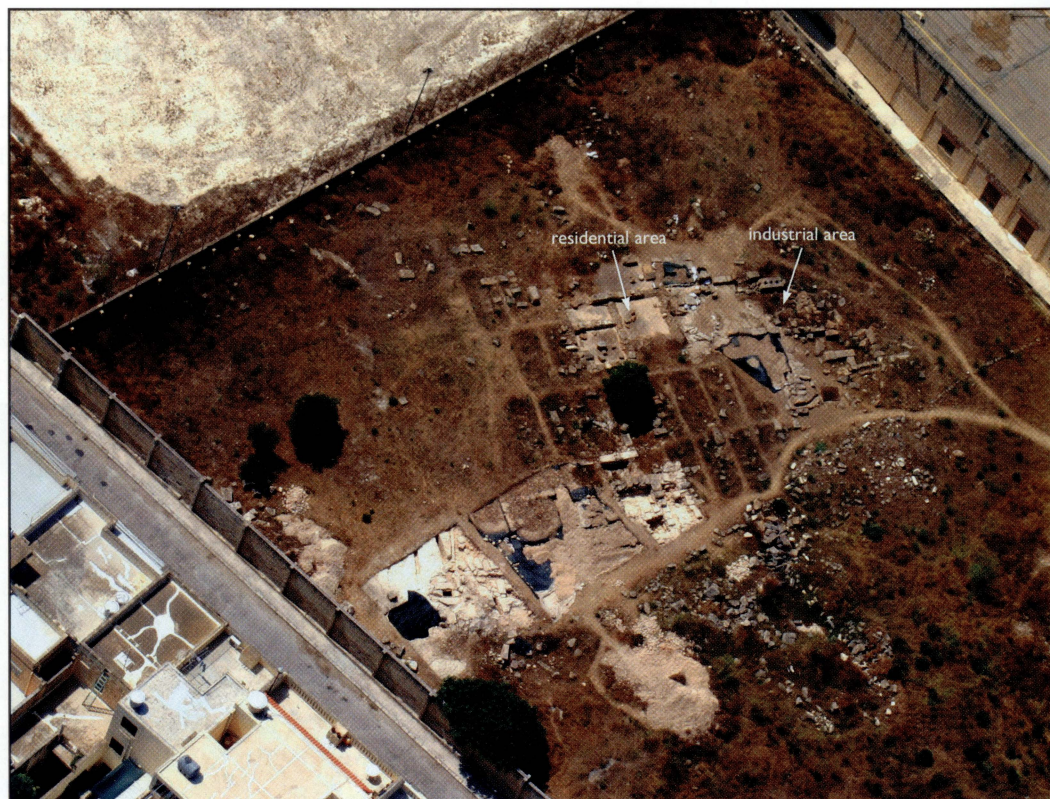
Fig. 1

Aerial photograph of the remains
of the Roman villa in the grounds
of the secondary school,
St Margaret College in Żejtun
(source: Armed Forces of Malta)

In 1961, while work was underway for the construction of the new village secondary school in Żejtun, ancient remains were discovered (Fig. 1). The archaeological excavations that began at the site in 1964 revealed a large cistern and some water channels, together with an area paved in stone slabs.

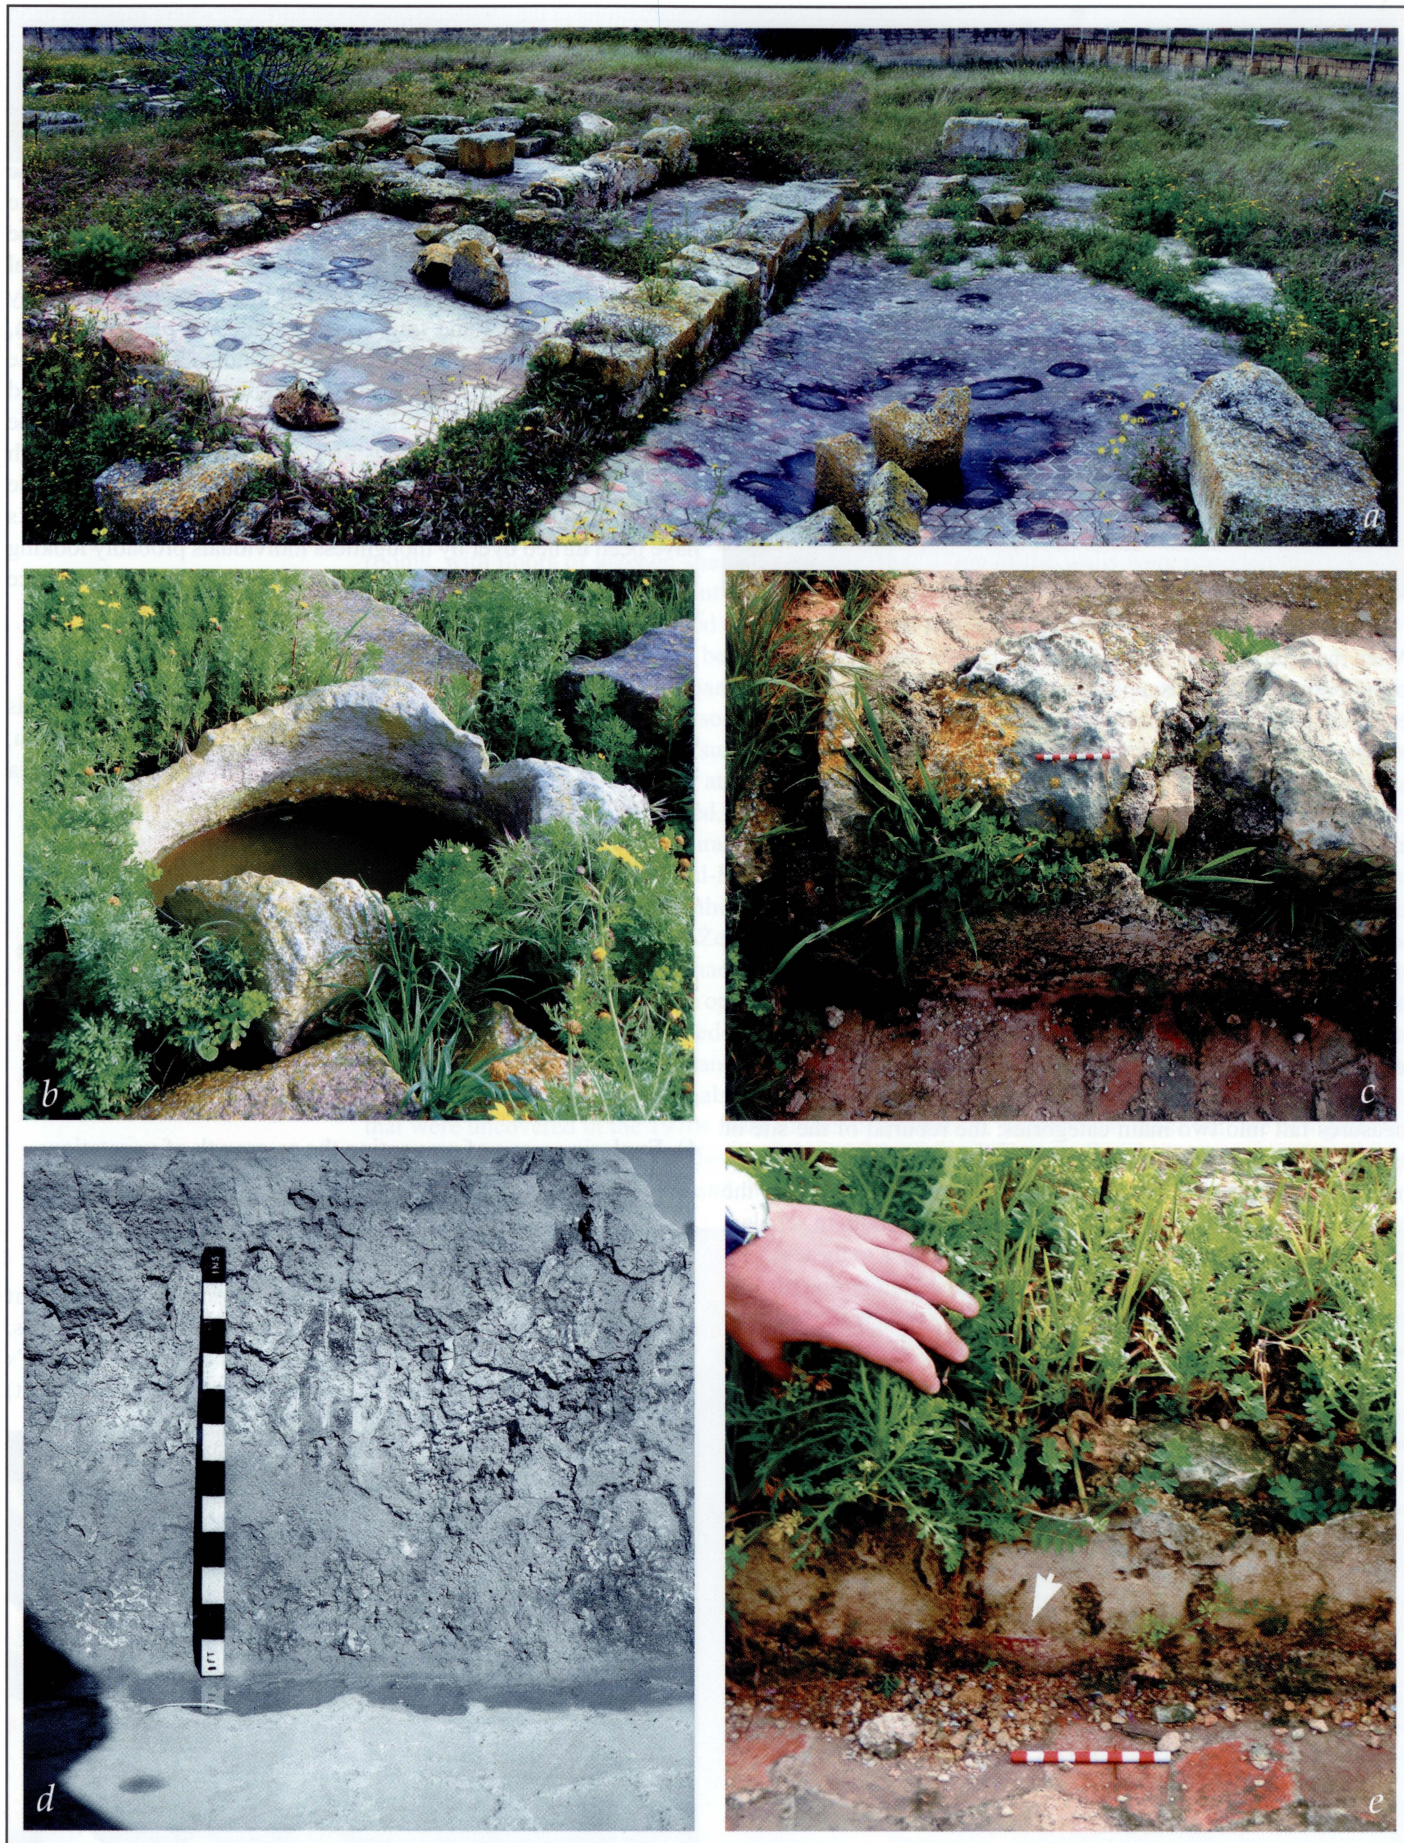
Fig. 4

(a) The residential area after the winter rains (b) the limestone vat filled with rainwater

(c) vegetation growing in the space between wall face and dislodged plaster layer, scale bar 10 cm

(d) state of painted plaster when it was discovered in September 1976, scale bar: 1 foot

(e) trace, arrowed, of red band on plaster in winter 2010, scale bar 10 cm (sources: a-c and e Żejtun Villa excavation project; d. Anthony Bonanno)

The fact that the remains of the Žejtun villa have been exposed to the elements for the last 30 years has resulted in the widespread deterioration of the site. This is particularly evident in respect of the tiled floors in the residential part of the villa and especially the remains of the plastered walls, which used to show evidence of painted decoration that is now barely visible (Fig. 4d, e). Although some emergency restoration work was carried out during the

The causes of deterioration are multiple and interact one with the other. As is typical with archaeological sites, they are largely of natural origin, eg rain, soluble salts, wind, sun and vegetation. The action of these factors is even more harmful since it is cyclic. The annual growth of intrusive plants and trees is certainly a major cause for concern since it is damaging structures, as well as archaeological deposits. Roots grow within the gaps in the structures and slowly dislodge fragile tiles and fragments of stone and plaster (Fig. 4a, c). Rain causes the collapse of plaster fragments and the fragile parts of stone walls, while recurrent puddles have been observed to form in several areas inside the tiled rooms (Fig. 4a). Even the vat is full of water after periods of heavy rain (Fig. 4c). Although most of the deterioration observed on site is attributable to adverse climatic conditions, humans also have a role. Several stone blocks have been turned over by thoughtless individuals probably looking for snails, whilst the current fragility of the site makes the presence of visitors, even careful ones, somewhat risky.

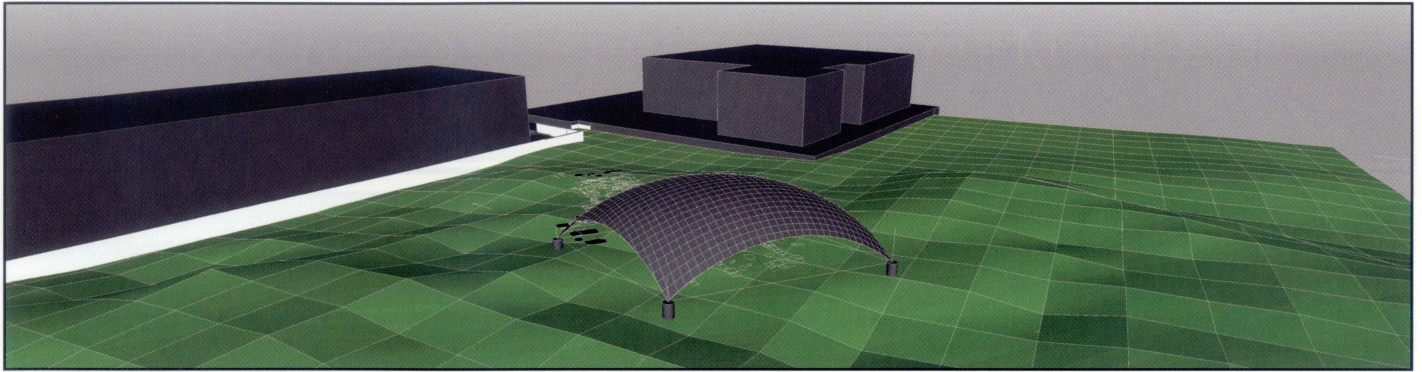
Fig. 6
Technical drawing of the temporary shelter to be erected over the residential area of the Roman villa (source: Kane Borg on behalf of design team members).

- 1) Recording, assessing and monitoring the site’s state of conservation;
- 2) Temporarily protecting the vulnerable parts of the site, while at the same time carrying out environmental monitoring;
- 3) Carrying out emergency conservation of the walls where there is an imminent risk of the plaster being dislodged or lost, and to the floors, where tiles are being lost;
- 4) Exploring ways of preventing the re-growth of vegetation;
- 5) Planning for the long-term protection of the site, including the erection of a permanent shelter over the residential area.

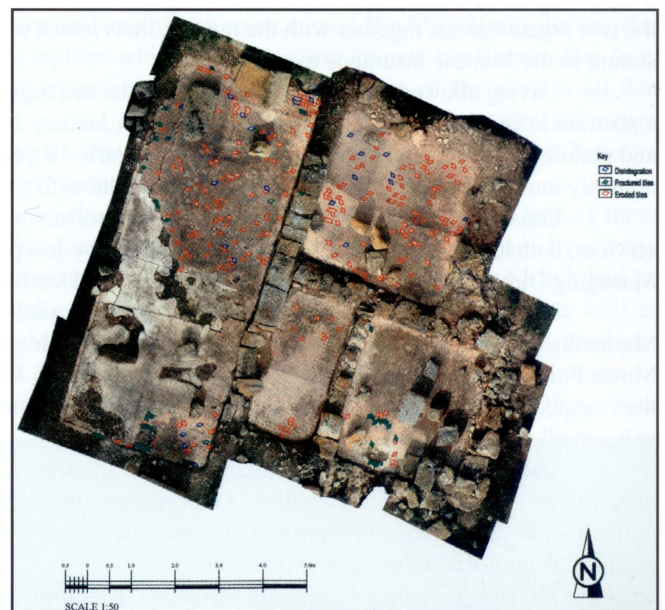
Fig. 5
One of several drawings showing the condition of the tiled floors inside the Roman villa based on data captured by conservation students in 2010 and transferred to a photogrammetric survey commissioned by *Din l-Art Helwa* (drawn by Joanna Hili Micallef).

and drawn up in collaboration with the Department of Classics and Archaeology. The recording and assessment of the site condition was carried out in collaboration with the Conservation Division of Heritage Malta (Fig. 5). Students of the Faculty for the Built Environment, supervised by Prof. Alex Torpiano, are designing the temporary shelter that will protect the residential part of the villa from the harmful effects of rainwater and solar radiation (Fig. 6). Earlier this year, a group of enthusiastic volunteers from HSBC and university students cleared the entire site from overgrown vegetation (Fig. 7). A plan to actively involve a number of schoolteachers and pupils from the local school in specific aspects of the current conservation plan is also in the pipeline, and a seminar will be held by *Fondazzjoni Wirt iż-Żejtun* in March next year to raise awareness of the remains of the Roman villa and cultural heritage in the area.
