RESEARCH ARTICLE

Architectural ruins: geoculture of the anatomy of buildings as illustrated by Casa Ippolito, Malta

Lino Bianco^{1,2*}

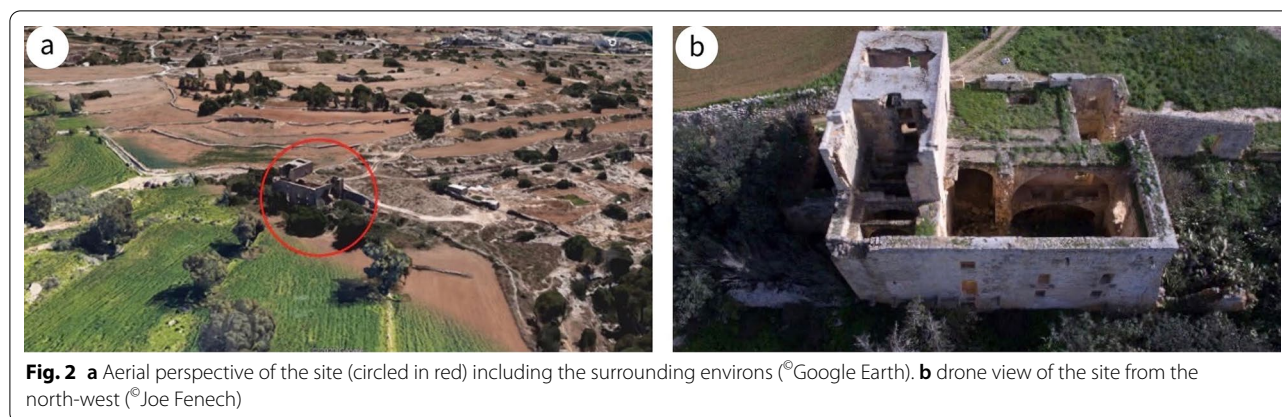
Fig. 2 a Aerial perspective of the site (circled in red) including the surrounding environs (©Google Earth). b drone view of the site from the north-west (©Joe Fenech)

The site is located on the flank of Żembaq Valley, west of the Roman ruins at Ta’ Kaccatura, on the limits of Birżebbuġa (Fig. 2a). By the time it fell into disuse, around 1919, the inscription on the main doorway had already deteriorated, the text “almost entirely illegible due to atmospheric erosion”.⁴ Since then, the building has been abandoned and is now reduced to a ruin, with most of the roofs, some floors and various walls having collapsed, while others are in a dangerous state (Fig. 2b). By 1967, the main fabric, subsidiary portions, roof and the interior were already in a bad state of preservation⁵ and vandalism had added its toll. In 1998, it was scheduled as a Grade 1 building [37], awarding it the highest level of protection in Maltese legislation, listed among buildings of “outstanding historical or architectural interest that shall be preserved in their entirety. Demolition or alterations which impair the setting or change the external or internal appearance, including anything contained within the curtilage of the building, will not be allowed. Any interventions allowed must be directed to their scientific restoration and rehabilitation. Internal structural alterations will only be allowed in exceptional circumstances where this is paramount for reasons of keeping the building in active use” ([38]: 88).

The present state of the ruin was established from drone images (for example, Fig. 2b). The period over which the collapse took place and the percentage area of the total roof are included in Table 4. Given their weak resistance to impact, when the xorok collapsed they caused the subsequent collapse of the underlying floors. The earliest collapse took place between the years 1967 and 1978 and the latest between 2008 and 2012.

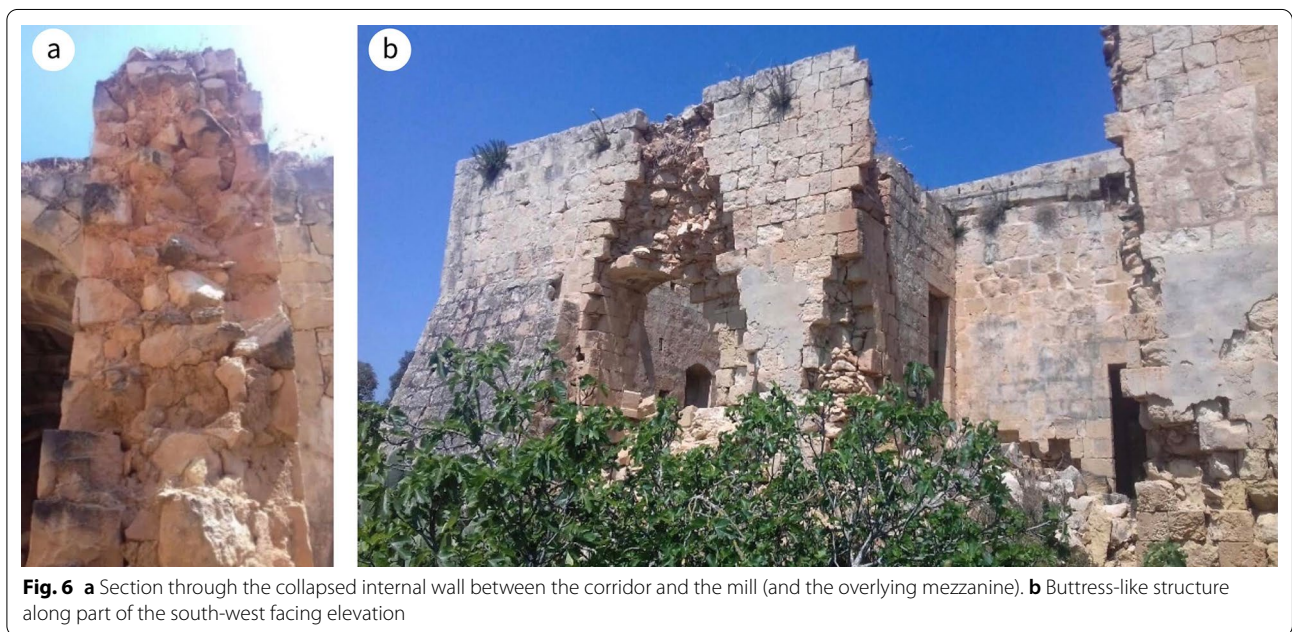
floor, ground-level, mezzanine and second storey (or first floor), the lower floor being accessible from the yard (Fig. 5). The entrance led to a hall and a corridor ending with an open balcony overlooking the agrarian land. The second room on the right upon entering the hall was used as a kitchen/dining room, indicated by a built-in chimney embedded in the wall and running up to the roof of the first level. The walls are thick (Fig. 6a) and on the south-west side there is a buttress-like structure (Fig. 6b), which suggests the premises might have been fortified, justifying Mifsud's inclusion of it in his publication [36]. The lower, ground and mezzanine levels were roofed over by masonry slabs (Maltese: *xorok*; singular: *xriek*), now mostly collapsed, supported by semi-circular masonry arches (Fig. 7a). The second storey was roofed in a similar manner but supported instead by timber beams

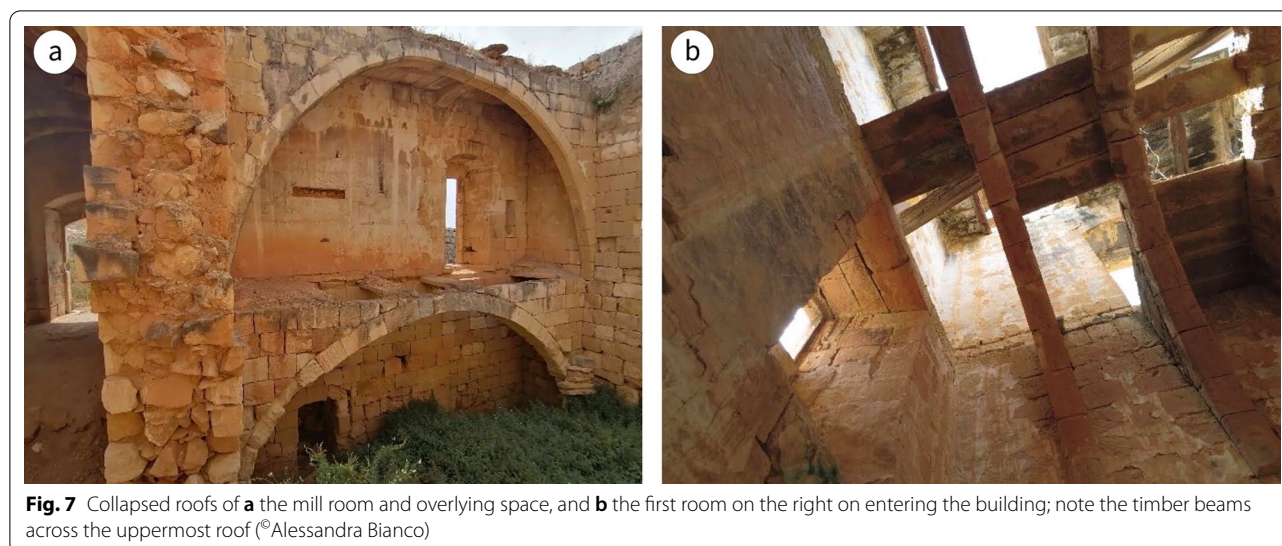
Fig. 7 Collapsed roofs of **a** the mill room and overlying space, and **b** the first room on the right on entering the building; note the timber beams across the uppermost roof (©Alessandra Bianco)

(Fig. 7b). The first levels, up to the roof of the ground floor, were linked by an internal staircase, while the first floor was accessed from that roof. The access and rooms of the second storey are typical of dry-rooms used for the storage of fodder (Maltese: *għorof*; singular: *għorfa*). This explains why the roof overlying the ground floor had

The masonry roofing slabs were LGL dimension stones, 75 mm thick on average. These were used to traverse between masonry arches or between timber beams (Fig. 7b). Masonry ribs were stronger, not vulnerable to biological rot and more fire-resistant than wood. The length of a xriek is the crucial factor in this type of construction. The typical length in Maltese residential properties erected prior to the Second World War was around 700 mm. The strength of the slabs in tension was minimal and their stability against failure due to excessive moments was marginal, although point loads were the crucial factor. The moment generated by a point load or a distributed load on a slab 700 mm wide was minimal. In general, only in the first case would failure occur.

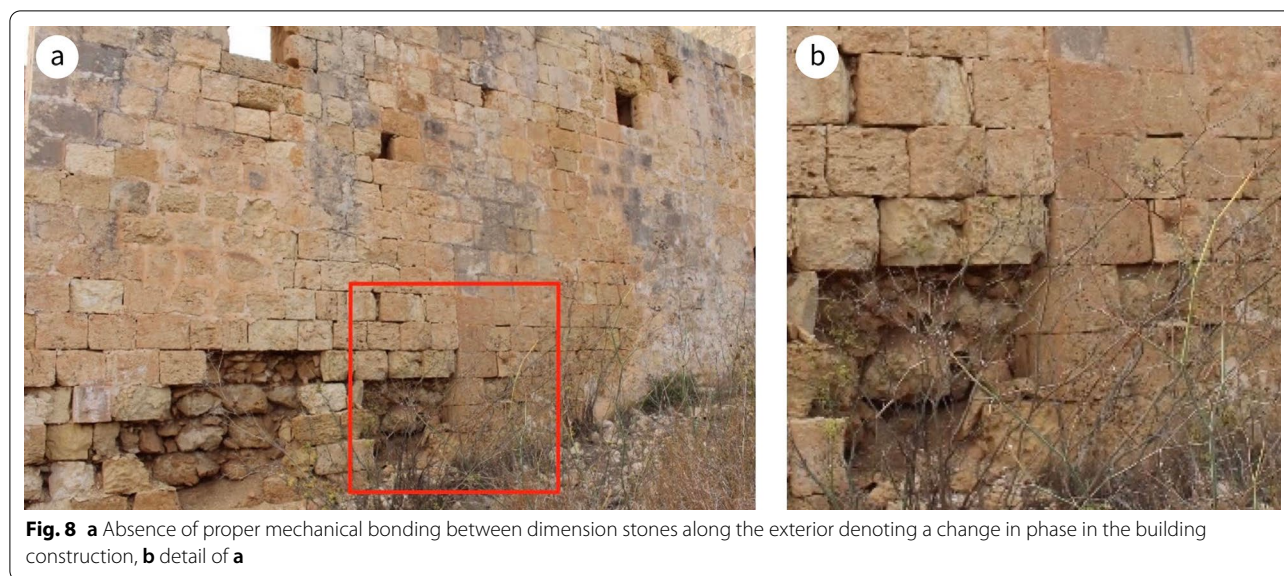
Fig. 8 **a** Absence of proper mechanical bonding between dimension stones along the exterior denoting a change in phase in the building construction, **b** detail of **a**

1. an absence of bond stones both on the exterior (Fig. 8) and on the interior up to the level of the lintel of the door of the room on the left upon entering the main entrance;
2. a change in the quality of the LGL used, differentiated by its weathering characteristics; and
3. the fact that the internal wall common with the mill and the overlying room is the same thickness as the external walls, implying that it was originally an external wall. The internal walls elsewhere in the house are narrower.

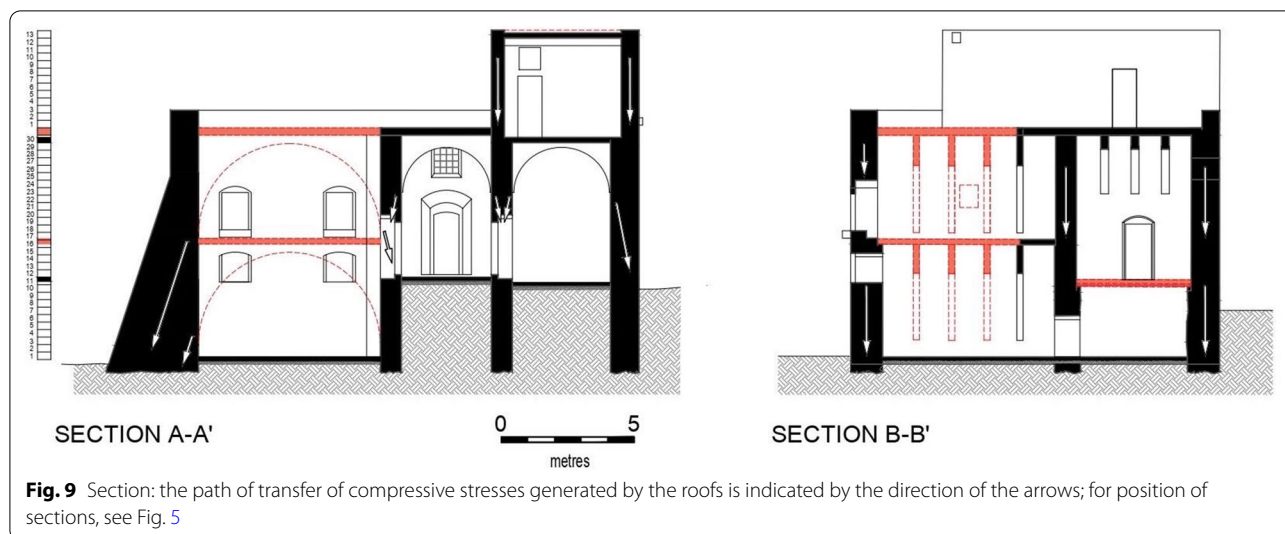
Fig. 9 Section: the path of transfer of compressive stresses generated by the roofs is indicated by the direction of the arrows; for position of sections, see Fig. 5

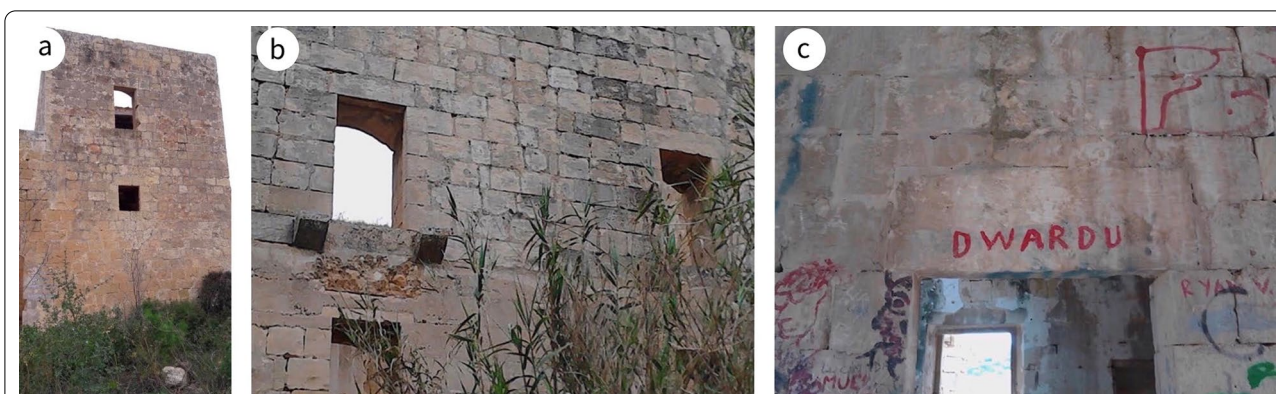
Fig. 10 Masonry lintels: **a** the lintel could be loaded without failure in tension up to a span ≤ 0.9 m; otherwise a relieving arch was introduced, **b** the stone above the lintel was notched, **c** depth of lintel increased by 50% the height of a building course

Spanning openings such as apertures and roofs is historically one of the biggest challenges in architecture. The spanning solutions for apertures in Malta’s traditional architecture are listed in Table 5. LGL can withstand compression but is weak in tension [24]; the rule of thumb among local builders using this material was that a stone lintel could be loaded without failure in tension up to a 0.9 m maximum span; any longer than this and a relieving arch would be necessary (Salvatore Bondin, personal communication) (Fig. 10a). When such an arch was absent, “the stones directly above the lintel were often notched out so that they did not rest on the top

corners of the lintel” [40: 198] (Fig. 10b). Another solution used at Casa Ippolito was to increase the depth of the lintel by 50% for a 0.9 m span [2] (Fig. 10c). Failures in masonry lintels for spans less than 0.9 m occurred due to corrosion and the subsequent expansion of the iron grills, which causes typical cracking in stone masonry—lintels, jambs, etc.—when the inserted metal corrodes. For larger openings, masonry arches were used.

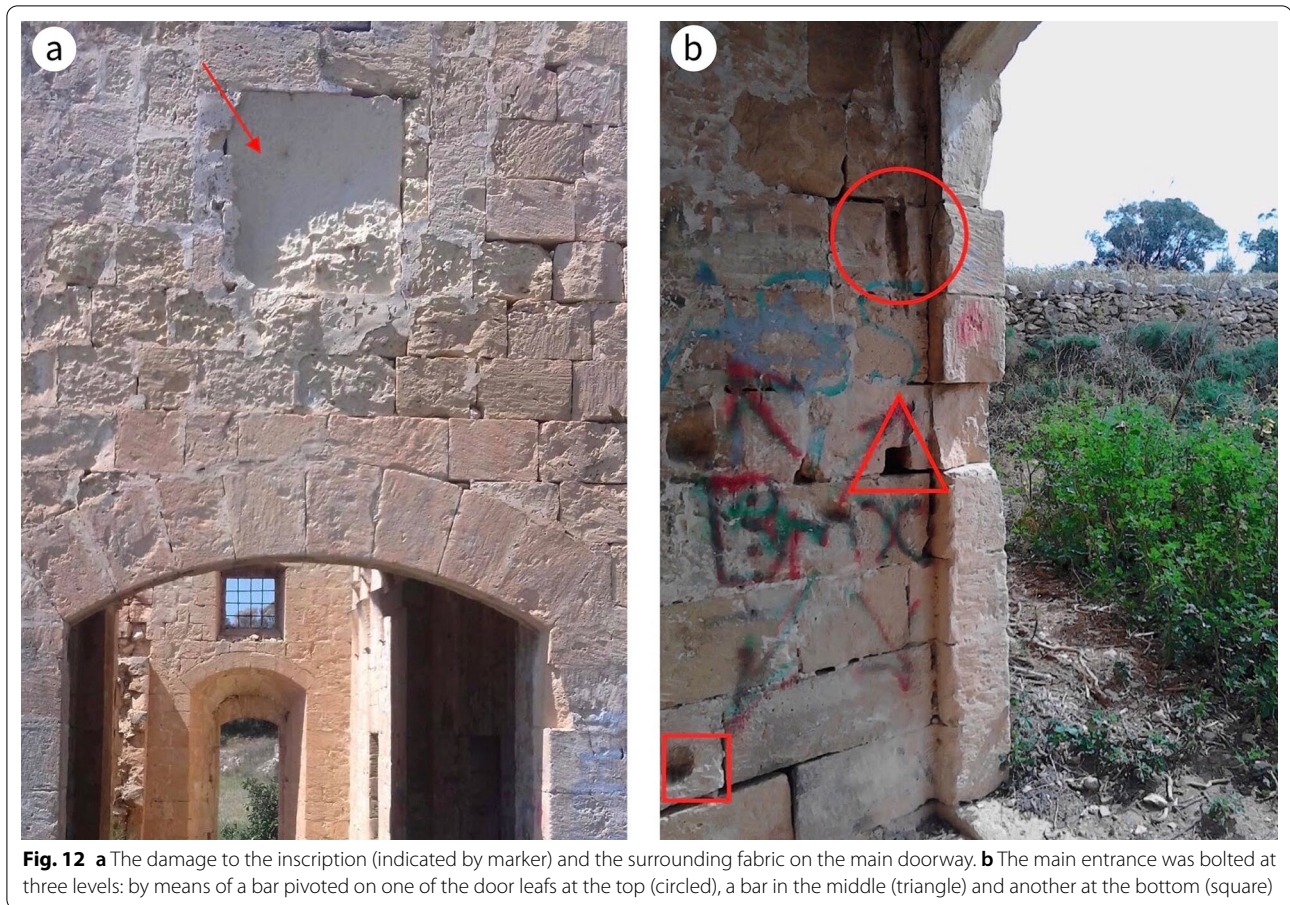
Freshly quarried LGL must be sculpted within the first four years, after which the stone forms a hard crust. If not used within this period, the stone would either be left unscribed or replaced. If the hard crust is damaged, the fabric deteriorates, with negative effects on the adjacent limestone ([40]: 199). The damaged inscription on the main doorway—which a century ago was still decipherable despite the stone being heavily deteriorated⁸—and the surrounding fabric exhibit this kind of deterioration (Fig. 12a).

1. At the top: there are two channels, both 50 mm wide and circa 370 mm long, set at the same height on either side of the door jamb (Fig. 12b). These grooves vary in depth along their length: viewed from the hall, the one on the right is 0 mm at the top and 40 mm at its bottom; the one on the left ranges from 0 mm at the bottom to 80 mm at the top; they appear to mark the outer edges of a circle. This implies they accommodated the clockwise motion of a bar, most likely made of timber, which revolved around a pivot set into the inside of the door. When the bar was in a vertical position the door was unlocked, and when swung clockwise into a horizontal position, its ends
