THE CONSERVATION & RESTORATION OF THE WALL PAINTED CEILING OF THE MELLIEħA SANCTUARY

Dott.ssa Maria Grazia Zenzani and Valentina Lupo B.Cons (Hons.)
ATELIER DEL RESTAURO

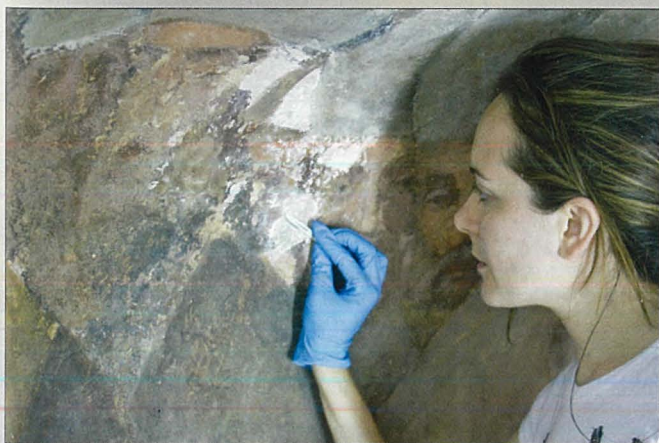
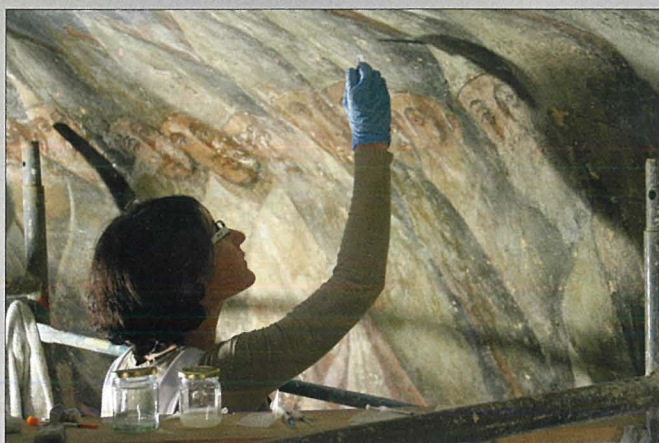
A conservation-standard adhesive was injected slowly under the detached paint layer and flaking

areas by means of insulin syringes. Heat and pressure were then applied over the area by means of a heating spatula. The heating spatula was used over a Melinex® sheet to avoid direct heat over the paint layer, pressure was then applied in circular movements to re-adhere the paint film to the plaster layer.
