# Resistance of ETICS with Fire Barriers to Cyclic Hygrothermal Impact

**Abstract:** The article presents the results of a set of hygrothermal experiments of an external wall insulated with an ETICS. As an add-on to previous studies, thermal insulation in the form of polystyrene with an additional horizontal strip of mineral wool was used. Laboratory tests were carried out in accordance with ETAG 004. The ETICS test rig was composed of combustible expanded polystyrene foam (EPS) and horizontal strips of noncombustible mineral wool (MW) fire barriers over windows. The physical and mechanical properties of four types of finishing renders (without an additional reinforcement mesh in base coat of the fire barriers) were analyzed across full hygrothermal cycles in a climate chamber. Temperature sensors were mounted onto different ETICS layers to collect thermal data during the weathering. The testing of ETICS regarding their hygrothermal performance revealed that there were no visible defects on any renderings and over the junctions depending on the type of used insulation materials. Results also showed that the joints of EPS and MW have approximately half of their bond strength from p

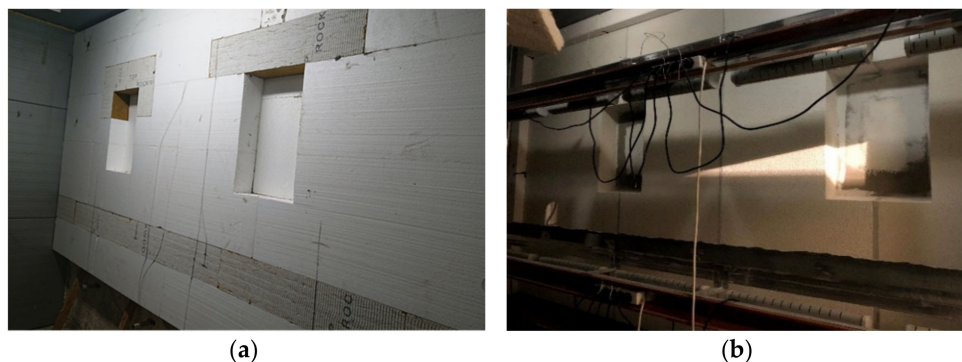
A silicate brick wall was constructed (3.0 m wide by 2.2 m high) with installed ETICS panels (Figure 1) in accordance with 5.1.3.2.1 ETAG 004 [19]. Four different types of thermal-insulation systems were applied on the wall, namely, with acrylic, silicate, mineral, and silicone finishing coats (of whitish color). Mineral rendering was painted with silicone paint. The thickness of the basecoat was 3–5 mm. In order to examine the worst-case scenario of ETICS, 1 mm thickness finishing coats were selected except for a 2 mm thickness mineral coat. Thermal-insulation boards were mechanically fixed with plastic anchors (4 pcs./m<sup>2</sup>) with supplementary adhesive.

**Figure 1.** (a) EPS thermal insulation with mineral wool fire barriers; (b) test rig with 4 types of plastering during the test.

The same mineral base coat together with a reinforcing mesh was applied to all ETICS without additional reinforcement mesh on the fire barriers. The horizontal strip of mineral wool (200 mm width) was installed in the lower part of the rig and above the openings. ETICS were installed according manufacturer's instructions; this was submitted to laboratory conditions (temperature  $20 \pm 5$  °C) for 4 weeks. During the first 20 days, the rig was subjected to 80 heat–rain cycles and 5 heat–cold cycles:

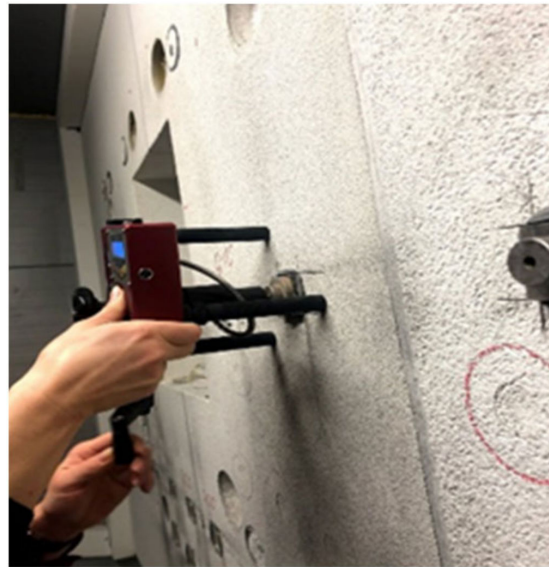
Furthermore, hard-body impact (as per ETAG 004 5.1.3.2.1 [19]) and bond-strength (as per ETAG 004 5.1.4.1.1 [19]) tests were performed. The test was performed with adhesion tester CONTROLS 58-C0215/T (Figure 3). The plates were pulled at a speed of 1 to 10 mm/min. Individual and average values were recorded and are expressed in MPa. The pull of the test was performed at  $18 \pm 2$  °C at SD =  $50 \pm 5\%$ .

**Figure 3.** Testing of the bond strength of ETICS.

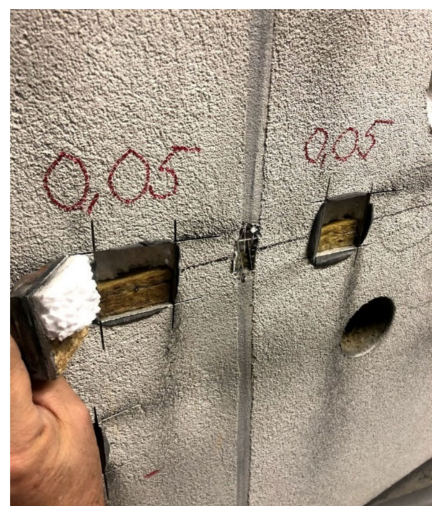
After the hygrothermal cycle had ended, the obtained adhesion strength was 0.11 MPa. This was measured at the points where pulling was performed from the polystyrene foam; at the points where pulling was performed from the mineral wool, adhesion strength was 0.1 MPa; when measuring connections between polystyrene foam and mineral wool, such pulling pressure stood at  $-0.05$  MPa (Table 3, Figure 6). Test results showed that the joints of EPS/MW had approximately half the bond strength of that of EPS. This was evident at the intersection of the two substances, polystyrene and mineral wool.

**Figure 6.** Testing of the bond strength of ETICS: an example of the typical pull-off at the joint of EPS/MW.

The joints of polystyrene and mineral wool had approximately half of their bond strength from polystyrene. The hard-body impacts to all tested ETICS were similar on all analysed types of thin-layer render surfaces. Only in the case of ETICS no. 3 (mineral render) was the damage greater when the base layer was applied on EPS, and in places where there was mineral wool and at the joints, the damage was smaller or nonexistent.
