## A Sustainable Development Centre: Xrobb il-Għagin Nature Park, Malta.

**ABSTRACT:** The Sustainable Development Centre is located within the Xrobb il-Għagin Nature Park at Xrobb il-Għagin in Malta. The scope of the project is to rehabilitate an existing complex of buildings used for other functions over the years, and to transform the buildings into a Sustainable Development Centre, within the Nature Park to accommodate a new scientific and educational facility. The sustainable rehabilitation of the buildings is based on a comprehensive approach, addressing the architectural value of the buildings, the functional requirements, structural interventions and repair of the structures, the conservation of resources, water conservation, waste water recycling and waste management, services, the inclusion of energy efficiency measures and the use of alternative and renewable energy sources.

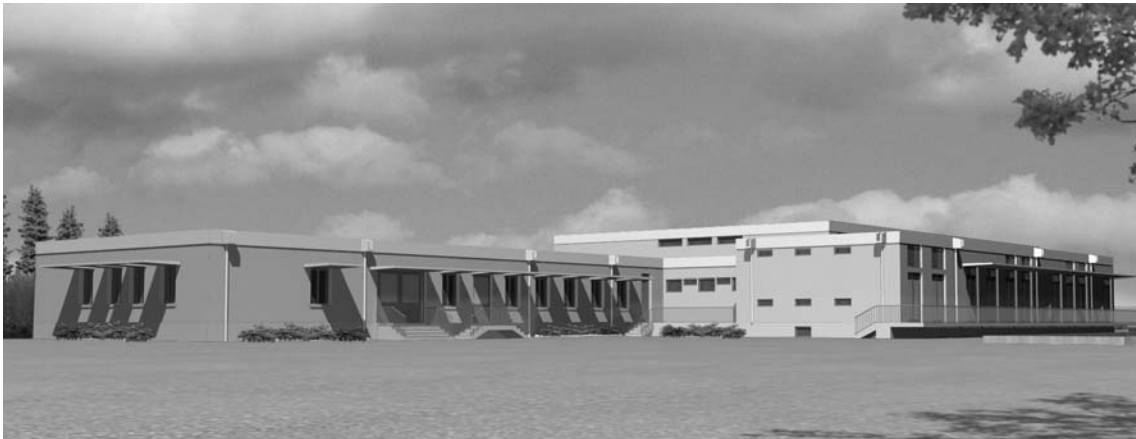
Figure 1. Representation of The Sustainable Development Centre after Rehabilitation.

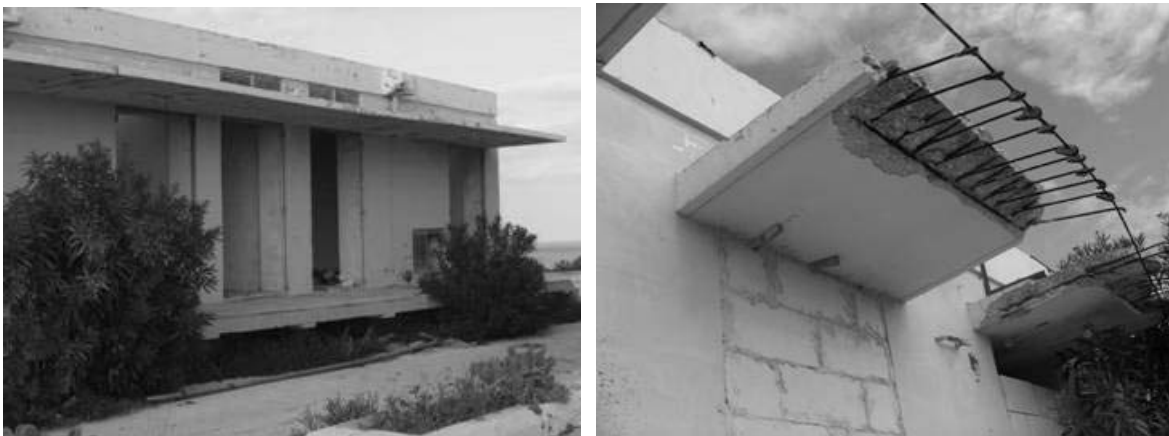
Figure 2. Existing deteriorated structure & reinforced concrete elements on façade prior to repair.

A number of defects were also noted in the structural elements, with the partial collapse of roof structural elements recorded. The main defects in reinforced concrete elements were cracked concrete, reinforcement corrosion and concrete spalling. In various instances, this resulted in detached concrete and exposed excessively corroded reinforcement and loss of elements and architectural features including the cornice and cantilevers on the façade. Specific roof structures were excessively deflected, in view of past actions on the roofs. Defects in the roof system included longitudinal cracks along the beam elements of the slabs, and defects and cracks in the concrete blockwork supported between beams in the roof slabs. Various defects were also noted in masonry wall structures namely hairline cracks and local defects in stone, due to impact and misuse, and defects as a result of inadequate interventions during past alterations to the buildings. Loss of finish and mortar on exposed surfaces was also recorded.

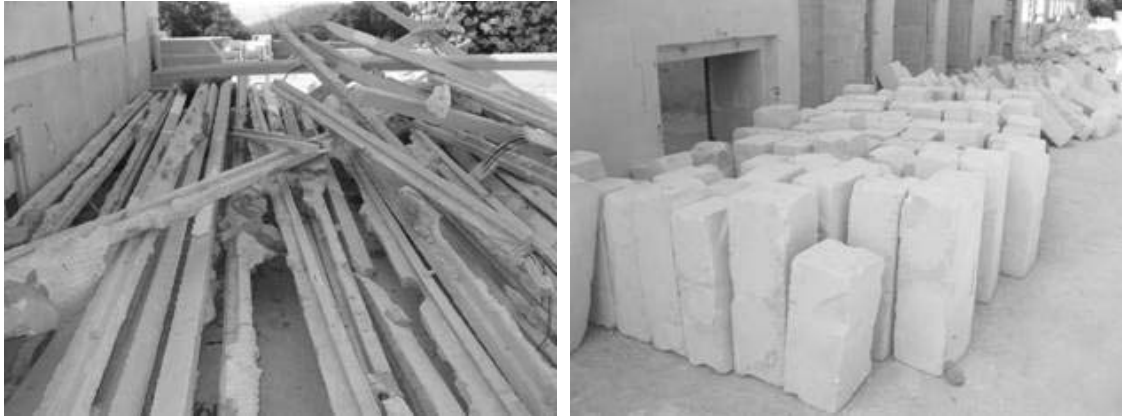
Figure 3. Dismantling and waste classification: RC roof elements and wall masonry elements.

The reuse and recycling required the separation and classification of the waste materials. The waste materials generated were identified and quantified and the methodology adopted followed the Waste Management Plan. The stone masonry blockwork was dismantled and stacked in a storage area on site. They were classified into two main groups; those suitable for reuse in secondary construction, and waste blockwork to be recycled for production of crushed stone for screed and other uses. The reinforced concrete elements were classified on site into two groups; concrete elements and reinforced concrete beams and slabs. These were transported for recycling. The reinforced concrete elements required the separation of the steel from the concrete for recycling, and concrete was crushed for the production of recycled concrete aggregate.
