PAST STONE RESTORATION METHODS IN THE MALTESE ISLANDS

Joann Cassar

Museums Department, National Museum of Archaeology,
Auberge de Povenue Valletta, Malta

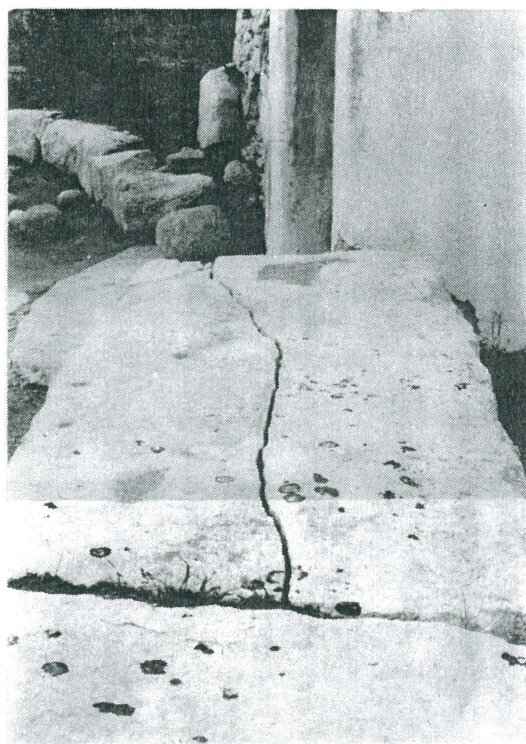
Plate 2 Horizontal block showing a deep crack throughout the entire length.
Tarxien Temples.

The prehistoric temples are subject to two types of deterioration: structural decay and surface decay. Structural decay manifests itself as cracks or fissures, usually in the vertical stones, but sometimes also in the horizontal ones (Pl.2). This may occasionally be attributed to the way the blocks were originally laid. In fact, they can at times be seen to be resting on an uneven base (sometimes even lying on stone rollers used to manoeuvre the megaliths into place and then left lying underneath them). The sheer weight of the block itself, often increased by that of overlying courses, sometimes results in the block splitting. Besides, neglect over thousands of years, accidents and vandalism have all contributed to deterioration of these temples. Another problem occurs when the massive blocks begin to lean rather dangerously, often threatening the collapse of the entire structure. This has occurred in the past in the Ggantija temples, and appears to be occurring more recently at the Mnajdra Temples.

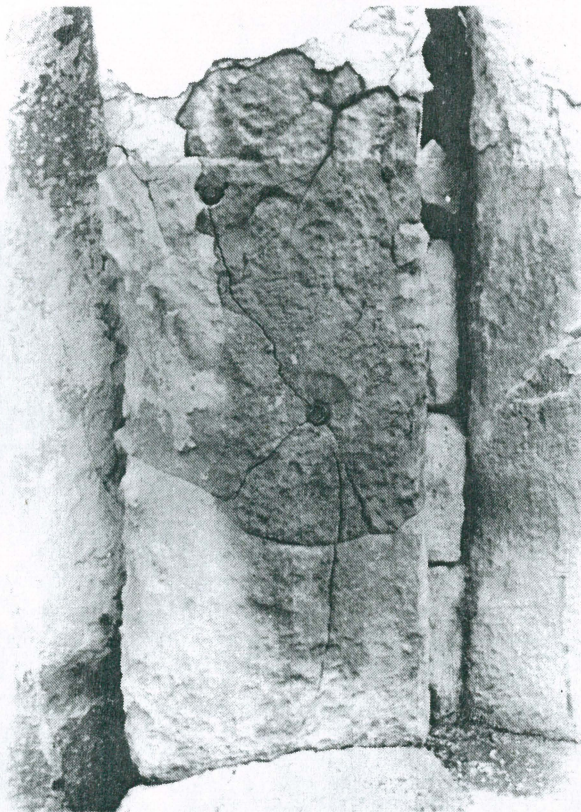
Plate 4 Rusting iron dowels cause the formation of a series of new cracks in the block where they are embedded. Tarxien Temples.

In more recent years we find that Portland cement was still being used to repair broken or cracked blocks in the megalithic temples. In 1972 a cement grout was used to patch up two badly cracked stones in the Tarxien Temple complex (the stones had been badly damaged by fire, probably during the Bronze Age when we know that the temple was re-used as a cemetery). Unfortunately, at some point it was also decided to insert iron dowels to hold one of the cracked blocks together, and the resulting damage caused by this repair can be seen in Plate 4. At times, instead of dowels, dove-tail joints, filled in with cement, were used to hold together two large pieces of the same block which had broken apart (Pl. 5).

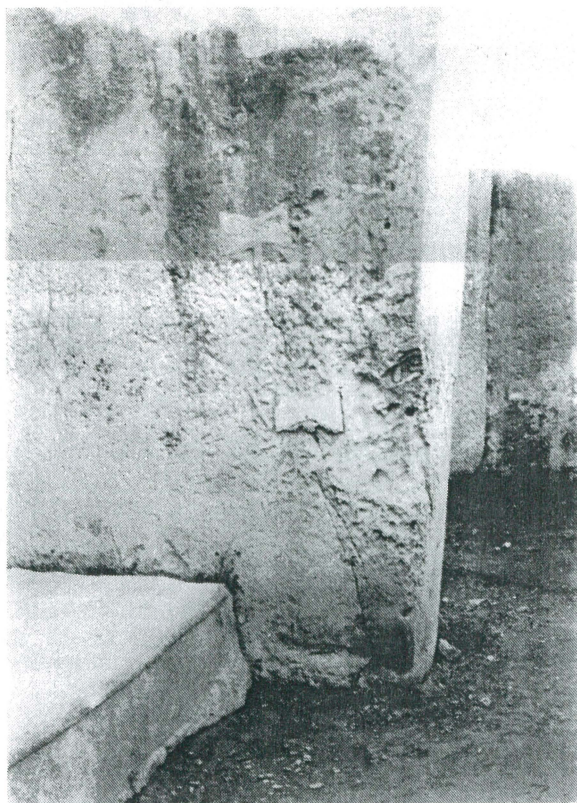
Plate 5 Dove-tail joints holding together two parts of a broken megalith. Tarxien Temples.

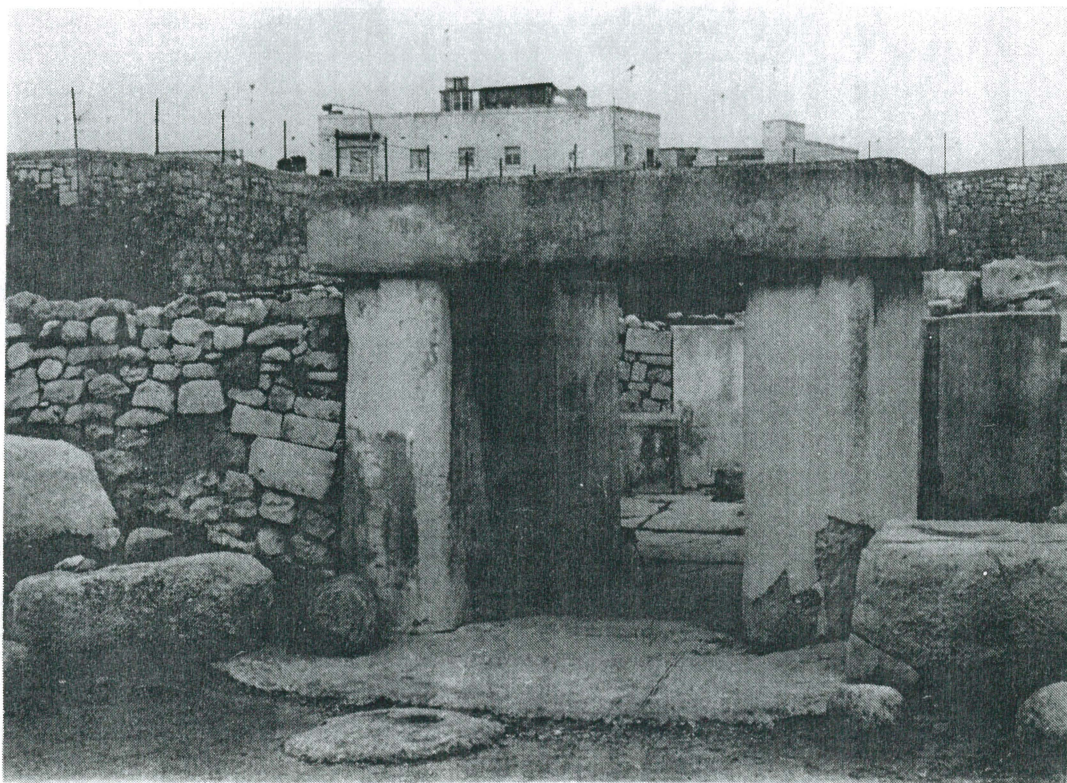
Plate 6 Main doorway of the Tarxien Temple Complex, restored in concrete.

of improving the general appearance of the site. In many cases this was done in order to replace the drystone-walling which had previously been used to complete missing apses and broken orthostats. As far as possible, the stones which were repaired were those for which evidence remained of their original dimensions. Where this was lacking, the top of the blocks was left irregular in order to indicate that these blocks were originally higher. In the case of the main entrance, however, the exact height was not known, and only by using calculations based on the heights of other doorways was this arrived at (Trump 1972) (Pl. 6).
