ACTIVE TRAVEL WORKSHOP REPORT

Findings and recommendations from the symposium on Active Travel and Technology

Institute for Climate Change and Sustainable Development - University of Malta

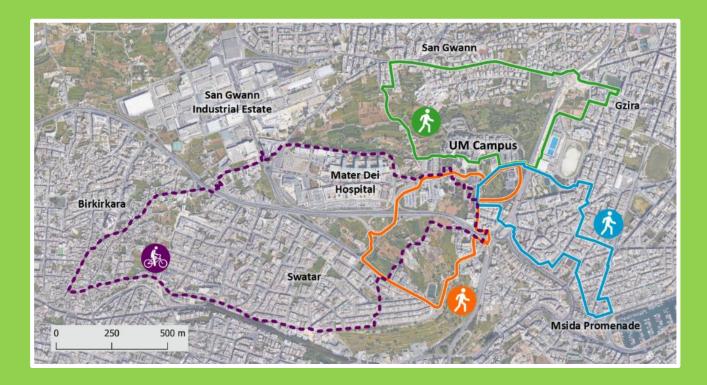
Figure 1. Walking and cycling routes around the UM Campus

Participants signed up to one of four groups and went for a guided walk or cycle following different predefined routes around UM Campus as part of the active travel workshop, in order to experience for themselves the different aspects of the infrastructure and the environment. The routes are mapped in Figure 1.

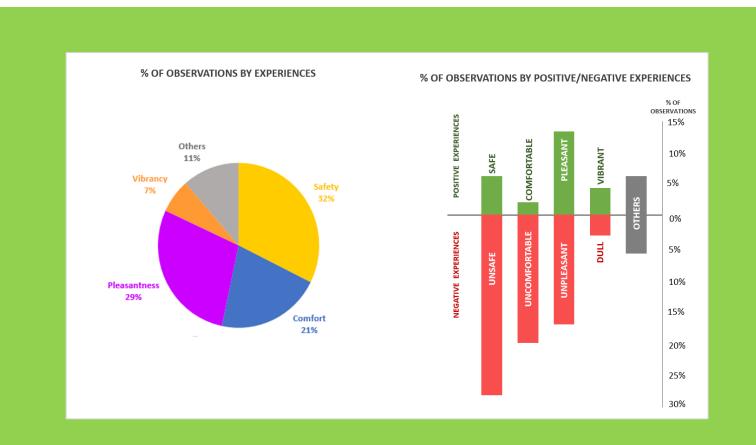
Figure 3. Distribution of all observations (n=105) by type of experience

Along the pedestrian and cyclist journeys, participants collected a total of 105 observations of the urban public space. Figure 3 presents the observations organised by type of experience. Safety was the main concern with over 30% of all observations, which had a remarkable unbalance between unsafe (82.4%) and safe (17.6%) experiences. Similarly, uncomfortable pedestrian experiences (90.9%) clearly outweighed comfortable ones (9.1%). Pedestrian experiences related to pleasantness were the second most cited concerns (29% of all observations) and they had a more balanced share between positive pleasant (43.3%) and negative unpleasant (56.7%) observations. Experiences related to urban vibrancy showed less reported cases (7% of all observations) with a rather even balance between vibrant (57.1%) and dull (42.9%) places. Although participants were asked to use predefined variables to rate their experiences, 11% of all observations either included different variables (i.e. not welcome, unattractive, problematic, and unhealthy) or the observations only included a picture or some text without any indication on the experience. These observations have been included as 'others'.

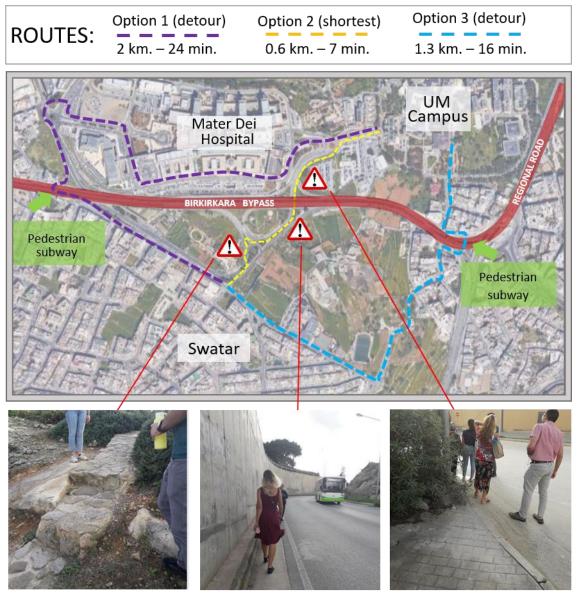
Dangerous path between UM Campus and Swatar

Irregular and discontinuous pavement

Absence of pavement. Pedestrian framed between wall and fast traffic

Absence of pedestrian crossing with limited visibility

One of the walks in the active travel workshop linked the UM campus to Swatar, following a path which is widely used by pedestrians, even though it fails to meet many safety and comfort standards. The residential area of Swatar (where many students live or park their cars) is safely connected to UM through two routes (subway to Mater Dei, Route Option 1 in the map above and subway through Skate Park, Route Option 3). However, these routes require a considerable detour. As a result, pedestrians often choose a much shorter route (Route Option 2), which involves walking on irregular pavement and on the road with no pavement, framed between fast traffic and long and high walls and then crossing the road without pedestrian crossing and very limited visibility. This is an example of how deficient pedestrian network connectivity encourages pedestrians to use dangerous alternatives to save time.

Create pedestrian crossings and a continuous pavement for pedestrians to safely cross from the Università bus stops, under the tunnel and up to Swatar (Route Option 2). Limit traffic speed to 30km/h, include traffic calming infrastructure and place pedestrian bollards along the area where pedestrians walk near the wall to improve the (perception of) safety near and under the tunnel.

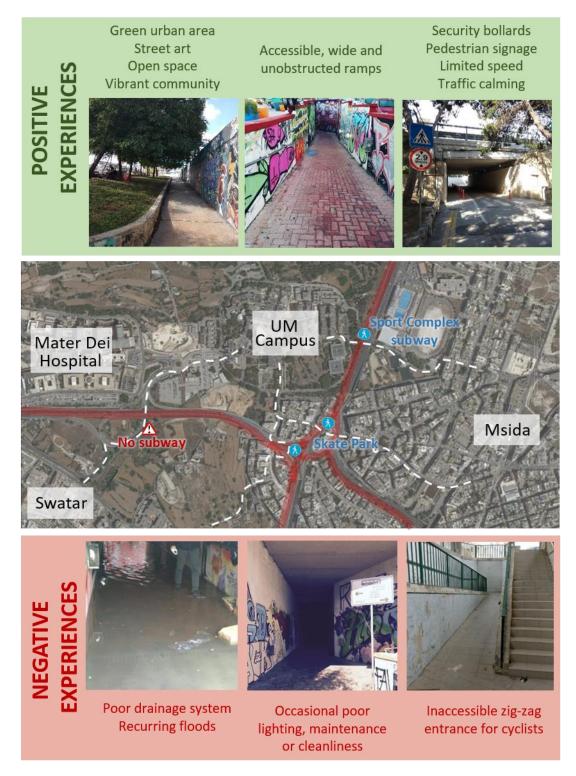
Subways at Skate Park and Mater Dei: a missed opportunity

The pedestrian subways allow pedestrians to cross main arterial roads, such as Regional Road and the Birkirkara bypass. While grade-separated infrastructure such as subways can be a good solution, the subways at Skate Park and Mater Dei need improvement and upgrading. Participants indicated that it feels a bit like a "rabbit hole" and gave them mixed feelings: on the one hand it is quiet and away from traffic, but on the other hand they report an unpleasant feeling: "it can be scary to walk here alone, especially in the dark".

Current issues with the subways relate to a lack of maintenance and proper design. Drainage is poor: the drainage facilities are so limited that during and after heavy rain the subway floods to the extent that pedestrians cannot make use of them. There is rubbish and debris lying around and a general lack of upkeep. The Skate Park and Mater Dei subways lack basic clear signage to indicate the appropriate directions and connectivity with the bus stops. The subway design includes a number of blind corners, which create danger and potential conflicts between the different users of the subways: pedestrians, people on skates and skateboards, cyclists and micro-mobility users (such as e-kick scooters). The lighting is substandard and many of the mirrors in the corners are broken, hindering good visibility and safety for users. The ceilings of the subways are low, causing problems for cyclists mounted on their bicycles, as well as adding to a feeling of enclosure, which can make people feel uncomfortable, especially at night.

Invest in the refurbishment of the subways, paying attention to the identified issues (lighting, visibility, space, drainage, rubbish). Draw up a management plan for regular maintenance by responsible authorities.

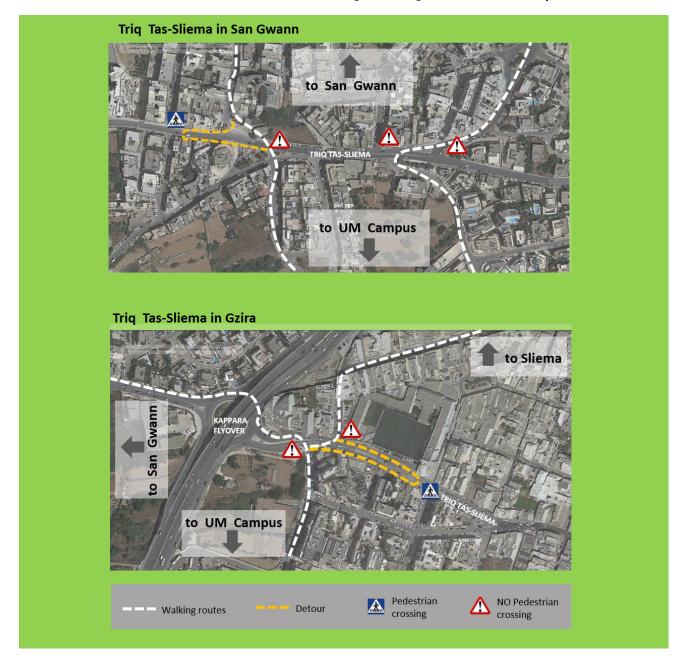
Locations of pedestrian crossings in San Gwann and Gżira

The group walking from the University campus to San Gwann, looping back from Gzira and the National Pool complex, encountered another example of deficient pedestrian network connectivity. In this case pedestrian crossings are placed far from their optimal position (the pedestrians' 'desire line') to promote traffic flow for vehicles. In the words of one of the participations, "this makes pedestrians feel like second class citizens" and does not encourage walking as a mode of transport.

Review road designs and explore possibilities for creating more direct pedestrian connections via the creation of additional (or replaced) zebra crossings at the locations where pedestrians desire to cross (as indicated by the red triangle traffic signs on the above maps).

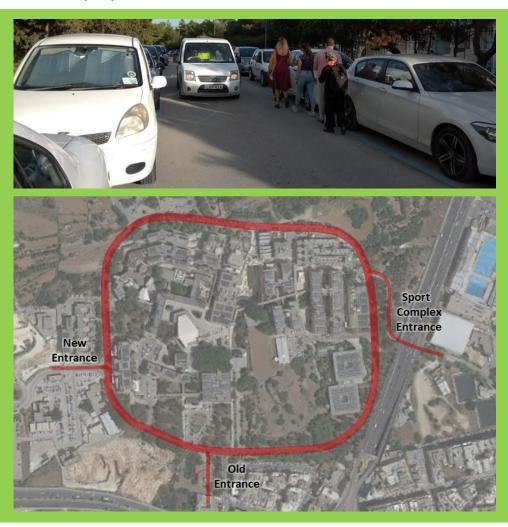
Ring Road at University of Malta campus

The ring road at the University of Malta campus consists of a one-way carriageway and parking bays on both sides. It is exclusively dedicated to cars even though it also serves pedestrians who walk to and from campus. There is no pavement or cycle path for pedestrians or cyclists, nor any signage indicating that this is a shared space. There are signs indicating that the speed limit is 20 km/h, but this is not observed by all drivers. The university ring road is frequently used by pedestrians and cyclists to move around the university, from one building to another. As one participant pointed out, "it is an uninviting welcome to pedestrians and cyclists". Participants explain that cycling against traffic on the ring road is risky, but since there is no infrastructure and in order to avoid having to cycle the full ring road just to go from the New Entrance (at Gateway) to the Old Entrance of University, some cyclists do this anyway.

Create safe and continuous pedestrian connections from all entry and exit points of the university. Use traffic calming measures and shared space signage to indicate that the ring road carriageway is for the shared use of all road users (pedestrians, cyclists, car users, etc.). Explore the possibility of making the ring road a pedestrian priority area. Create a contraflow lane for bicycles and micromobility users between the New Entrance (at Gateway) and the Old Entrance to University.

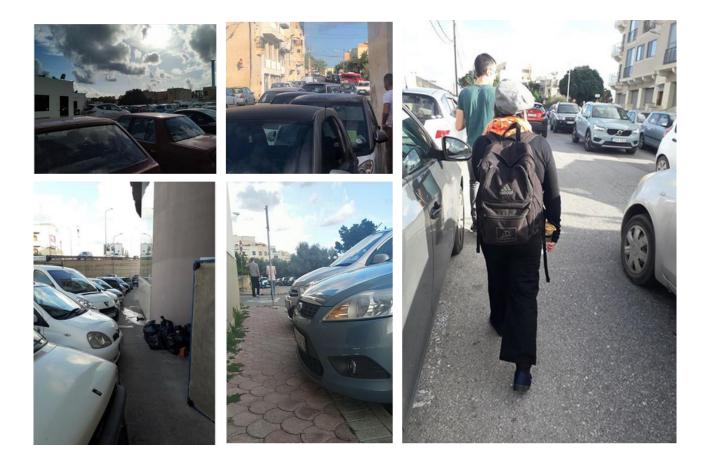
Narrow village streets and public space taken up by cars

Narrow village streets with cars parked on either side make it increasingly difficult to walk or cycle in what could be a pleasant environment. In certain areas the pavement is of such poor quality, or is blocked by rubbish, construction materials or parked cars, that there is no choice but to walk on the road. Participants noted that sometimes it was entirely unclear where they should walk, or who should have the right of way in a conflict situation with a car. People are left feeling vulnerable and unsafe, in the words of a participant: "do we need insurance just to walk around the street?"

Review road designs to reclaim and protect pedestrian space. Actively enforce illegal parking. Introduce traffic calming measures. Explore the possibility of (partial) pedestrianisation of village streets and/or replacing on-street parking to a parking area outside of the village core. In addition to the specific issues described above, there were also a number of recurring and crosscutting issues related to the active travel environment that were observed and experienced by the different groups. Potential solutions to these issues are classified into "hard" measures (infrastructure and design) and "soft" measures (incentives and enforcement).
