MINISTRY FOR TRANSPORT,
INFRASTRUCTURE AND CAPITAL PROJECTS

Triton Fountain Restoration & Inauguration

January 2018

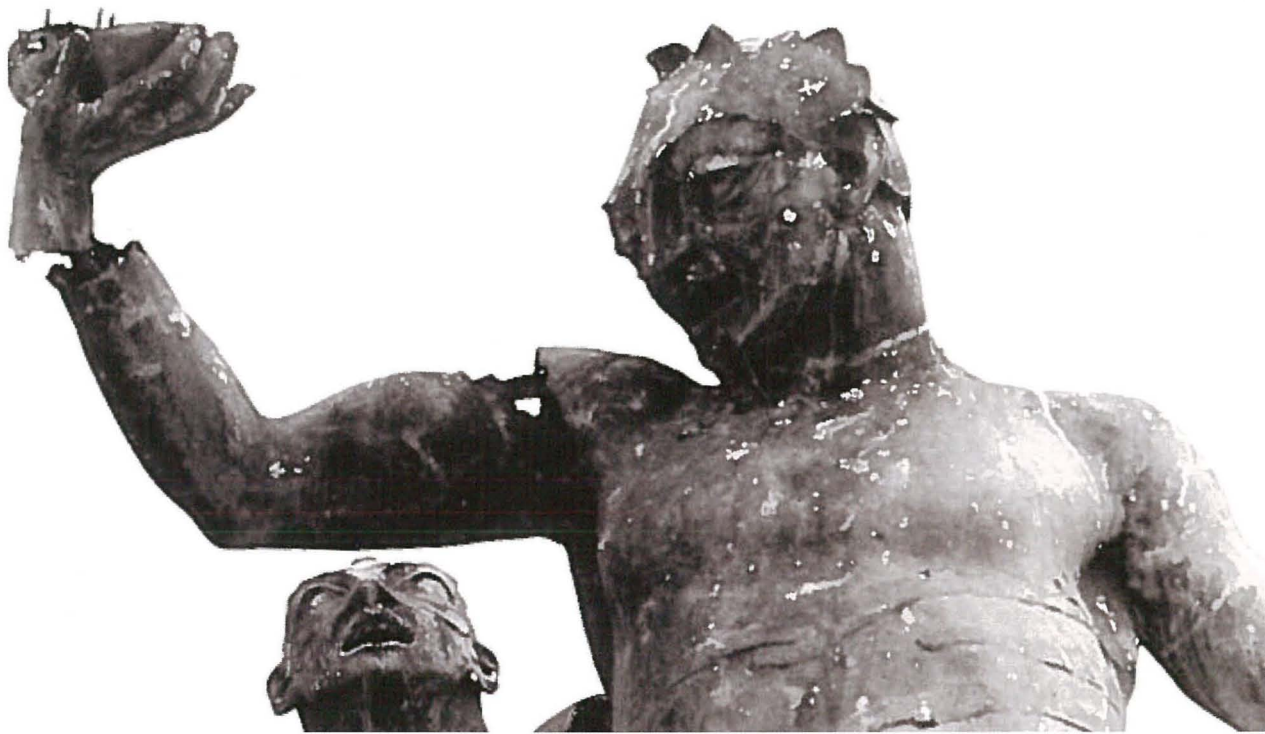
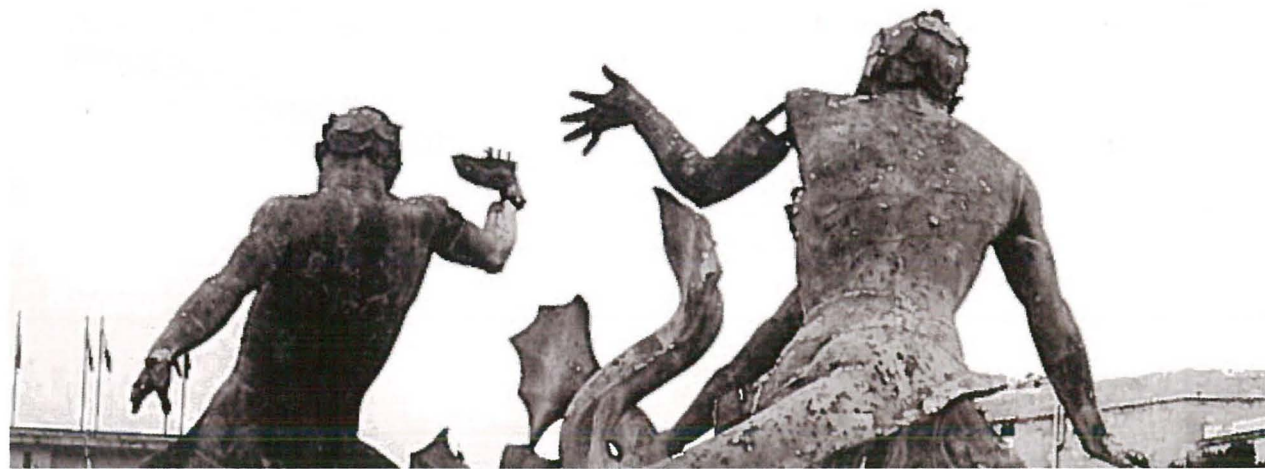
Although extensive surface damage was clearly visible, the internal decay of the sculptures was concealed. The most evident damage had been sustained by trauma and inappropriate repair. The casting quality of the statues left much to be desired. They are replete with manufacturing defects such as pores and steam cracks. Despite these defects,

The basin on top of the tritons was badly warped: by over 300mm at certain points, and was having a negative effect on its function as a water retaining and cascading element. To level the edge of the basin, a brass border had been welded to the lip, however this proved not to be sufficient and a second brass border had been soldered to the entire circumference of the basin. This again was not as effective as it was intended to be and this was corrected by the casting of a levelled reinforced concrete border along the irregular circumference of the basin.

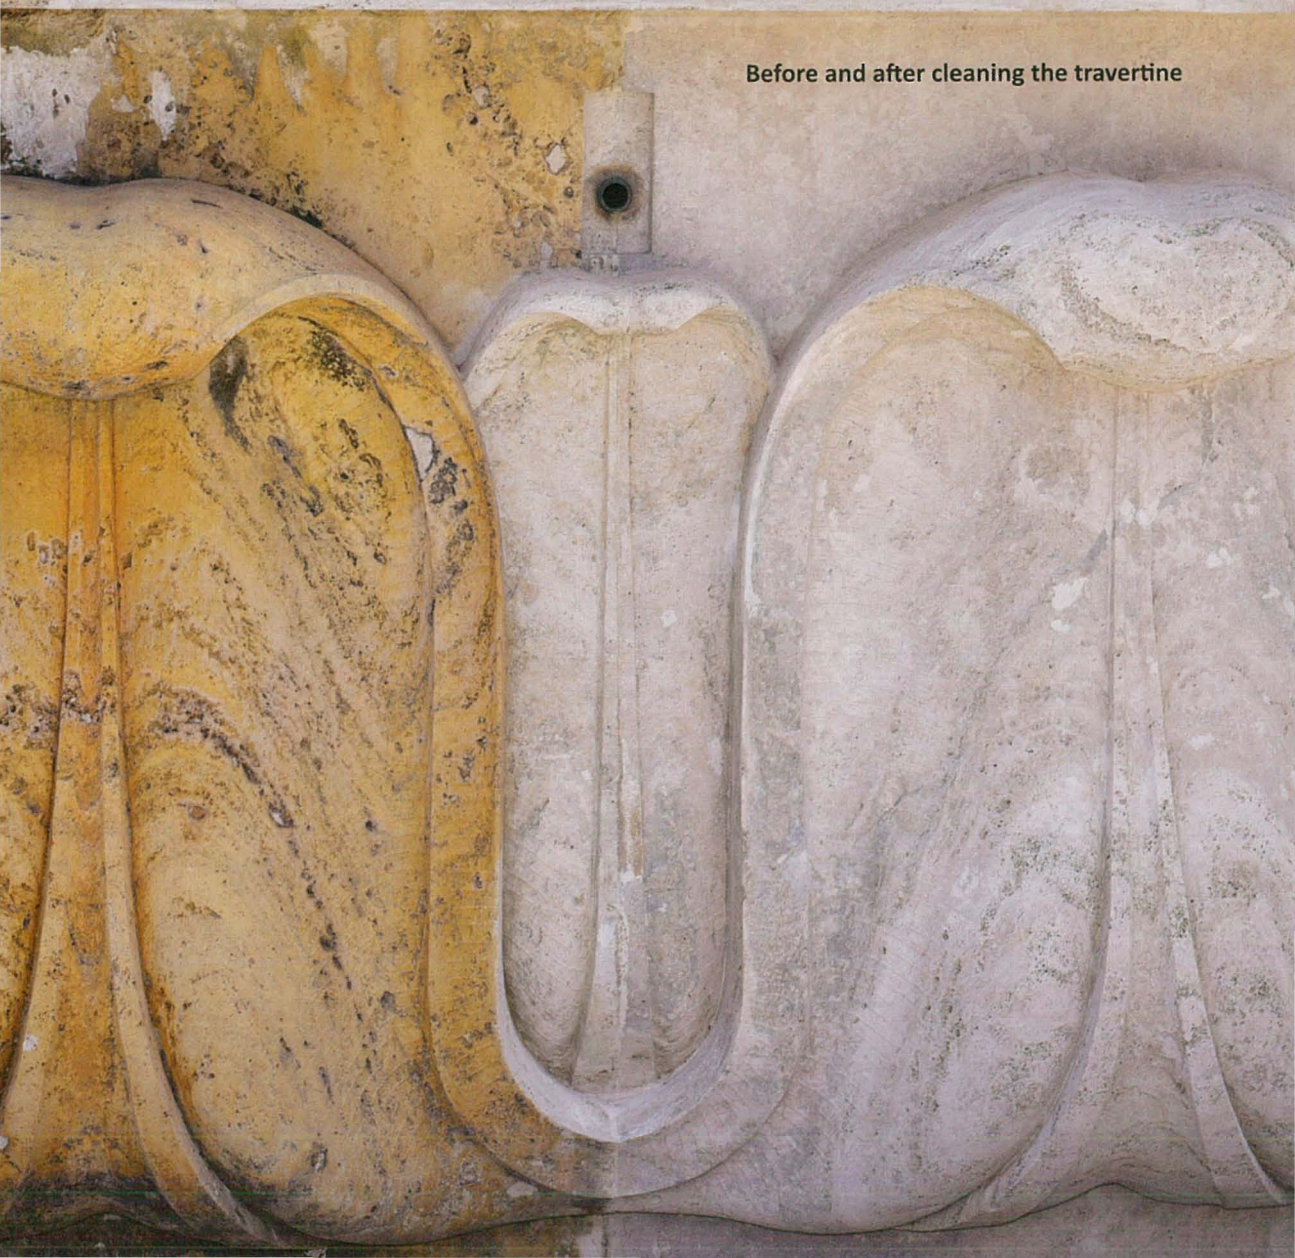
Before and after cleaning the travertine

Stains were removed by means of poulticing that extracts the salts and other pollutants from the pores of the travertine and by micro-blasting that removes stains from the surface of the travertine. The former was used for the carved relief
